WELLINGTON WATER RUAMAHUNGA FINDINGS ON MARTINBOROUGH OVERFLOW INCIDENT

**Appendix 1 – Martinborough
Wastewater Treatment Plant Overflow
Incident Investigation and Report**

Martinborough Wastewater Treatment Plant Overflow Incident Investigation and Report: January 2020

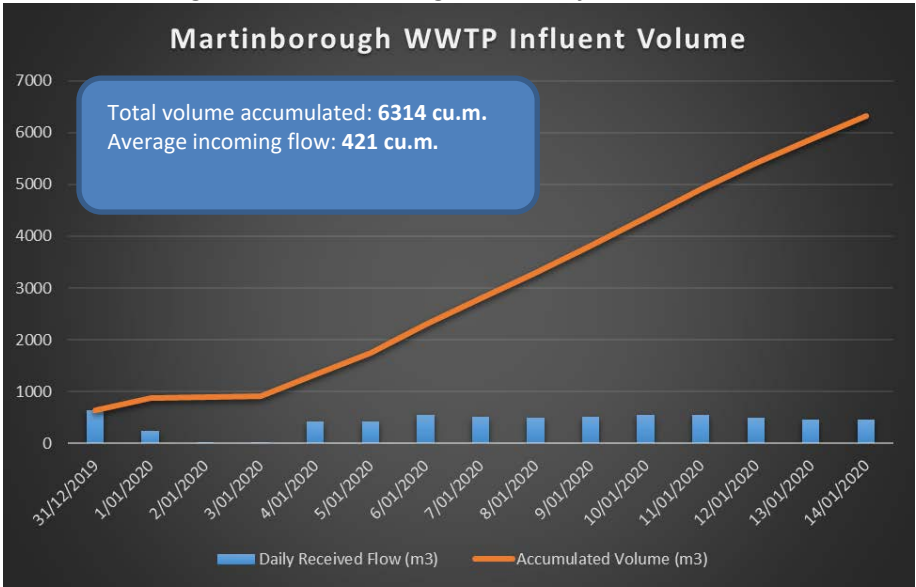
Figure 2: Martinborough WWTP Influent Volume

The accumulated incoming wastewater volume from December 31, 2019 to January 14, 2019 was 6314 cubic metres which is about 27% of the total capacity of the pond and exceeded the capacity of the available storage. The inability of the system to irrigate treated wastewater to land eventually led to an overflow from the maturation pond’s overflow pipe and over the pond’s bank. The graph for the inflow data is shown in Figure 2.

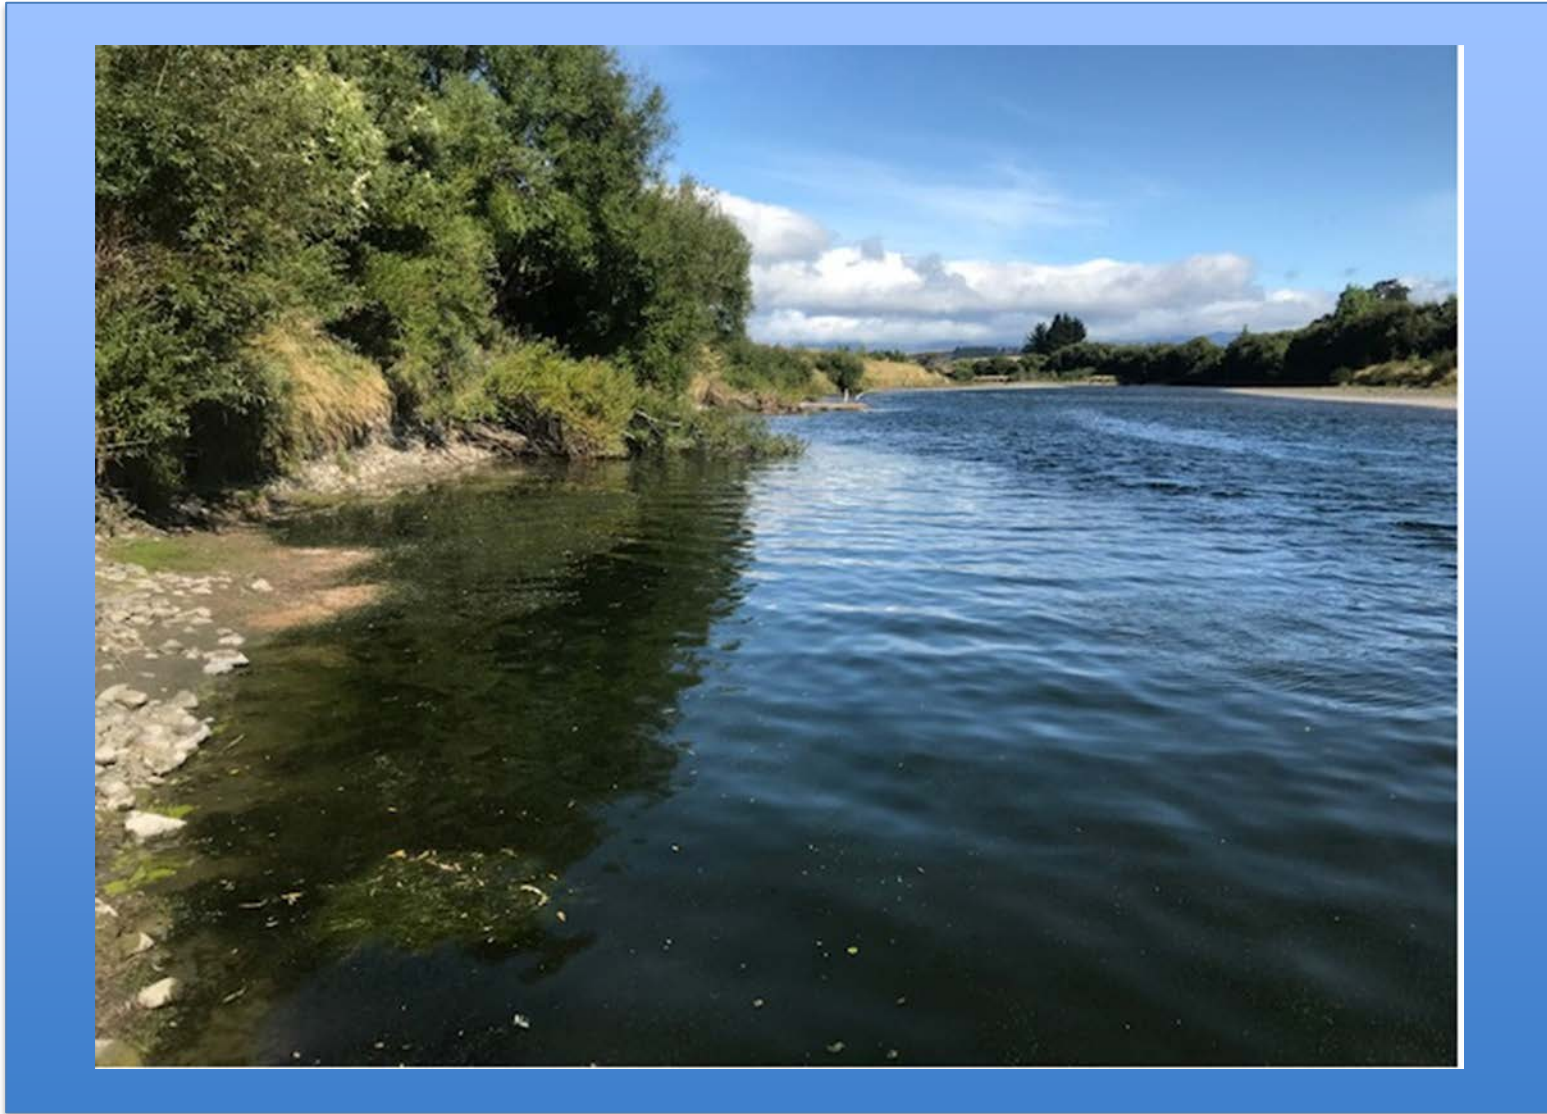
Visual Status of the River within 30m from point of discharge
