Appendix F

Performance of Existing Coastal Protection Measures

F.1 Section 1 – DOC Station

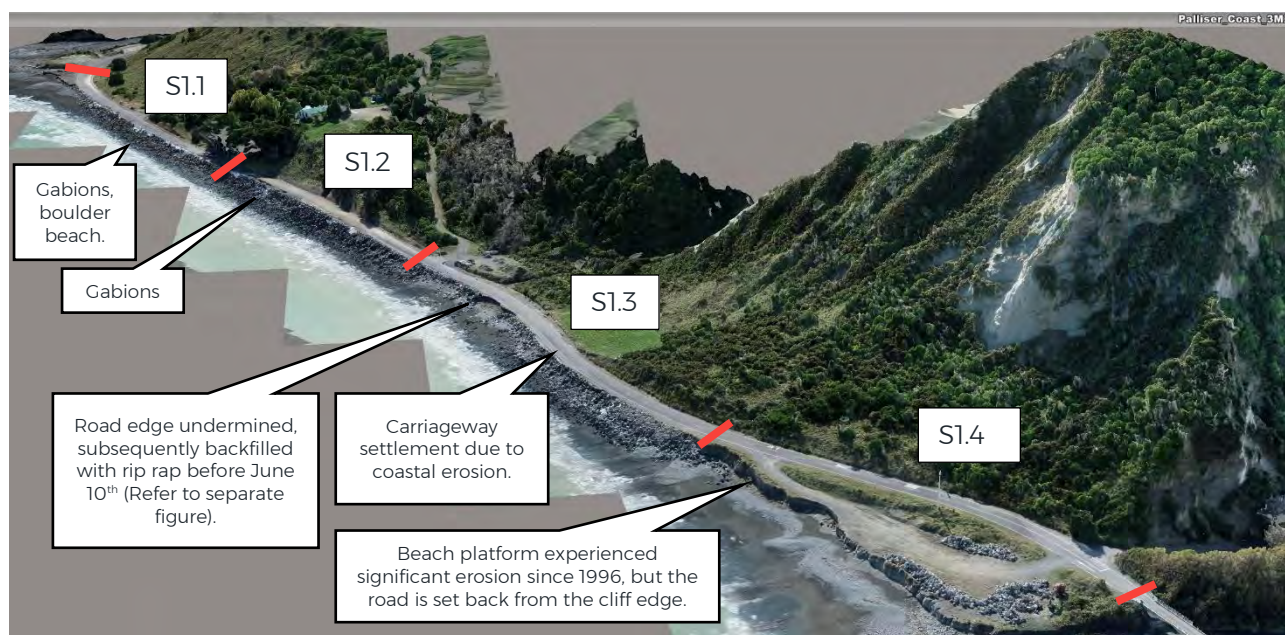
The cliff edge of this section is primarily covered by randomly placed rocks with exposed gabion baskets and geotextile (Figure 25). Technically, a coastal revetment structure can be determined as a failed structure when the most exterior layer of rocks, the armour layer, is moved by currents, turbulence and/or wave action, and leaves either underlayers or geotextile material exposed.

Figure 25: Screenshot from the May 2020 3D model of section 1, DOC Station, looking north. Subsection limits are represented by the red-lines.

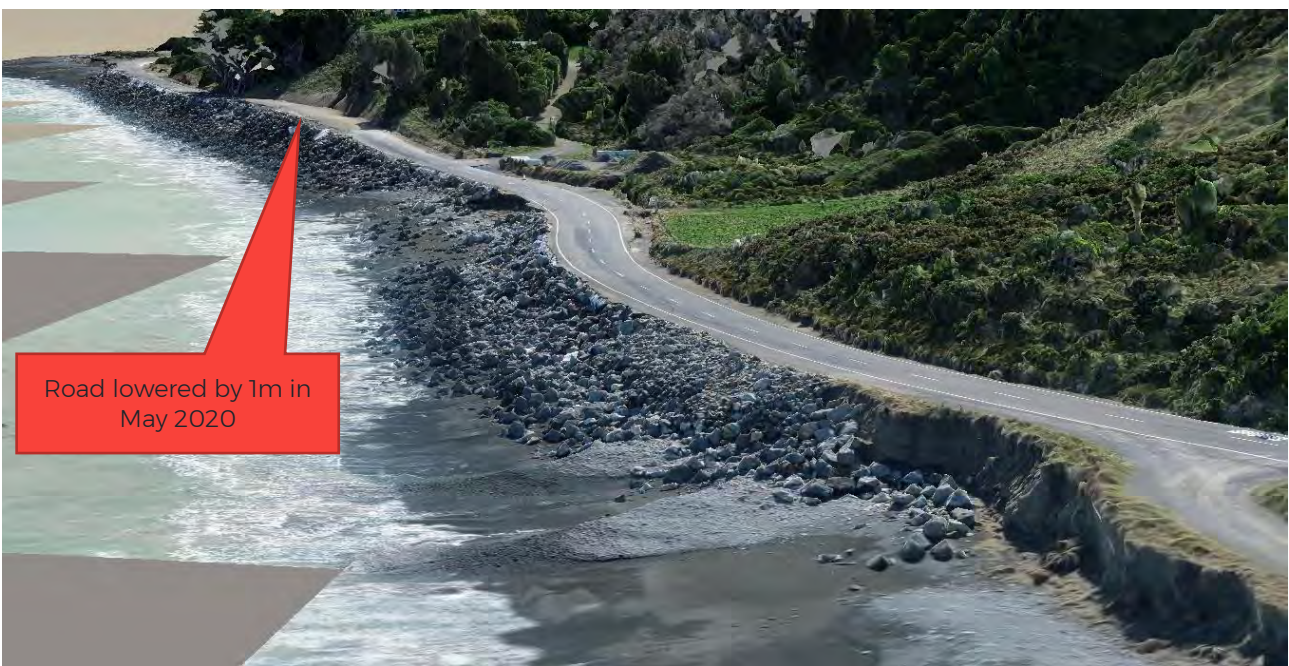
- There is clear **slope steepness irregularity** (Figure 27). Different slope steepness along the revetment can lead to sections of the revetment that are more susceptible to wave run-up and wave overtopping. The most vulnerable sections are usually those with steeper slopes, and these can be identified as the road behind these tends to require maintenance after storm events. It has been noted that a section of the road within Section 1 is lowered (Figure 27) to alter the slope and to reduce frequent maintenance costs. An elevation profile along the road is shown in Figure 28.

Figure 27: Perspective view of DOC Station (Section 1), approx. 800m in length. From WSP's UAV model, May 2020.

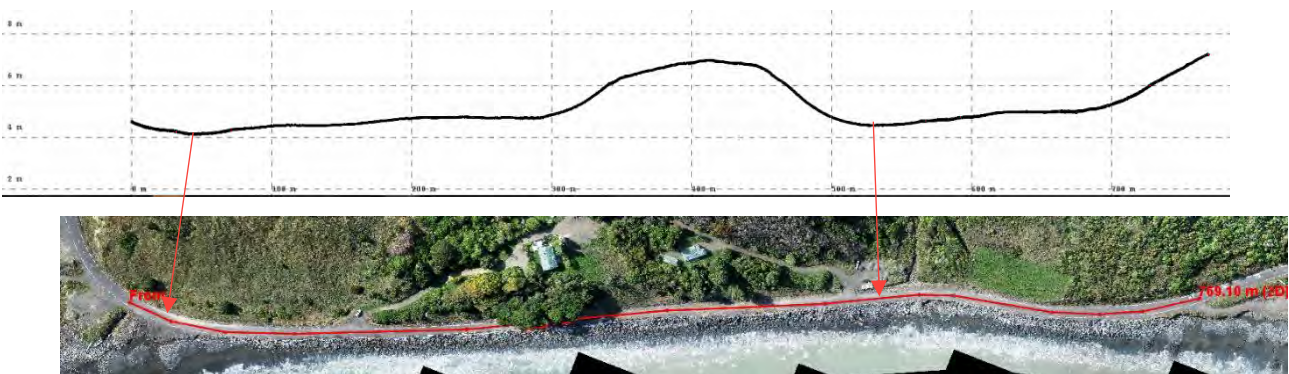
Figure 28: Road centre-line elevation profile for Section 1. Vertical scale is exaggerated. From WSP's UAV model, 10 May 2020.

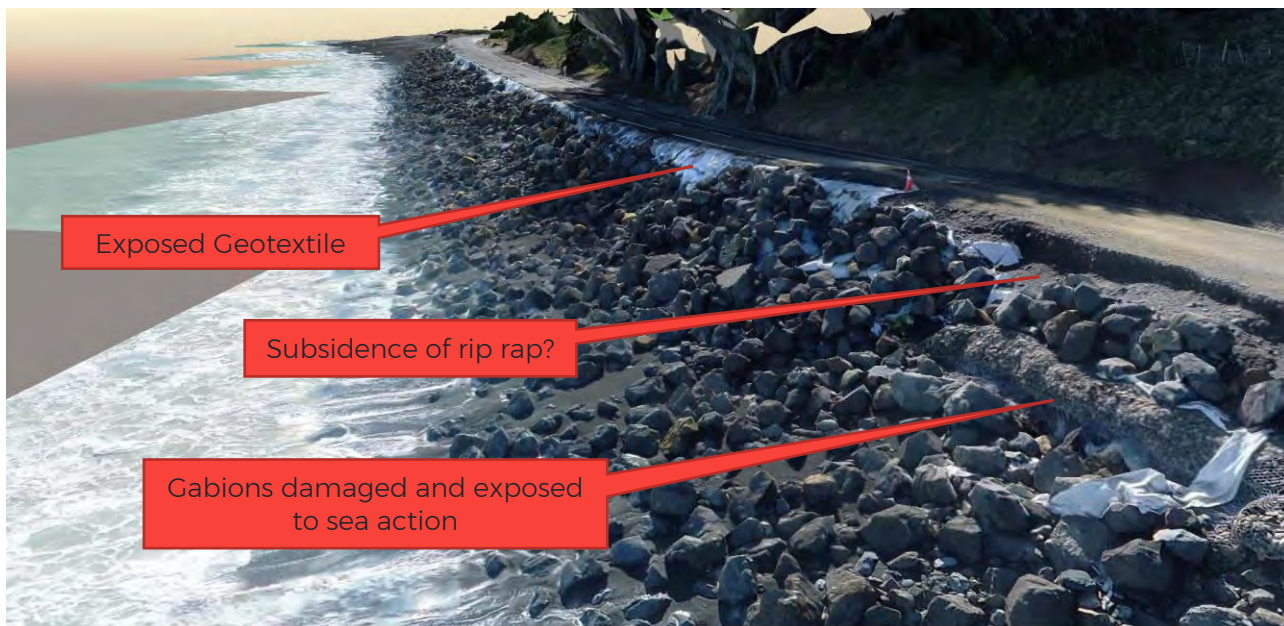
- **Exposed geotextile and gabion baskets** (Figure 29). The original revetment design (Figure 26) is no longer withstanding. The rocks composing the rock revetment armour layer are now scattered along the beach creating longshore irregularities. Also, both the geotextile placed underneath the armour layer and the gabions baskets used as a wall to sustain the road embankment are now in poor conditions and exposed to sea action. As mentioned before, this coastal structure is no longer fulfilling its erosion protection function.

- **The lack of base or support** directly affects the integrity of the structure. Screenshots from the May 2020 3D Model show revetment subsidence (Figure 29), which can be directly linked to the lack of structural support combined with wave action and natural fluctuations of foreshore levels. In Figure 32, a tension crack on the road is apparent along a section with newly placed rock rip-rap.

Figure 29: Coastal protection structures in Section 1.1. From WSP's UAV model, May 2020.

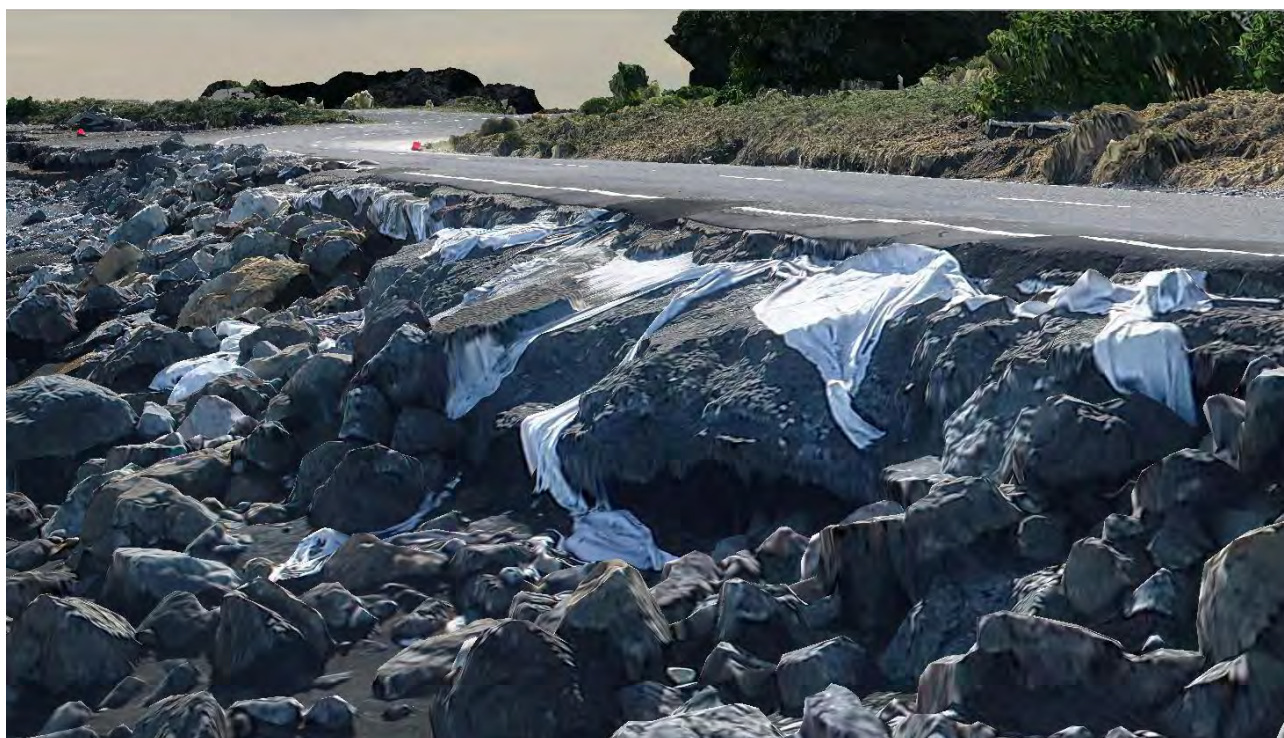
- **Stabilising cement sections are now undermined** (Figure 30). Cement has been used in the past in order to provide support to the road. The stabilisation cement is now overhanging and “floating” because wave action, combined with foreshore level fluctuations, have undermined the structure further. Undermining of the structure increases the risk of sudden

failure of the road and this, in turn, increases the risk of failure of the landward embankment and/or cliffs. Furthermore, with no base, the overhanging cement adds tension to the road and the cliff edge.

Figure 30: Section where stabilising cement has been used in the road sub-base in the northern section of the DOC Station reach.

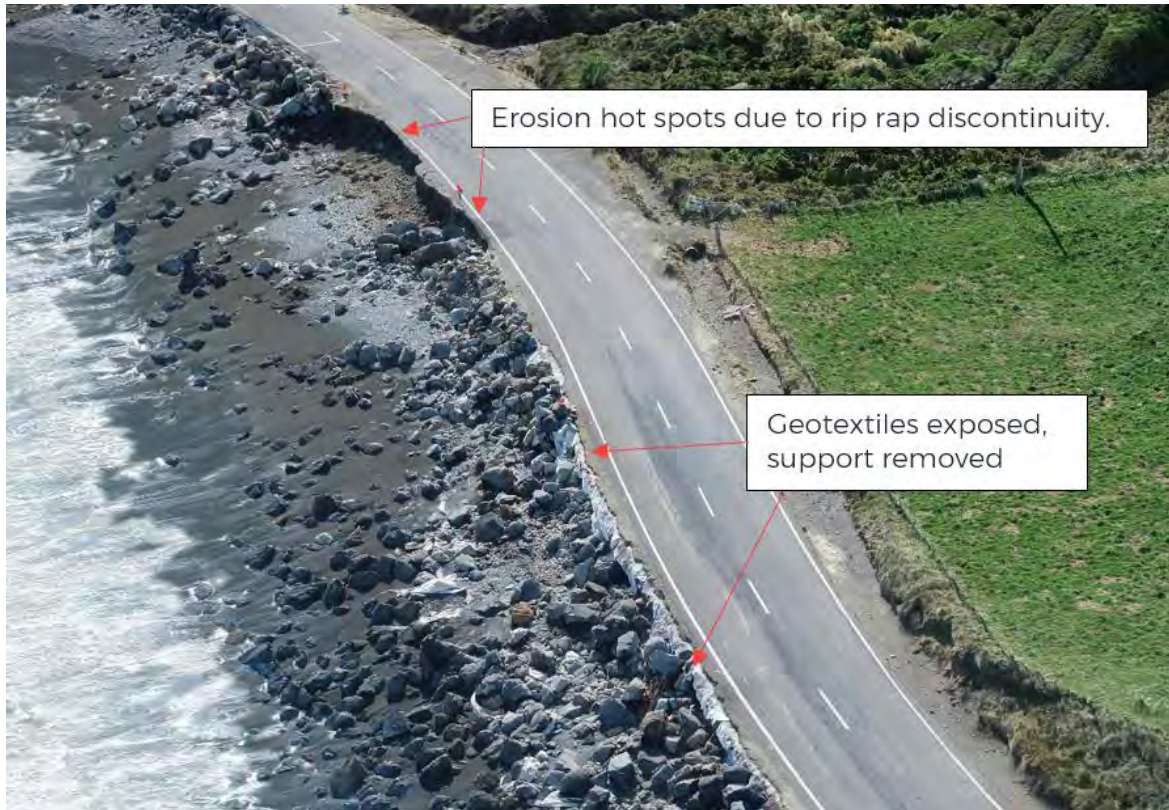
- **Erosion hot spots due to alongshore discontinuities** (Figure 31). The placing of hard structures along the coast usually imply *end effects*: the transition between hard structure and, in this case, coastal cliff, tend to suffer from aggravated erosion. To avoid these *end effects*, a good transition zone between structure and natural cliff is necessary. If no transition zone is design and constructed, it is likely that turbulence and differences in water set-ups generate erosive currents at this particular zone as alongshore irregularities favour that phenomenon.

Figure 31: Screenshot of Section 1, DOC Station, showing from aerial view erosion hot spots and exposed geotextile at the road edge.

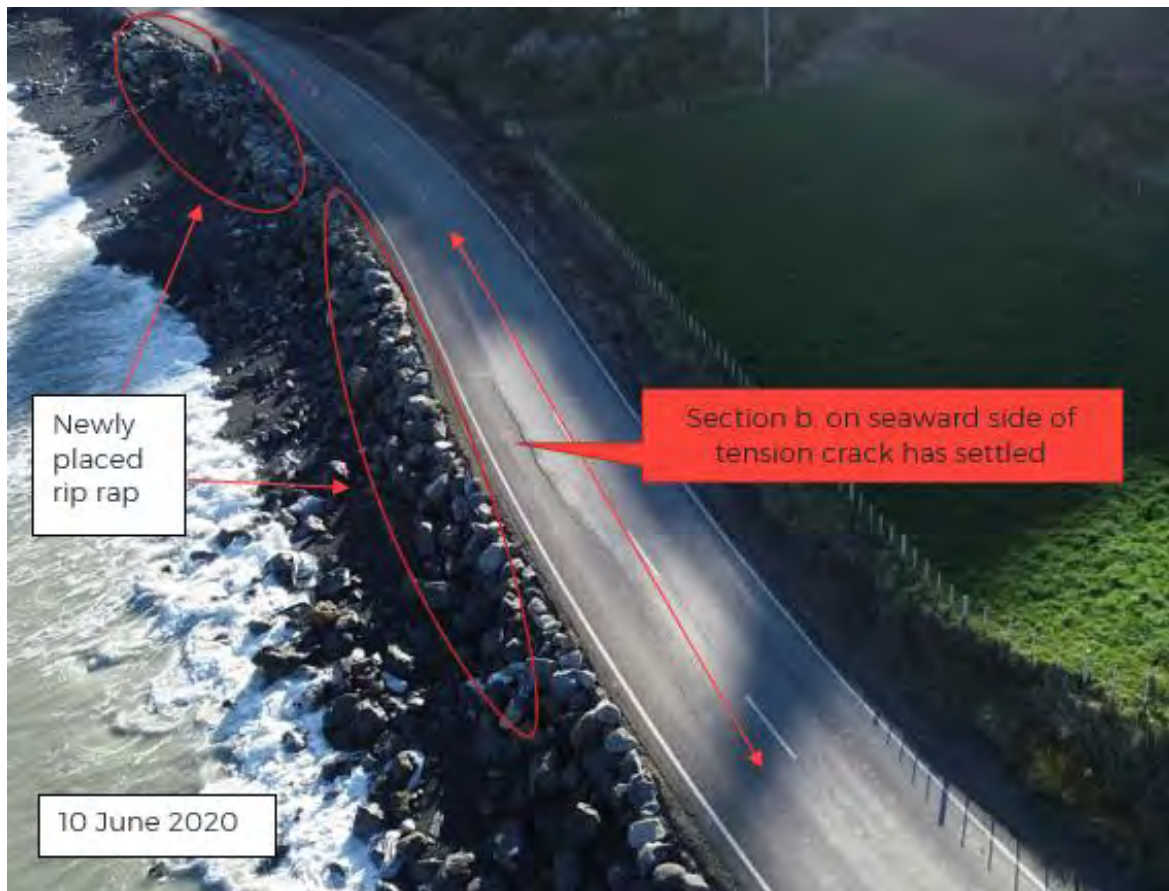
- From drone imagery, more **recently placed rock rip-rap appears to have a steep slope**. As mentioned before, steep slopes are more susceptible to wave run-up and overtopping. Furthermore, if new sections of revetment are placed on top of existing rocks without considering the reinforcement/improvement of the structure's toe, the coastal structure integrity is likely to be more vulnerable to coastal dynamics.

Figure 32: Drone imagery in central section of Section 1 from May and June 2020, showing crack and displacement of carriageway in foreground and earthworks to lower road level in middle distance. Newly placed rip rap indicated.

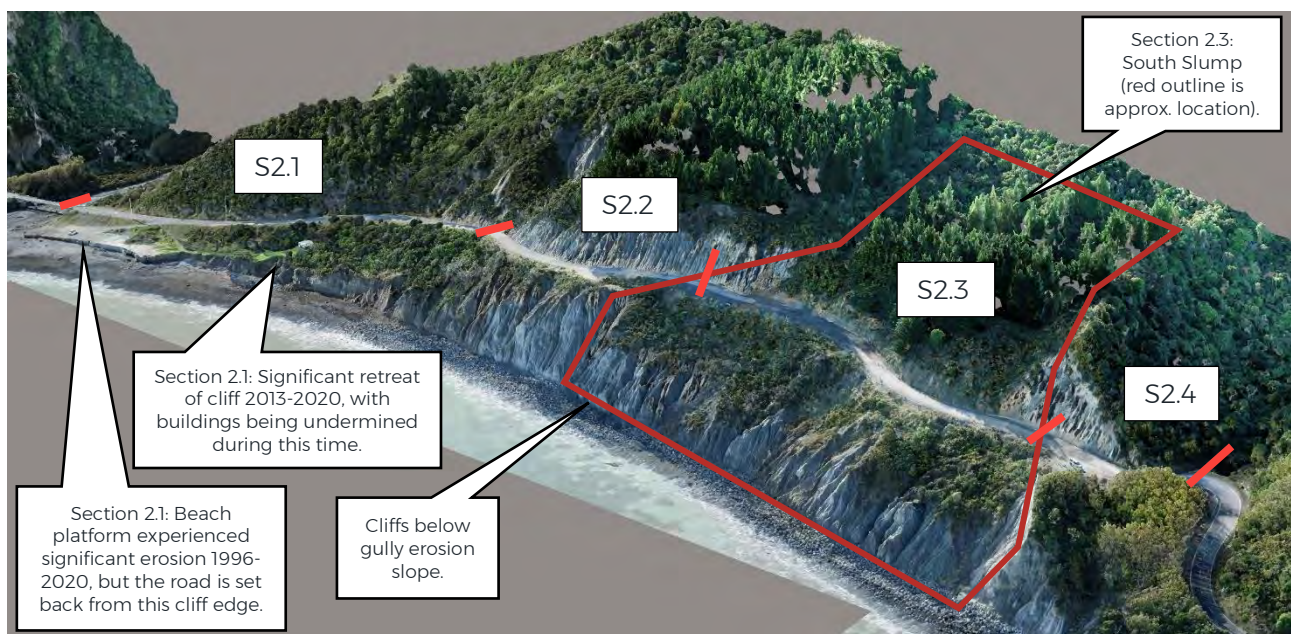
A screenshot of Johnson’s Hill section from the May 2020 3D model is presented in Figure 33. The road in this section of the study area is not as evidently affected by coastal erosion as Section 1 (DOC Station). The following comments extracted from observations of the May 2020 3D model are highlighted:

- Coastal **erosion rates are large** for Section 2.1 (Table 4) and erosive patterns are visible at the coastal platform edge. The absence of coastal erosion protection measures in this subsection is likely to contribute to a faster cliff recession. Nonetheless, in this section overall, the road is at a considerable distance landwards the coastal edge: the land between road and cliff edge acts as a buffer against coastal erosion.

- Section 2 **road has a higher vertical elevation** than Section 1, which protects the road from wave overtopping erosive effects. Nonetheless, the Section 2 cliff face appears to be heavily eroded by water run-off as it presents vertical indents produced by water eroding the soil, potentially faster during rainy events.

- **The toe of the coastal cliff is affected by wave induced coastal erosion.** Wave action causes erosion of the cliff base, i.e. undermining of the cliff, which contributes to slope instabilities and consequent slope failures.

- The **rocks placed at the toe** of the southern side of this section seems to contribute to wave energy dissipation and to the mitigation of wave induced erosion. Nonetheless, some undermining is present along the rocks. Also, as the rocks are not uniformly placed, erosion hot spots are present due to the irregularities along the cliff toe. Because of structural end-effects, these erosion hot spots are generally present at the *rock rip rap* terminations and discontinuities.

Figure 33: Johnson's Hill, looking north-east. From WSP's UAV model.

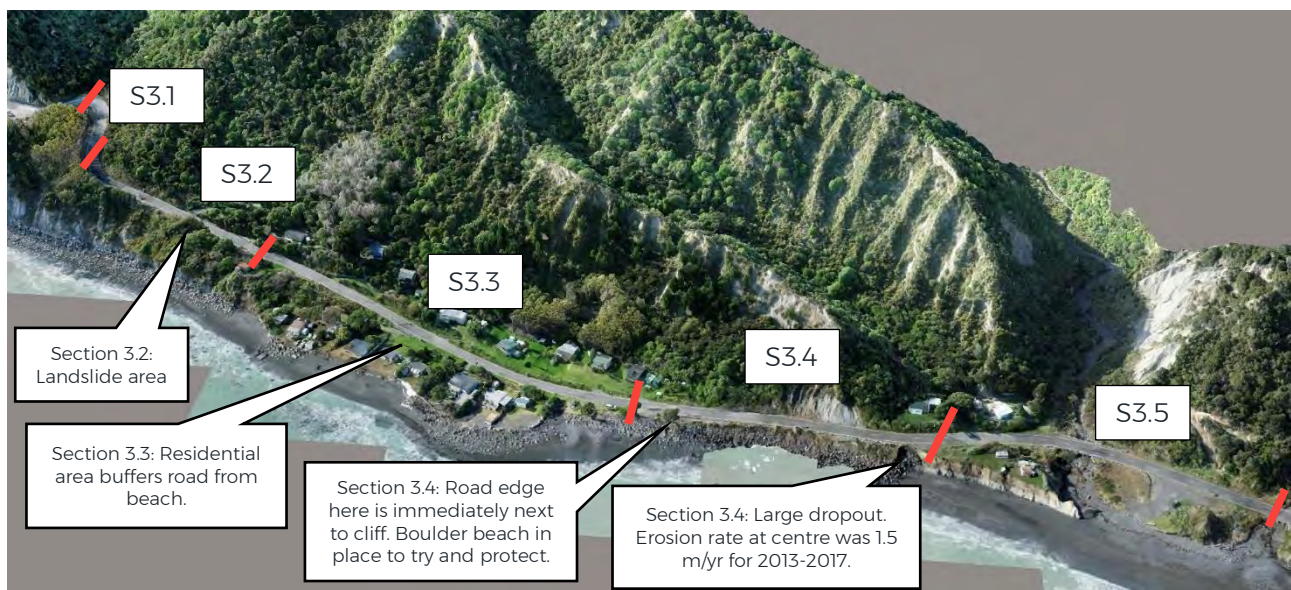
A screenshot of Te Kopi section from the May 2020 3D model is presented in Figure 34. The northern section of this road (S3.1 and S3.2) have similar characteristics to section 2. The road at S3.3 is further inland, protected from coastal erosion by a buffer of both vegetation and private land. On the contrary, the most southern subsection of the road (S3.4 and S3.5) are clearly affected by coastal erosion. For the most exposed subsections, S3.4 and S3.5, the following comments extracted from observations of the May 2020 3D model are highlighted:

- **Cliff erosion** is evident and threatening the integrity of the road at S3.4. The existing vegetation and the current rock rip-rap may contribute to wave energy dissipation during storm events. Nonetheless, high water levels can reach the top of the cliff, making this section of the road vulnerable to erosion.

Figure 34: Screenshot from the May 2020 3D model of section 3, Te Kopi, looking north-east. Subsection limits are represented by the red-lines.

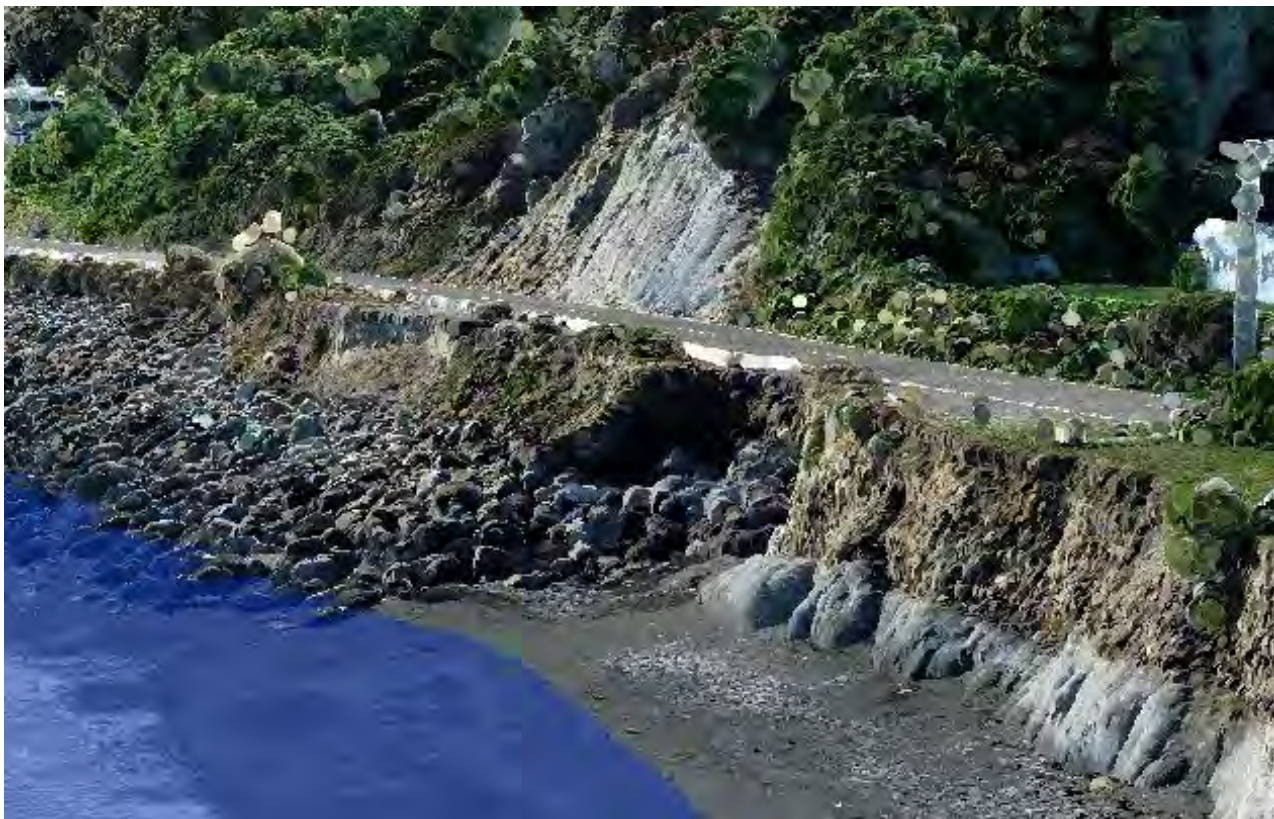
- Between S3.4 and S3.5, there is a clear **erosion hot spot** where the road shoulder has been partially eroded (Figure 35). This erosion hot spot is likely to be consequence of an end-effect of the rock rip-rap and the discontinuity between cliff toe composition in this particular section. Both alongshore discontinuities are likely to have caused an erosion focused area by enhancing both strong currents and turbulence during storm events.

Figure 35. Screenshot from WSP's UAV model, showing the significant dropout in Section 3.4.

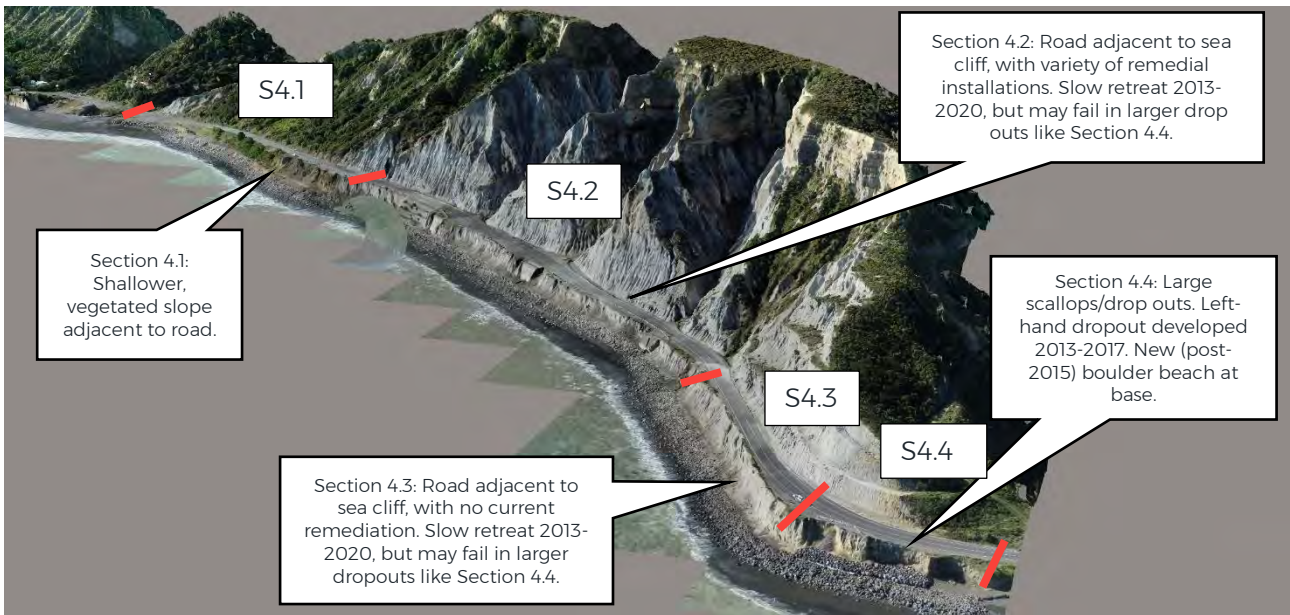
A screenshot of Whatarangi section from the May 2020 3D model is presented in Figure 36. This section appears to be the most exposed to offshore wave conditions: S4.4 has the largest erosion rates in this section (Table 4), with three distinct scallops cut into the cliffs. The following comments are made from observations of the May 2020 3D UAV model:

- **Cliff erosion** in S4.2 is a consequence of not only coastal erosion, but also water run-off. This sub-section cliff is made of more easily erodible material and has no vegetation to help against erosion.

Figure 36. Screenshot from the May 2020 3D model of section 4, Whatarangi Bluff, looking east. Subsection limits are represented by the red-lines.

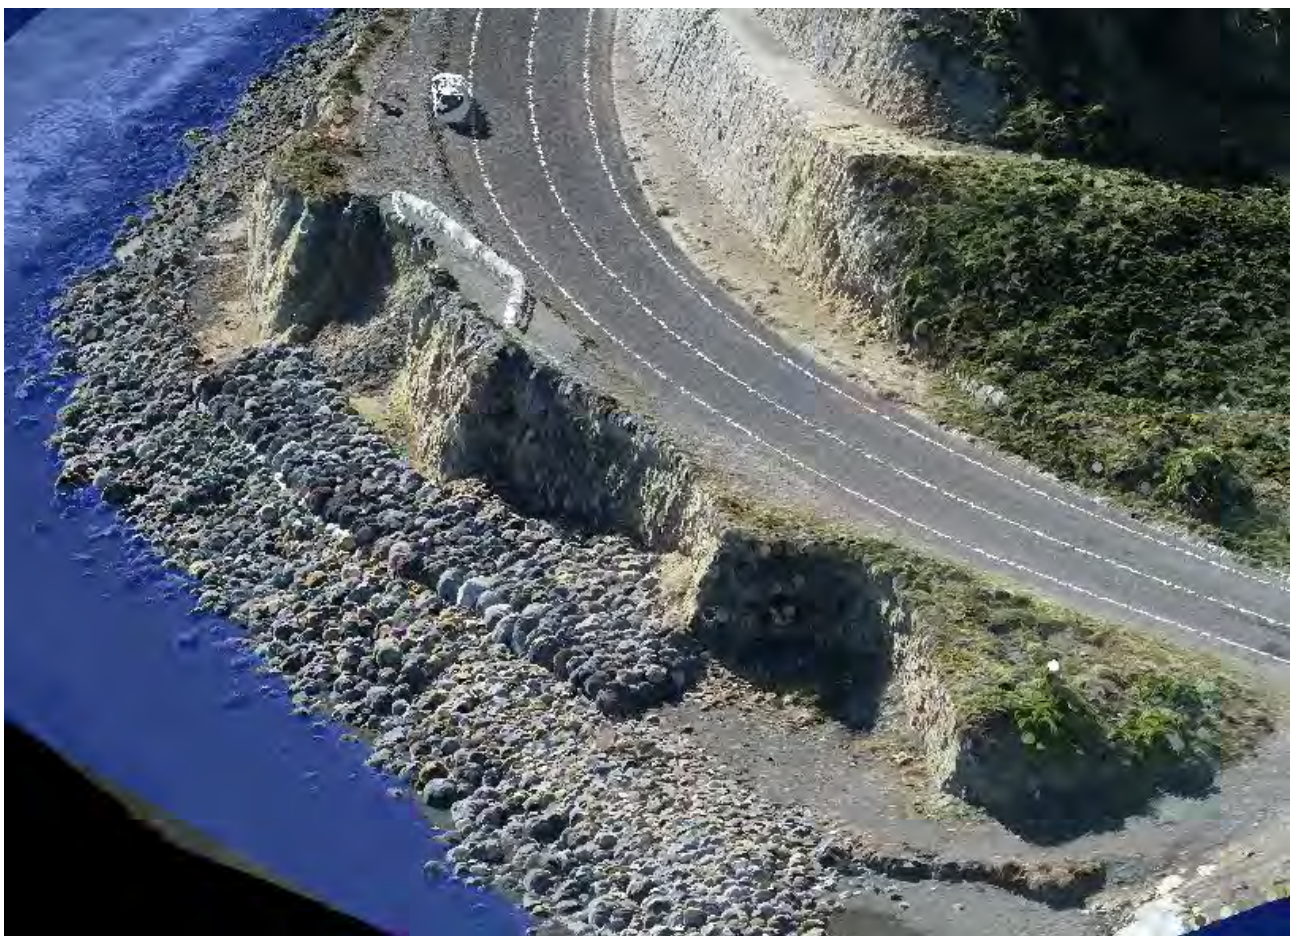
- Section 4 southern corner appear to have suffered from **episodic erosion** (Figure 37). Erosion in this area may not only be caused by coastal erosion as poor water drainage is likely to have contributed to cliff failure. The currently eroded areas are likely to enhance further erosion due to the alongshore irregularities created. The rock rip-rap placed at the bottom of the cliff indents may help reduce wave energy and cliff toe wave erosion, but can also create end-effects as seen in other sections of the embayment.

Figure 37. Screenshot from 3D model showing S4.4 eroded areas and placed rock rip-rap, which are currently creating alongshore irregularities.

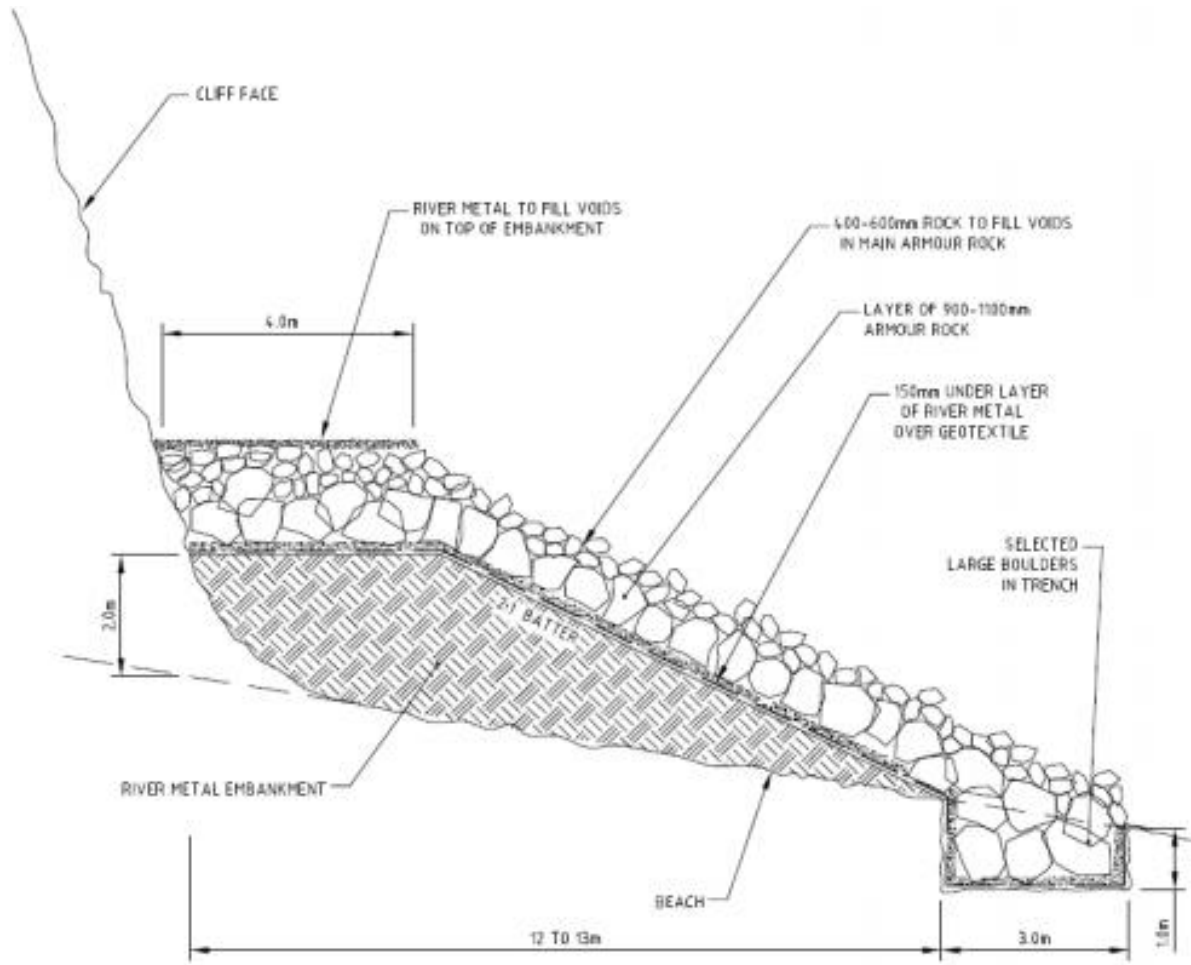
- Figure 38 shows a typical cross section of rip rap structures present at the base of the cliffs throughout Section 4. These rip rap structures have been damaged and undermined in places due to wave action, with boulders lost (Figure 38) and geotextile exposed (Figure 40). The function of these damaged sections is compromised, and once the geotextile is ruptured the underlying river metal is likely to erode out quickly. Repair or reconstruction of these structures would be prudent to form a more robust defence.

Figure 38: Typical rip rap arrangement to protect cliff areas, reproduced from Beca (2009).

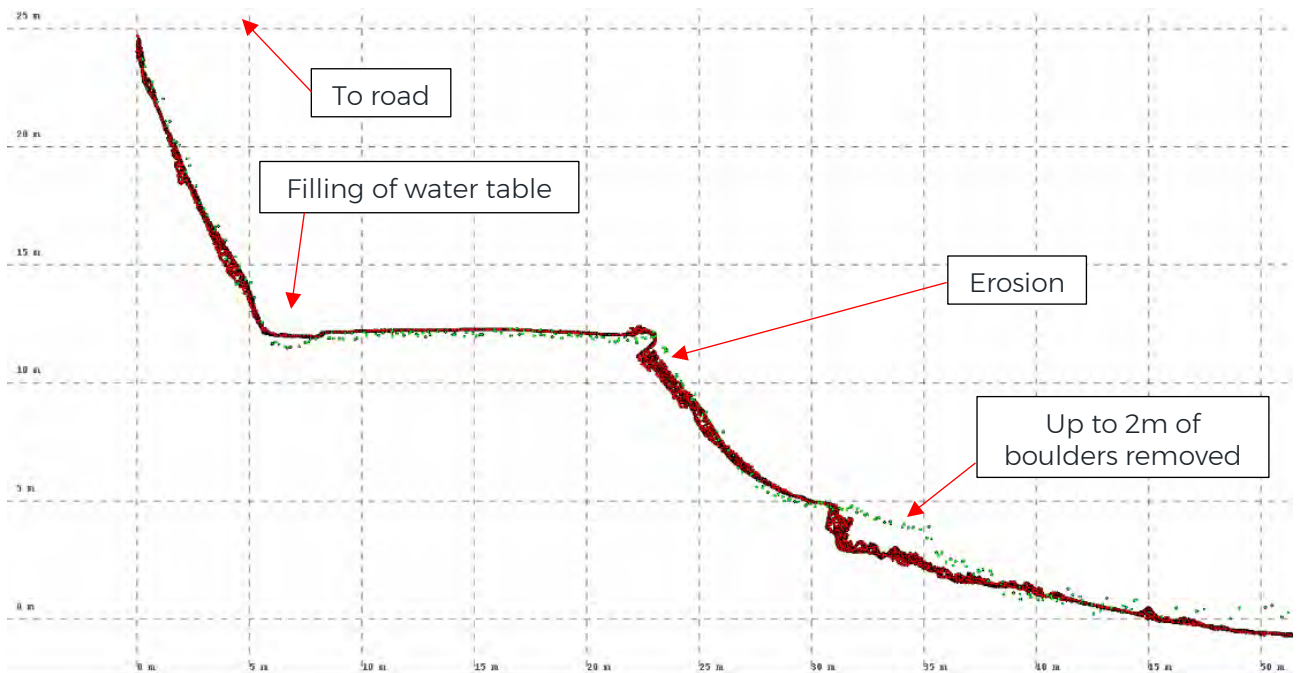
Figure 39: Comparison of elevation profiles from 2013 LiDAR data (green) and 2020 UAV data (red) at Whatarangi Bluff (RP 15.7), showing loss of rip rap structure.

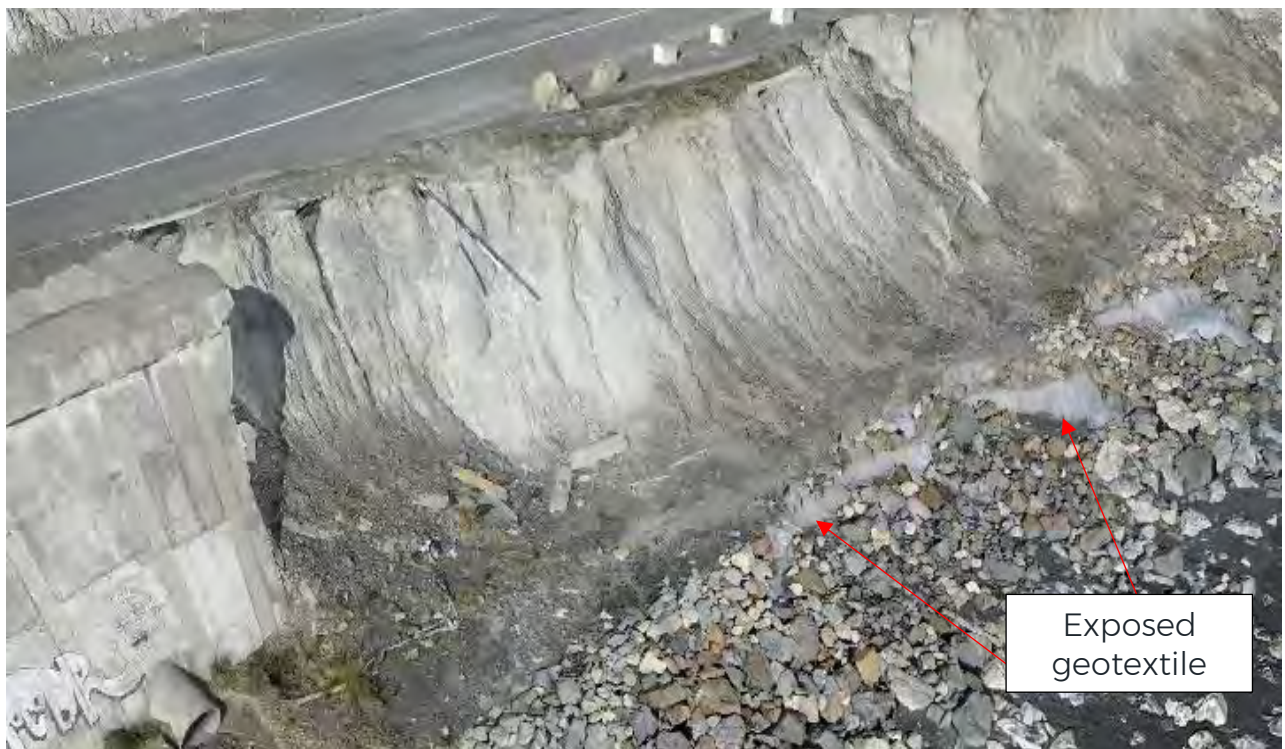
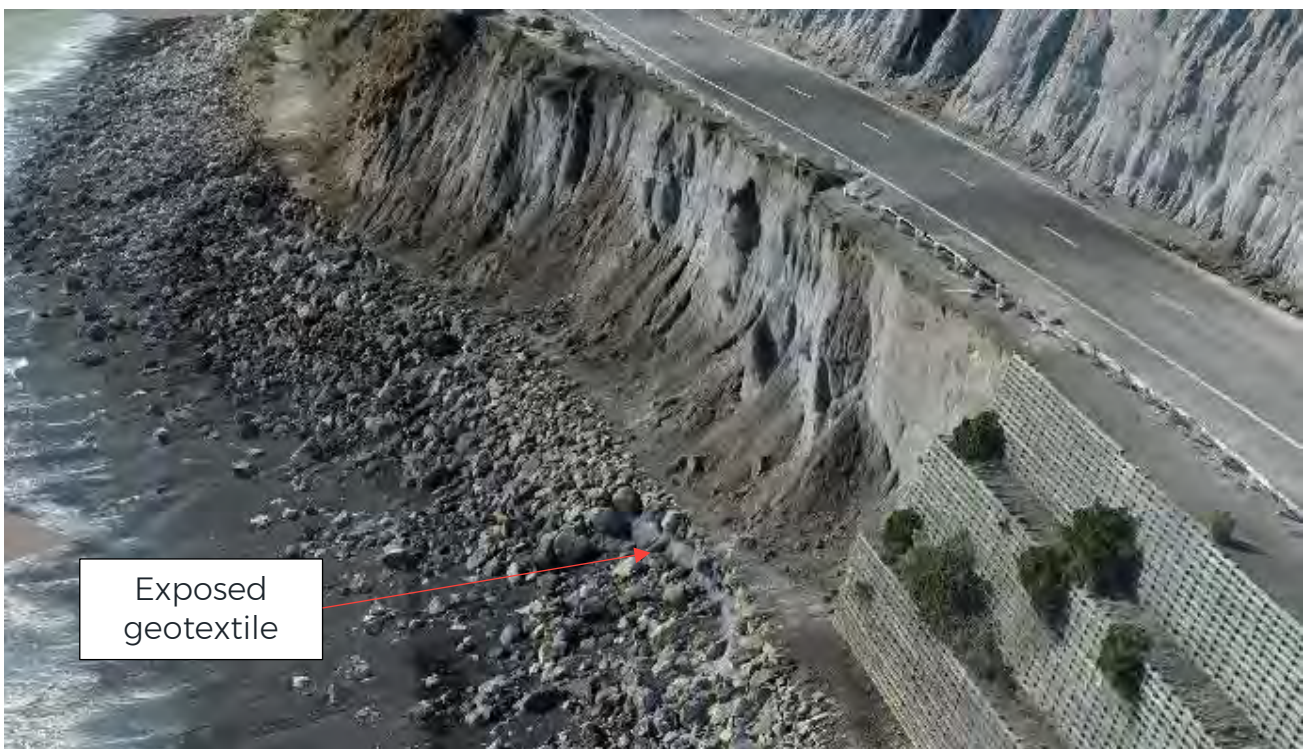
Figure 40: Sections of exposed geotextile at Whatarangi Bluff, where the rip rap structure has collapsed and needs repairing or replacing to reinstate effective coastal protection. [top] South of concrete wall (CONC2 in the preliminary risk assessment table). [bottom] North of crib wall (CRIB1).

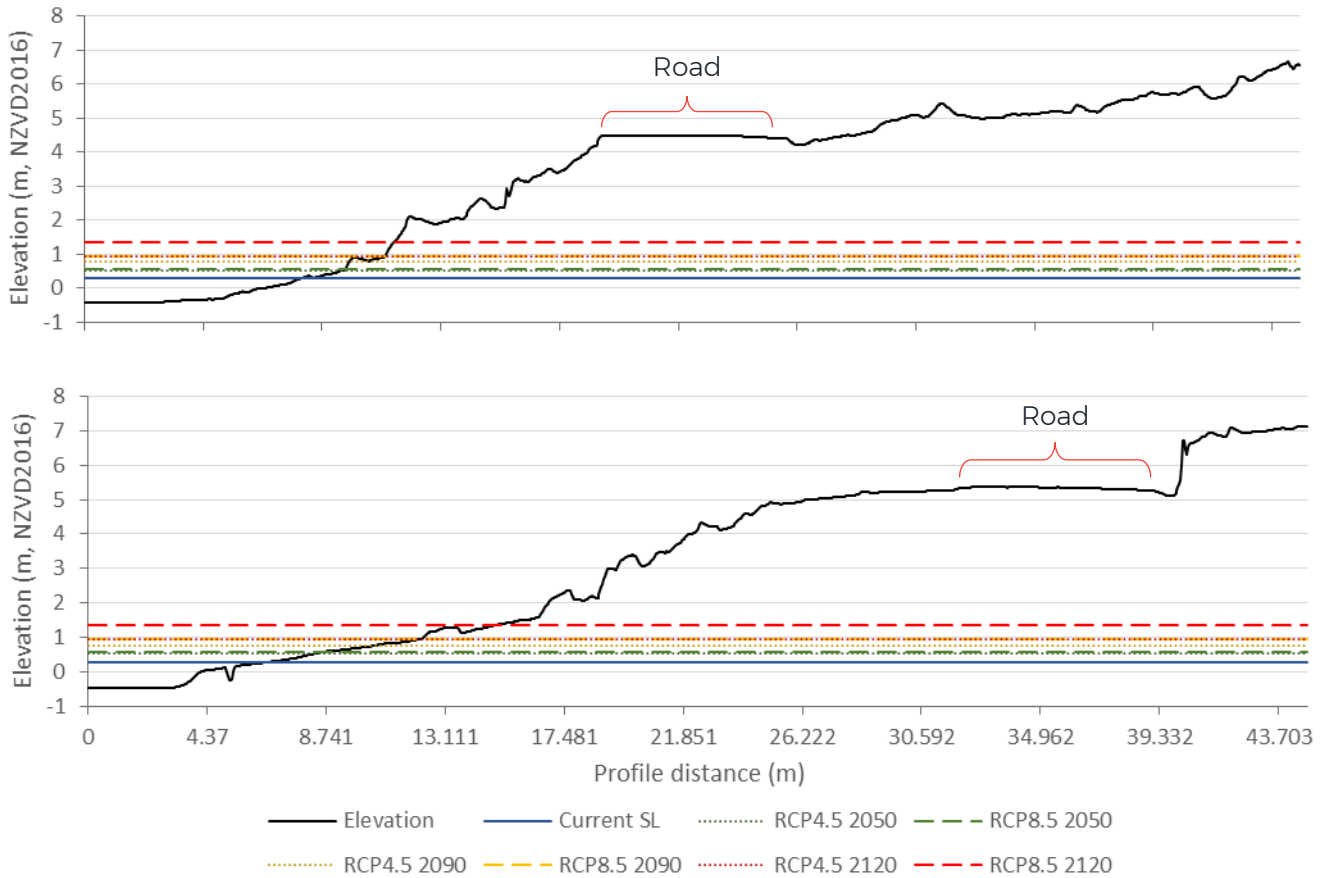
Figure 42 shows two particularly low sections in the study area, one from DOC station and one from Te Kopi. The simulated water levels in Table 10 represent MHWS still water levels and do not include wave heights or the higher water levels produced by King tides or by low atmospheric pressures (i.e. storm surge). It is also important to note that wave heights nearshore largely depend on water depth, and that higher wave heights can be expected with higher water levels.

Figure 42. Sea level rise projections for two sections: DOC station section above and Te Kopi section below. Current SL refers to current MHWS tide mark.
