# **SOUTH WAIRARAPA DISTRICT COUNCIL**

**20 FEBRUARY 2019**

### **MARTINBOROUGH WATER SUPPLY CONTAMINATION INCIDENT**

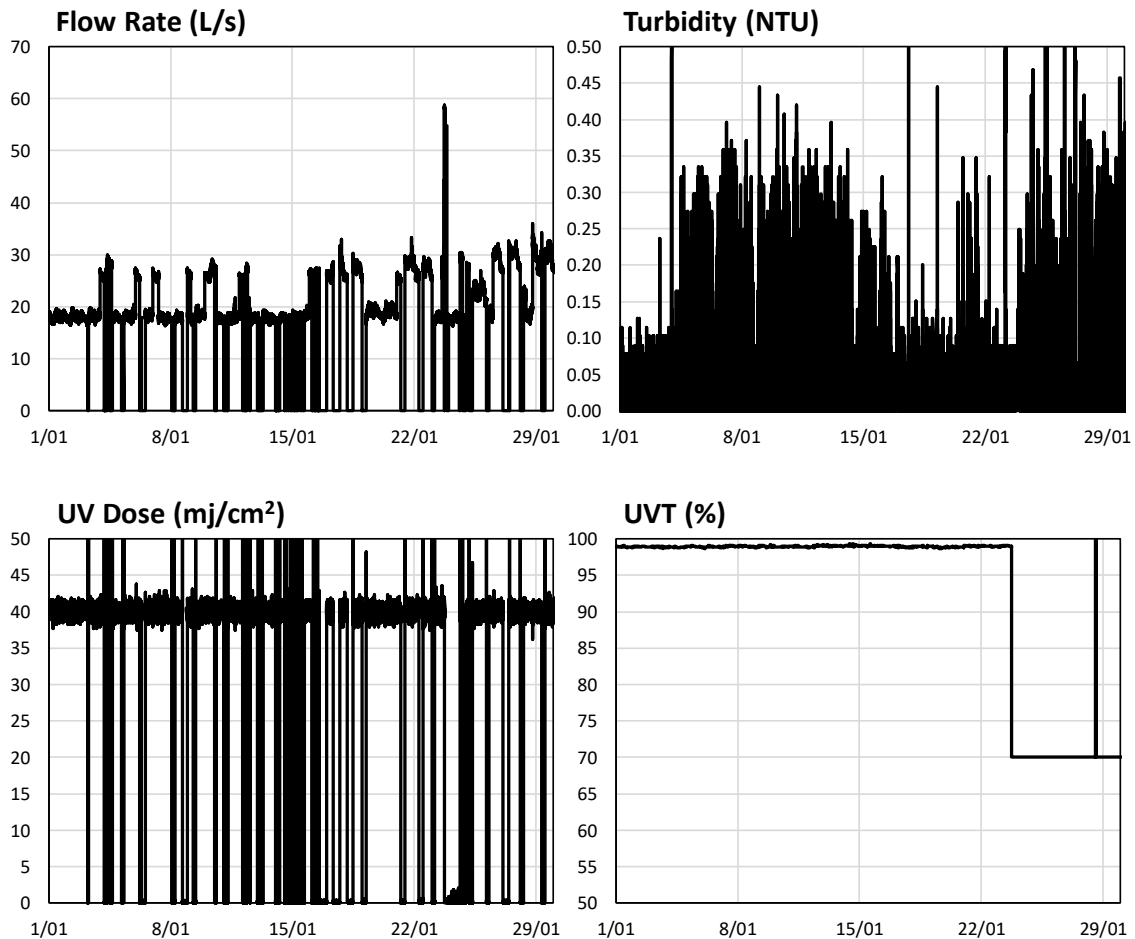
Figure 1: UV Plant Operation January 2019

As can be seen above, the UVT step-changed from 99 to 70%. This was an instrument fault and not deteriorated raw water quality (as indicated by the instantaneous transition). This fault was present for the remainder of the month. Operations staff are reported to have entered a manual UVT of 95% into the UV controller during this time.

The plant ran without UV treatment from 23:07 on the 23rd to 14:18 on the 24th (15h 11m).

Given the performance of the UV plant indicated above, this is considered highly likely to be the source of the contamination.

Work is currently underway to address issues identified with plant performance and control, with Lutra currently working on validation checks, checks to controls, and alarms, preparing a re-commissioning plan, reviewing operating processes and protocols, and ensuring adequacy of operator training.

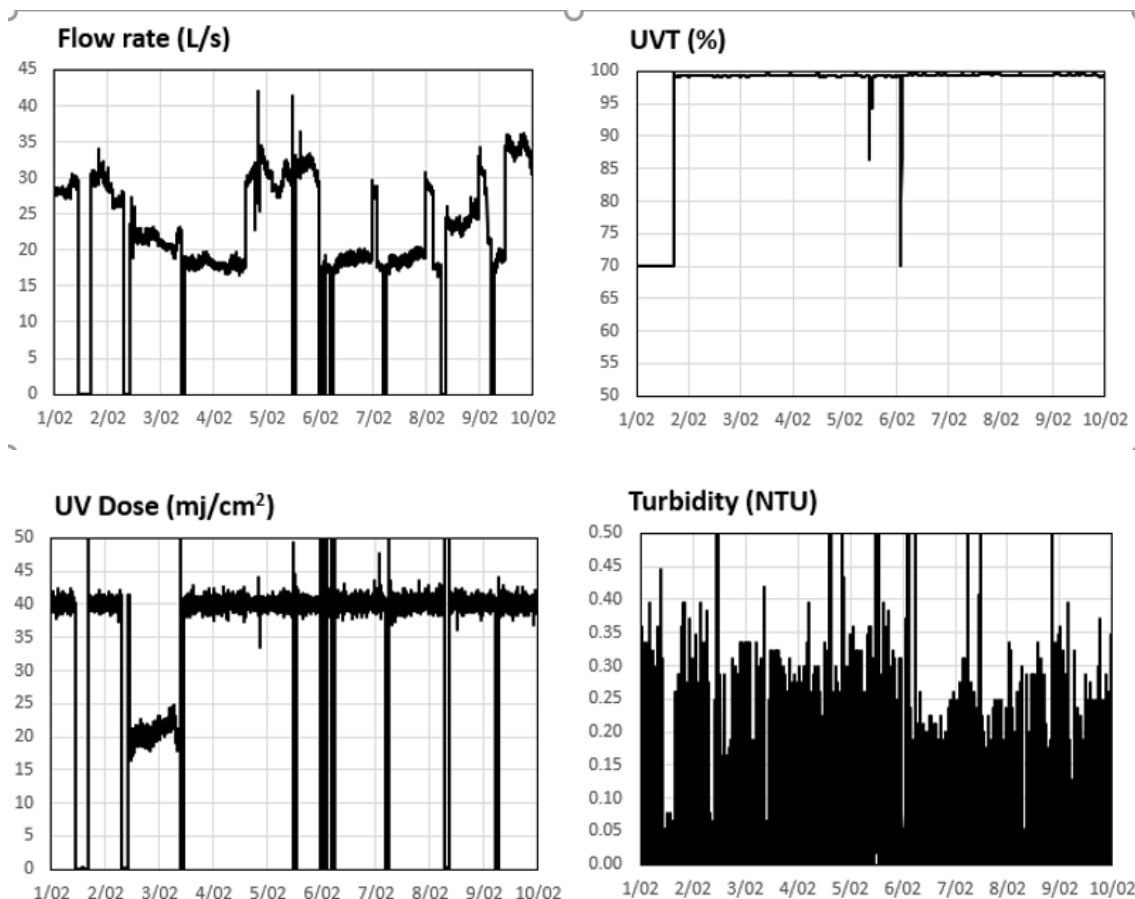
Figure 2: UV Plant Operation February 2019

Analysis of plant performance in February indicates the UV plant running at around half dose on the 2nd and 3rd of February 2019, possibly due to lamp failure, though no alarm was recorded (see following charts).
