MEMORANDUM

SWDC BRIDGE 94

14 December 2023

This memorandum responds to the request from Carterton District Council to carry out an urgent inspection of SWDC bridge 94 on Te Awaiti Road.

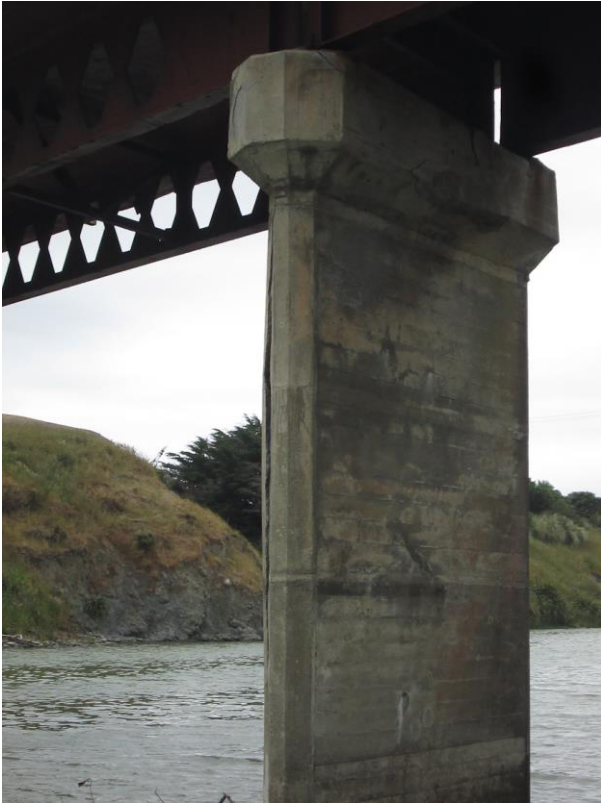
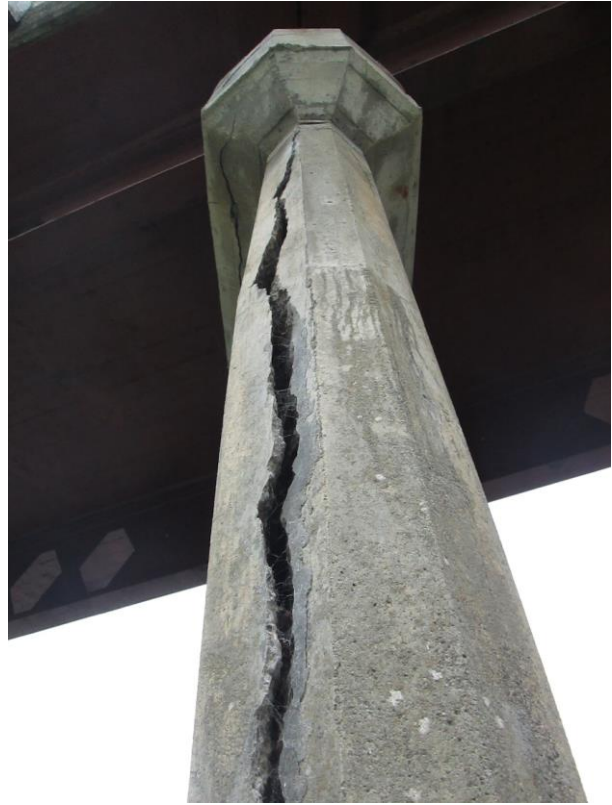
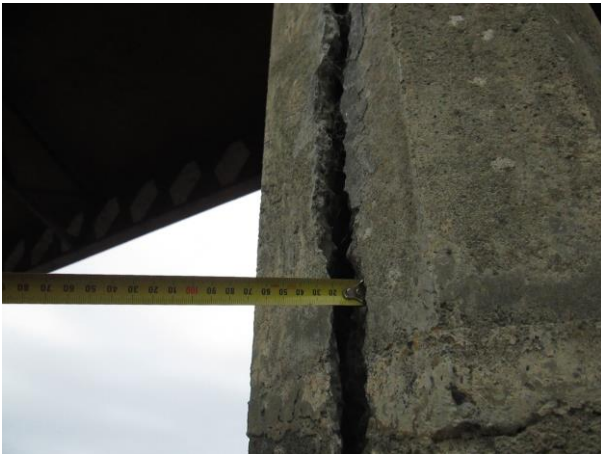
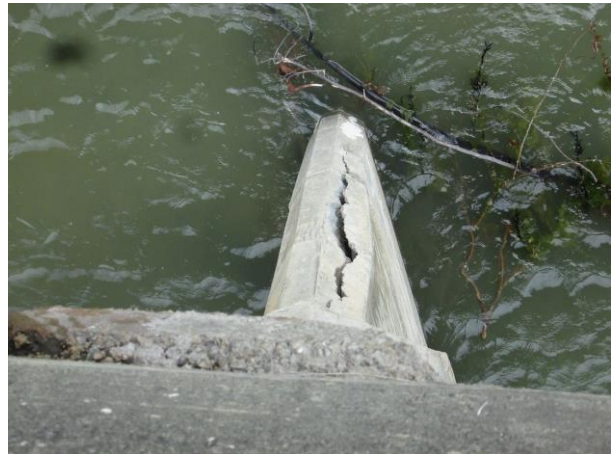
There is a wide vertical crack in the upstream edge of pier 3 (the western pier), on the east side of the pier centreline. The crack extends from the underside of the pile cap to approximately 1 m above current water level. The crack is widest at about two-thirds of its height. At a height of approximately 2 m above bed level the crack is approximately 20 mm wide at the surface. We could not determine the depth of the crack. No reinforcement was visible in the crack, so we could not determine whether the crack extends into the reinforced core of the pier or is just in the cover concrete.

There are visible cracks in the underside of the pier cap on both sides of the bridge, these cracks are widest on the same side of the pier as the vertical crack.

There is a minor longitudinal crack in the deck above the damaged pier, approximately 700 mm long crossing the expansion joint. We are not sure if this is related to the pier damage.

We are not sure what has caused the crack as the width does not seem to be consistent with being caused solely by reinforcement corrosion.

According to SWDC records the bridge was constructed in 1950. The crack occurred, or widened sufficiently to become visible, between May 2017 and February 2019. Between 2019 and now the crack has widened significantly.

It is likely the axial load capacity of the pier has been compromised and further investigations will be needed to confirm the full extent of the damage before remedial options can be advanced.

As there appears to be on-going widening of the crack and the axial load capacity of the pier has likely been compromised, we strongly recommend proceeding with further investigation of the damage and remedial work as soon as practicable.

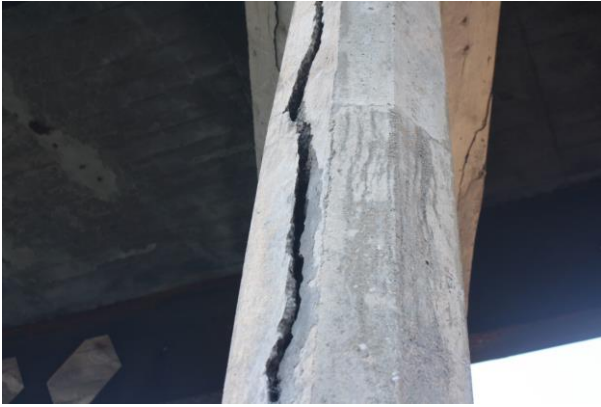
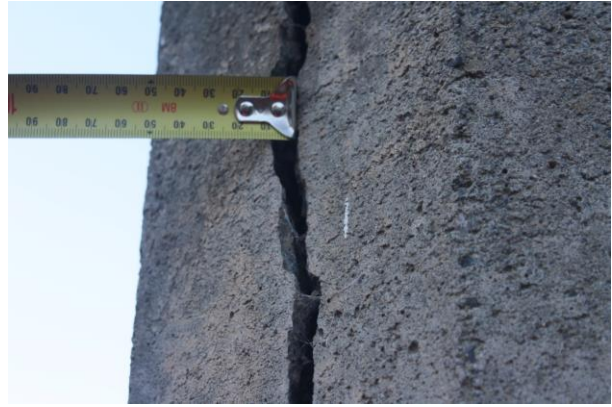
Photographs from February 2019 inspection

The February 2019 report notes a wide and long vertical crack in the upstream edge of pier 3 with the crack measuring 10mm wide (see photograph below). A photo taken at a similar position to today’s photo above shows that the crack has widened significantly since 2019.
