HINEKURA ROAD EROSION AND LANDSLIDE REMEDIATION REPORT

HINAKURA HILL - RECOMMENDED EROSION AND LAND SLIDE REMEDIATION PLAN

To	Ben Turner, Tim Langley (South Wairarapa District Council)
From	Giles Farquhar, David Stewart
Office	Wellington
Date	16 August 2021
File/Ref	5-C4072.01; GER Report 2021/46
Subject	Hinakura Road Landslide July 2021 Assessment

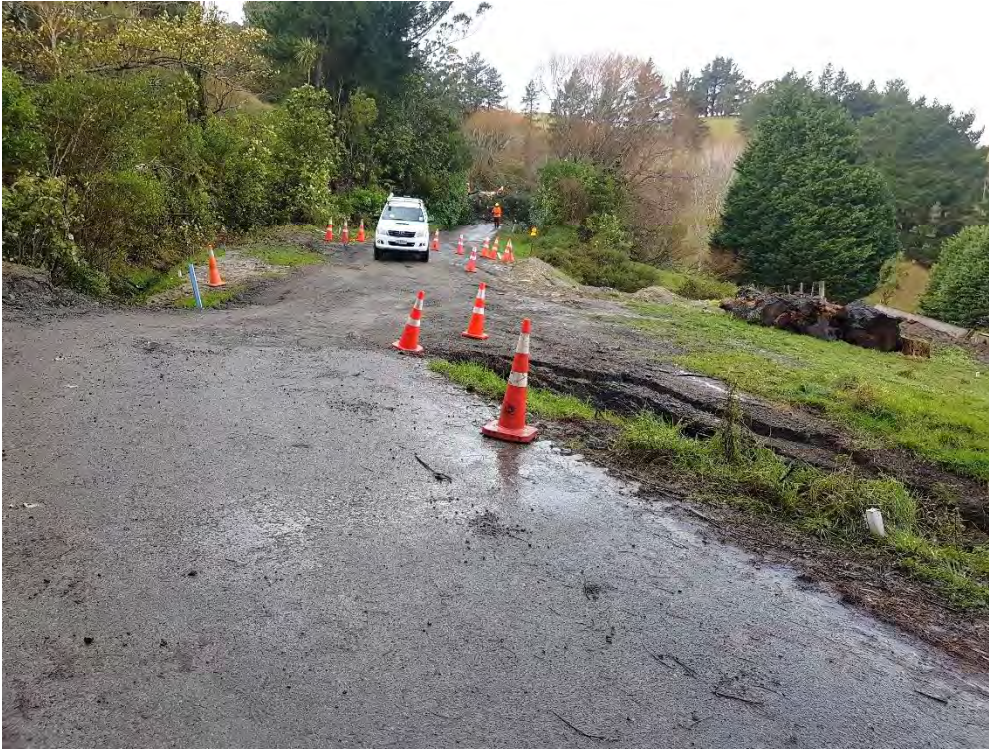
Photo 1: Site on 29 June 2021, showing translation of the road downslope. Lateral scarp in foreground has been removed to allow arborists in to cut down tilting trees (arborist staff visible in background). White SWDC monitoring pegs visible at right and just to left of blue culvert marker.

At road level the road had been reinstated. Trees above the road are tilting downslope with the movement. SWDC have undertaken removal of some of these tilting trees (Photo 1) because of the risk they posed to the road.

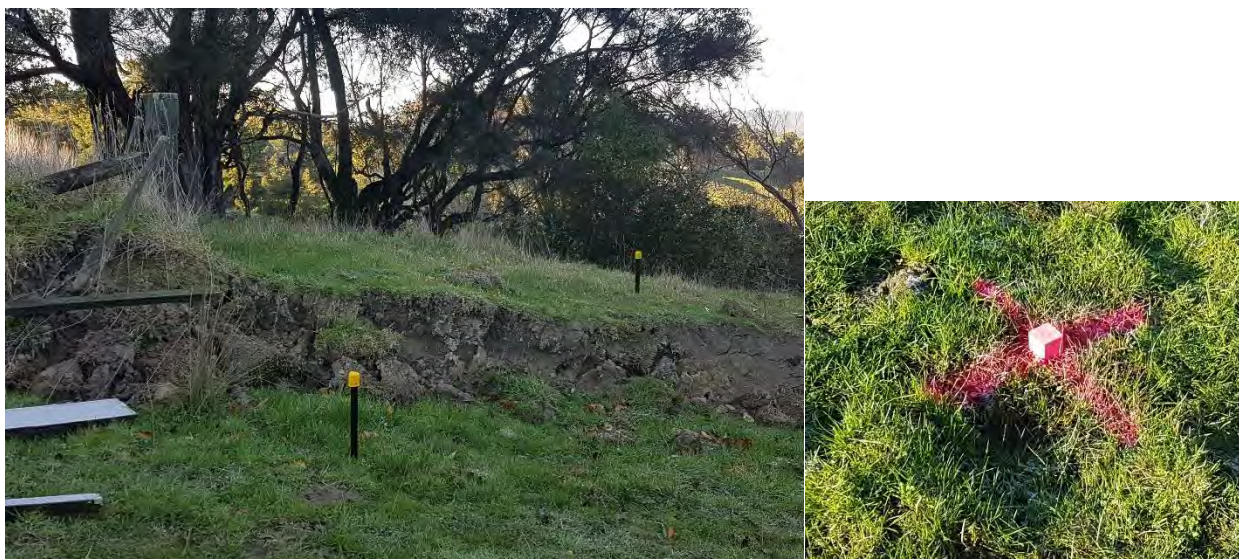
Installation of a pair of waratahs, one either side of the 'fissure' below the dam which marks the western lateral margin of the landslide (Photo 2). The initial measurement (using steel tape measure) between the two waratahs was 5.02m on 5 July 2021.

The pegs were installed to just above flush with ground level (Photo 3) and initial coordinates were surveyed by RTK GPS.

Photo 2: Waratah extensometer below dam (offset broken fence at left) and Photo 3: Survey peg

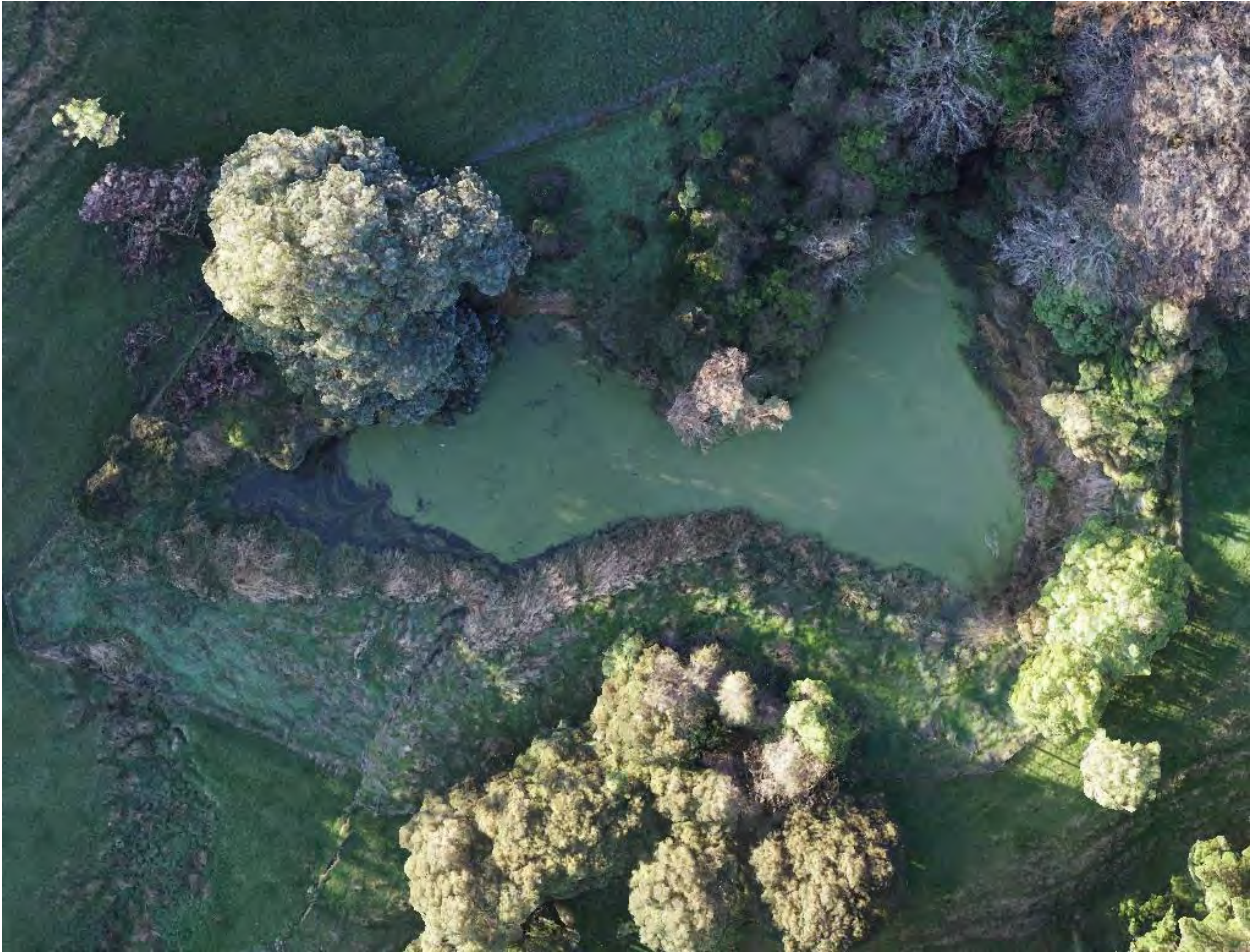
The dam crest has changed markedly since the June 2020 visit (compare Figures 1a and 1b).

Figure 1a: Farm Dam as at June 2020

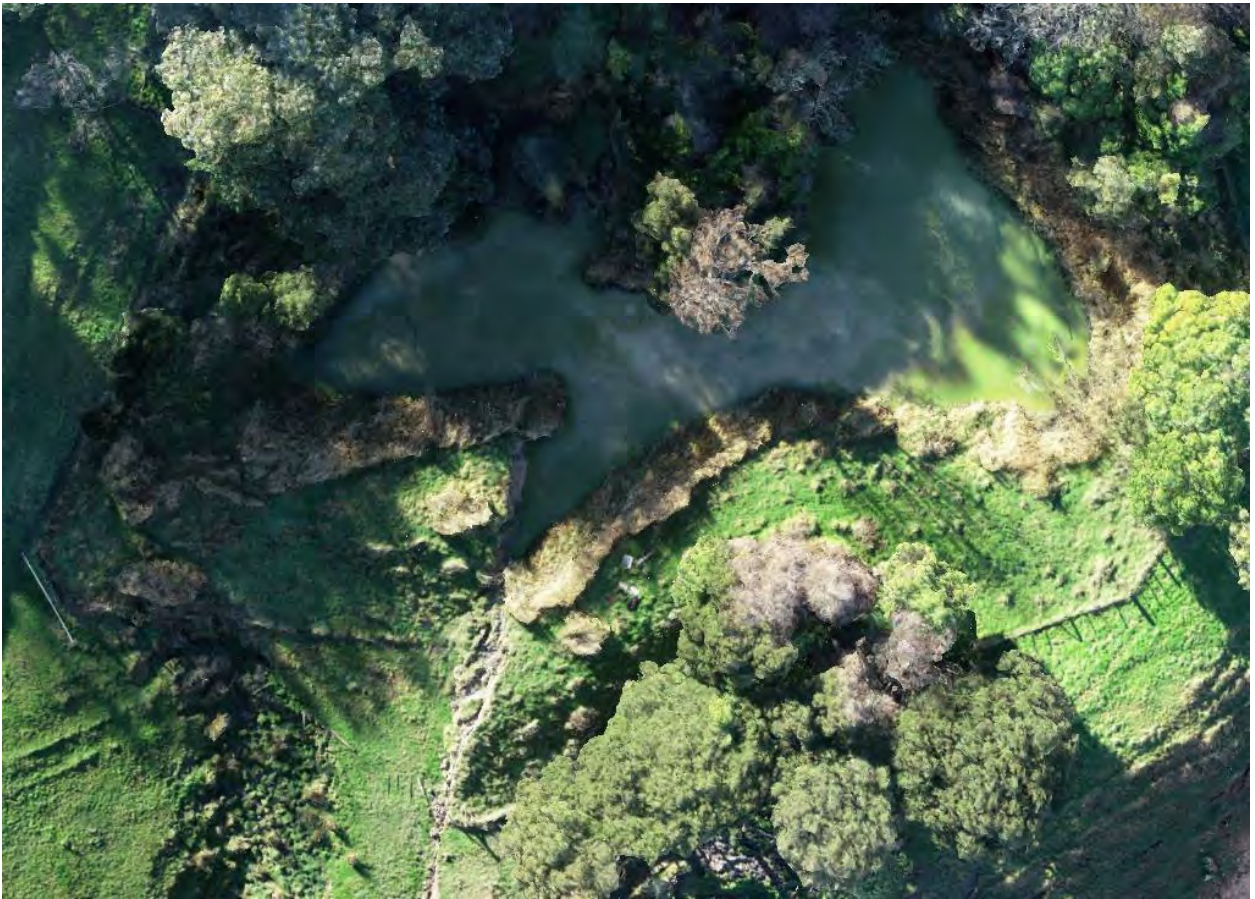
Total horizontal offset of ~ 10m is indicated at the dam crest as the fissure marking the western extent of the landslide intersects the dam (Figure 1a). Horizontal movement of the fence below the dam crest between June 2020 and July 2021 is ~8.5 m (compare Figures 1a and 1b and Figures 2), with about 1.6m of vertical displacement over this 12 month period (refer Appendix D). Comparison with the 2013 LiDAR (Figure 2) shows that much more movement happened in the last 12 months than the period between 2013 and 2020.

With further movement of the landslide, the water from dam is expected to increase in flow onto the slope below and into the lower part of the landslide

Figure 1b: Offset of dam crest as at 5 July 2021

- Dewatering of the farm dam in a controlled manner as soon as possible, supervised by appropriate geotechnical and / or dam specialists.
- Continue engaging with GWRC and implement drainage and tree planting measures to assist stabilisation of the landslide.

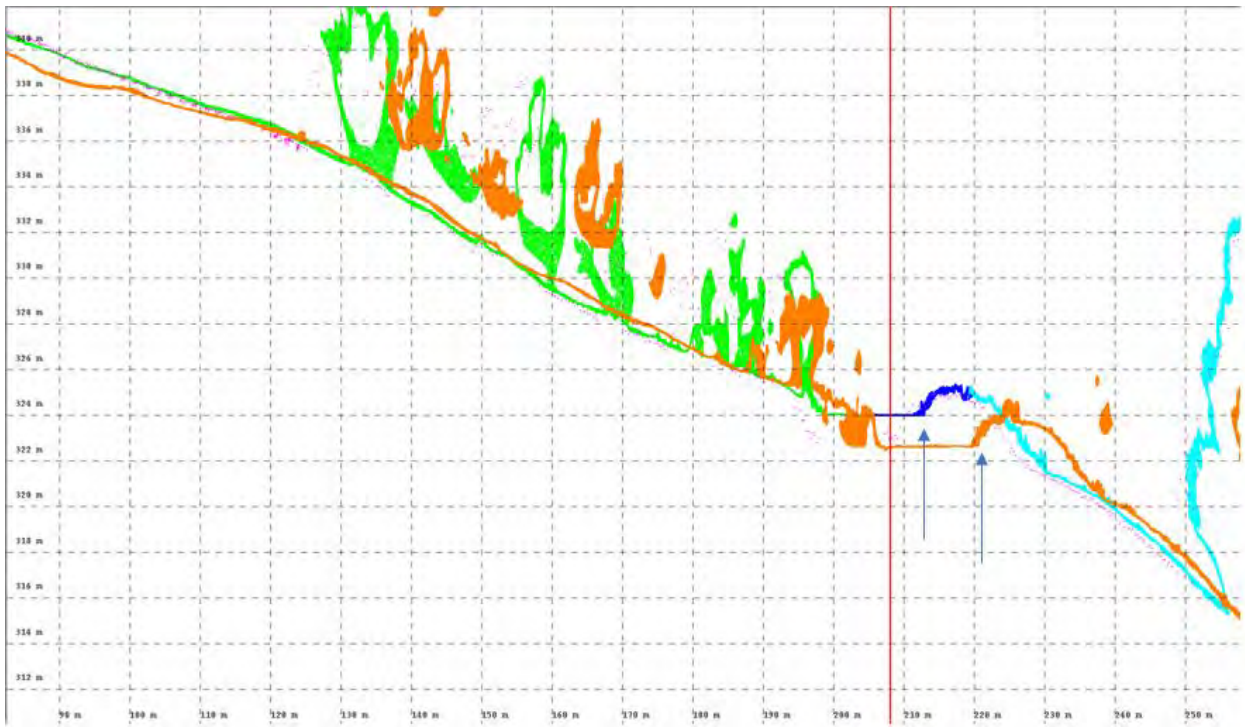
Figure 2: Movement at the dam displayed by blue arrows, 2020 (blues and green) and 2021 (orange). 2013 LiDAR is visible as pink dots

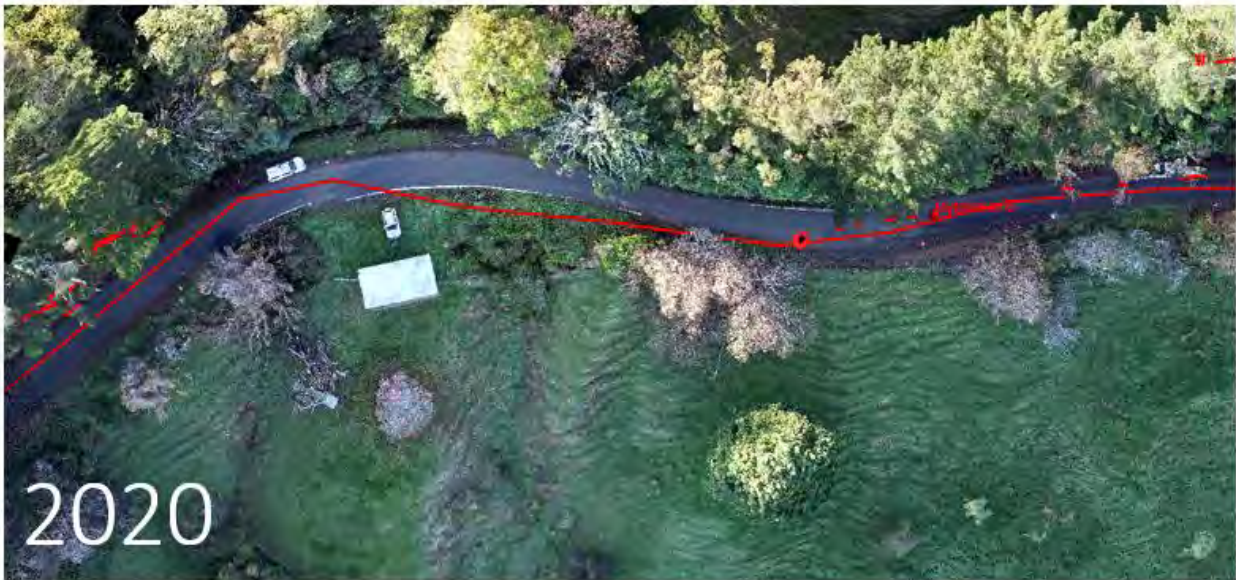
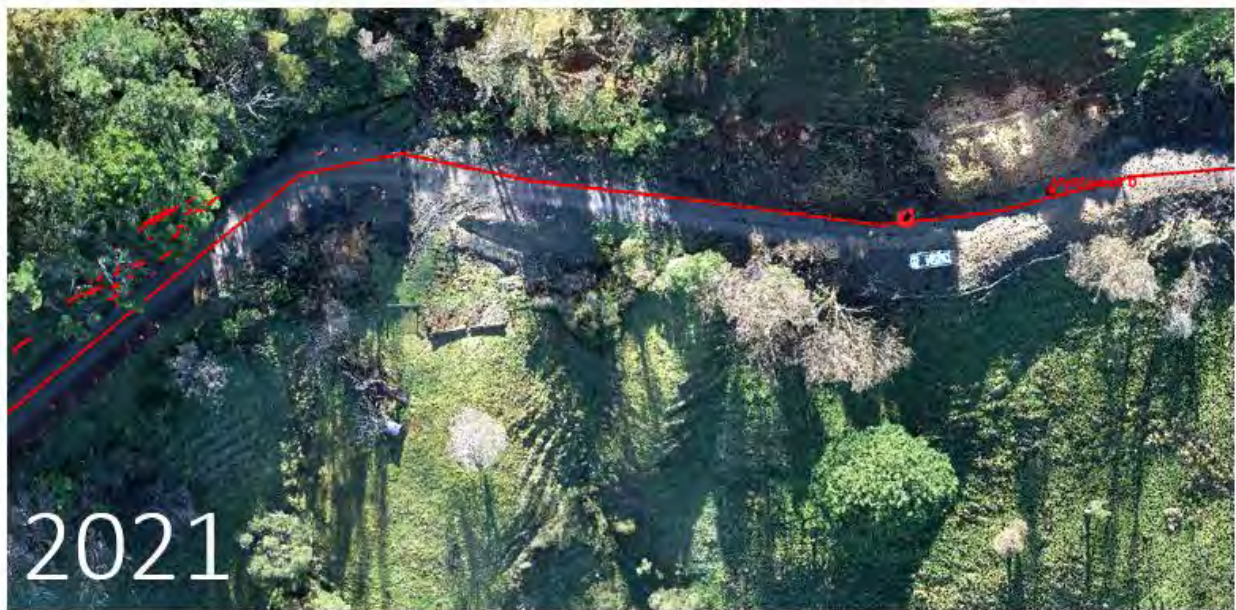
Movement of the road is of a similar order to the farm dam with ~8m horizontal and 1 – 2m vertical drop indicated from June 2020 to July 2021 (Figures 3 and 4).

The barn that was present in 2020 below the road has been removed by the farmer after a tension crack intersected the structure (Figure 3).

Figure 3: Movement of the road from June 2020 to July 2021. Red line remains in the same location showing the movement of the road from north to south.

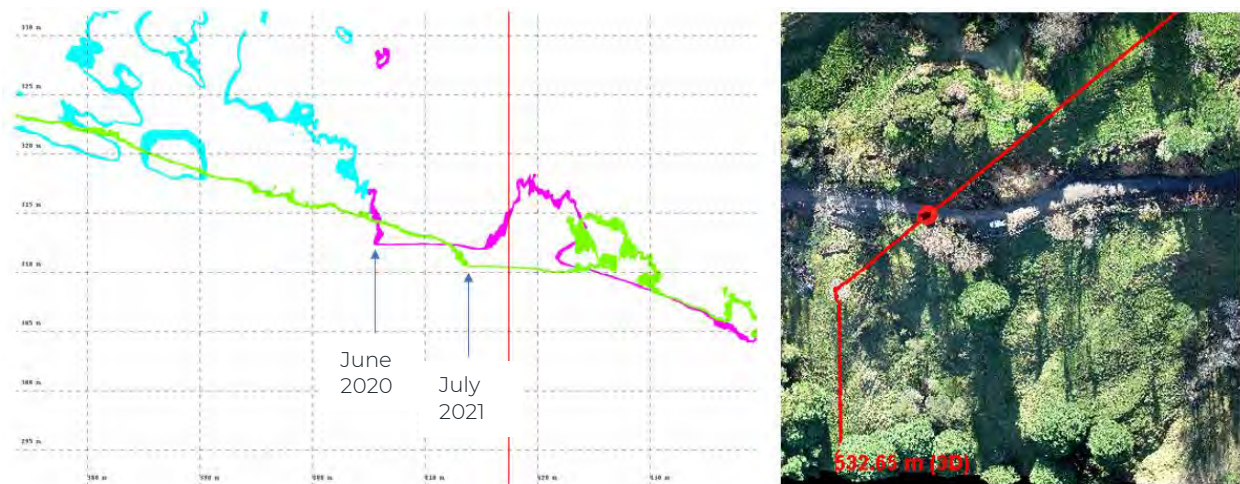
Figure 4: Horizontal and vertical offset of the road edge between 2020 and 2021. Profile position is along red line at right, which is parallel to the direction of slope movement - oblique to the road alignment

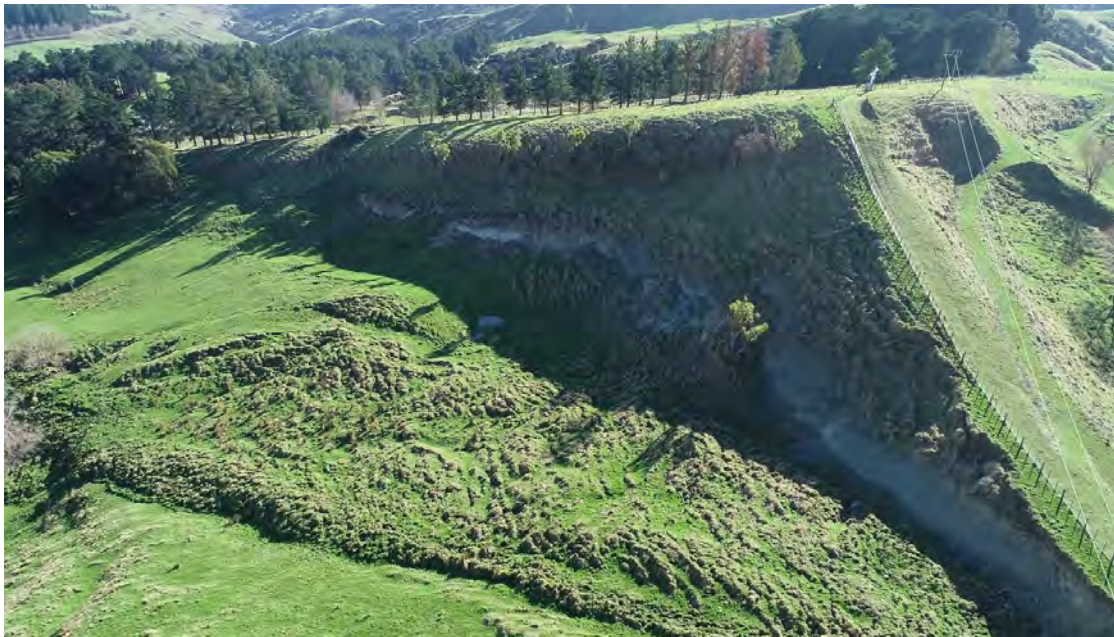
The head scarp at the top of the slope is more obvious and appears to have become larger with a large amount of exposed in-situ mudstone in the upper northern lateral scarp (Photo 4).

Photo 4: UAV image from 5 July 2021 of the head area of the landslide

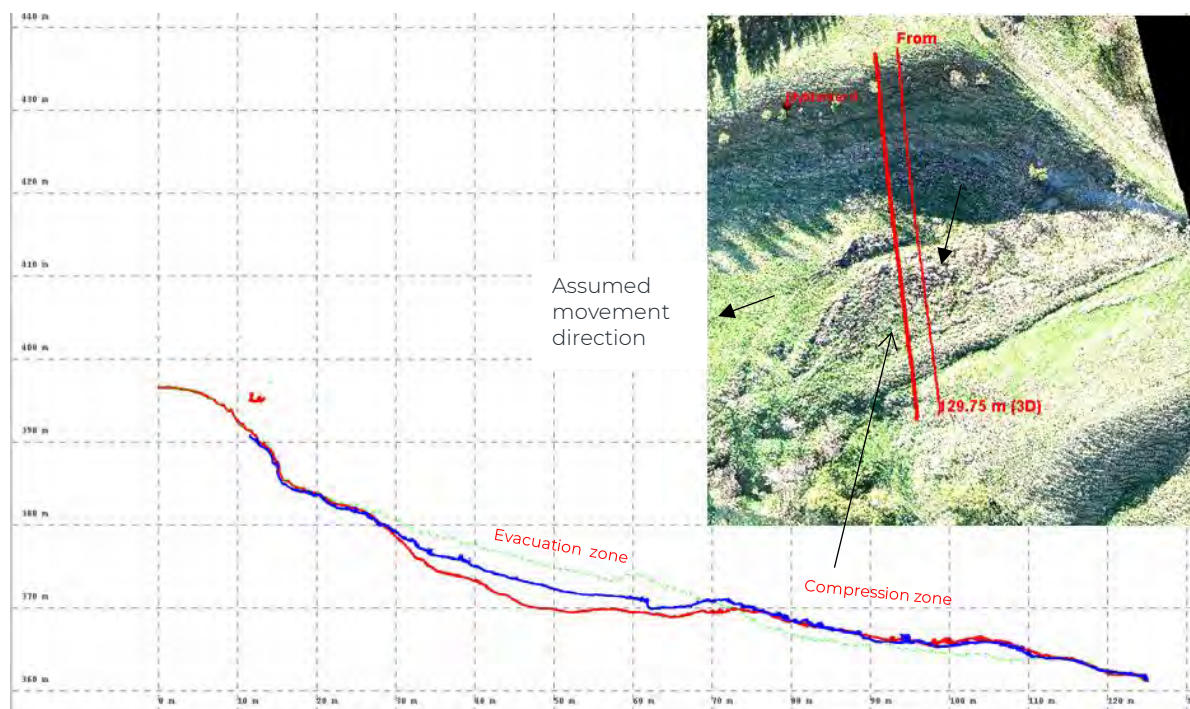
Comparison of the 3D survey models shown that the ground surface has dropped significantly (refer evacuated zone on Figure 5) just below the headscarp. The upper southern margin has a zone of buckled ground inferred to be a compression zone and has risen slightly suggesting that the movement direction here has been largely southward, before becoming more westward moving further downslope. The influence of this upper slope movement on the whole landslide is worthy of further consideration.

Figure 5: Comparison of ground surface in upper landslide area in 2013 (green), 2020 (blue-uncorrected) and 2021 (red). Profile along thicker red line.

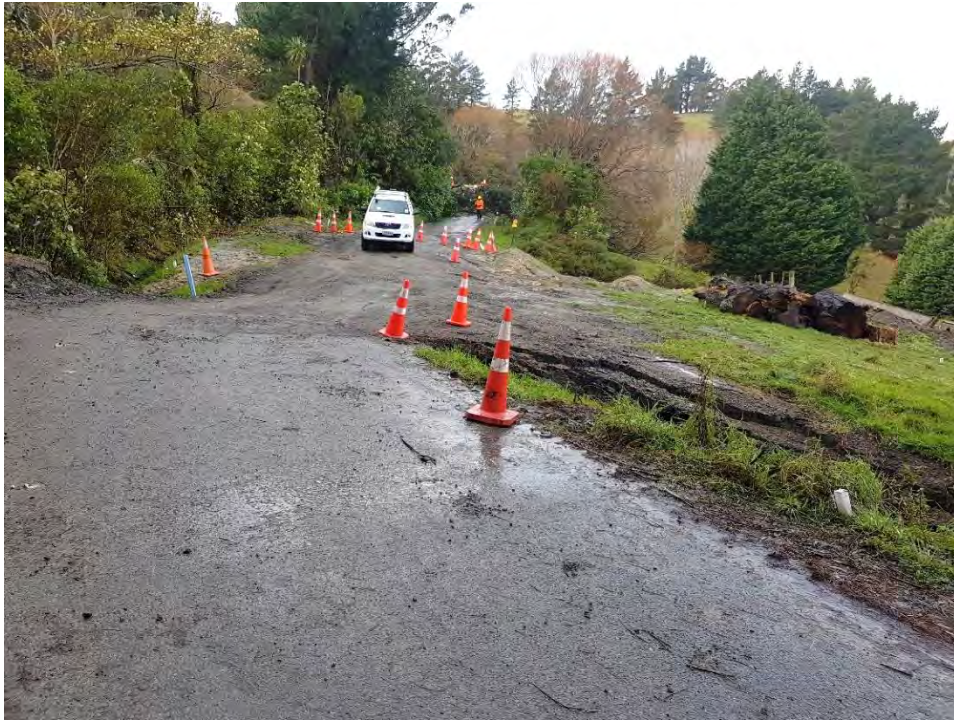
Approx. 4-5m offset of original white edge line to right of cones

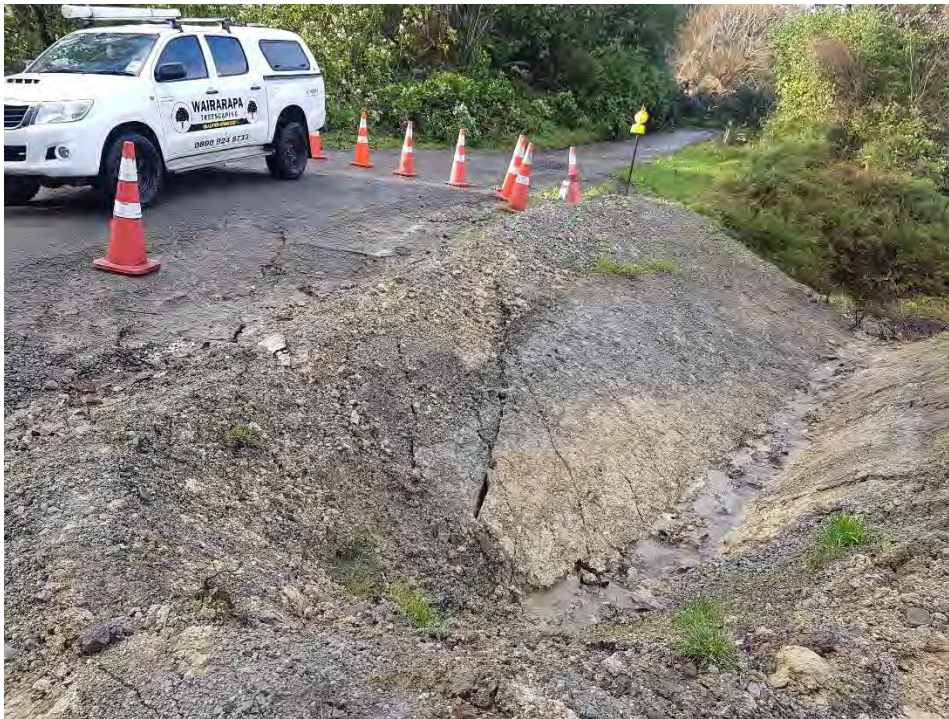
Sharp tension cracks in (1 year old) drain

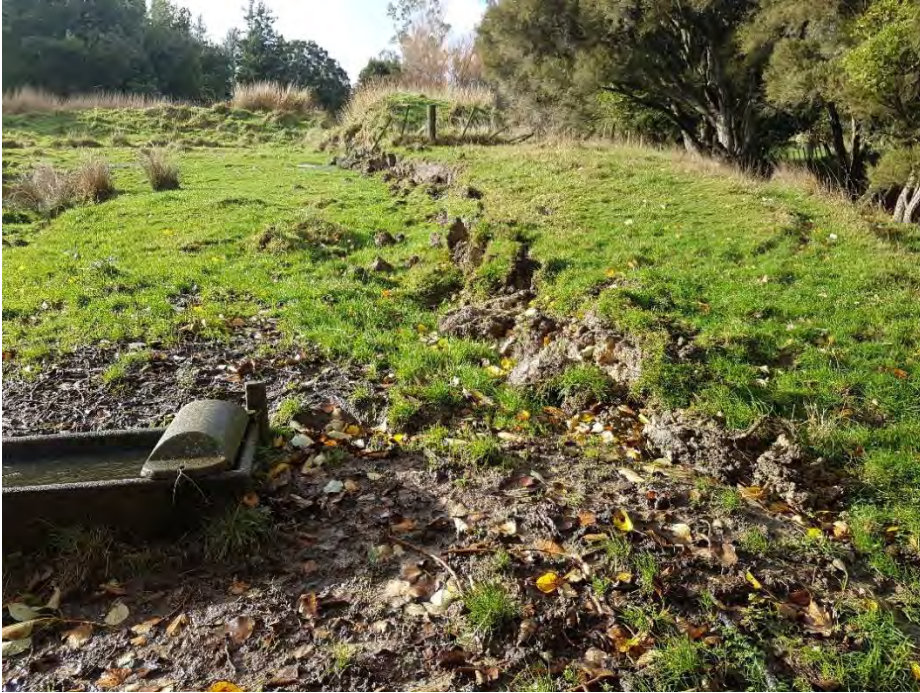
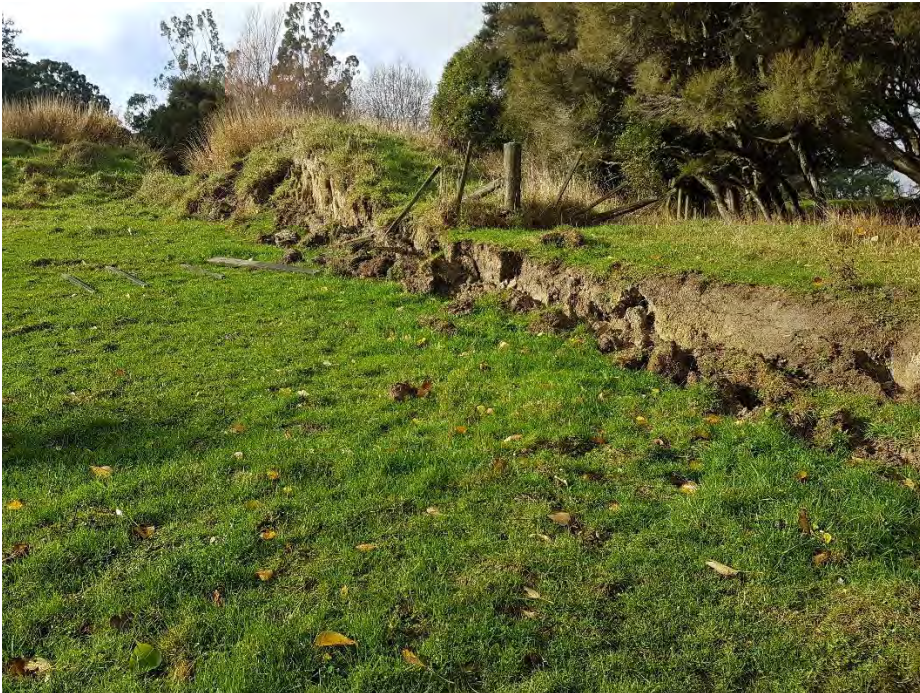
Landslide margin through/ below dam face

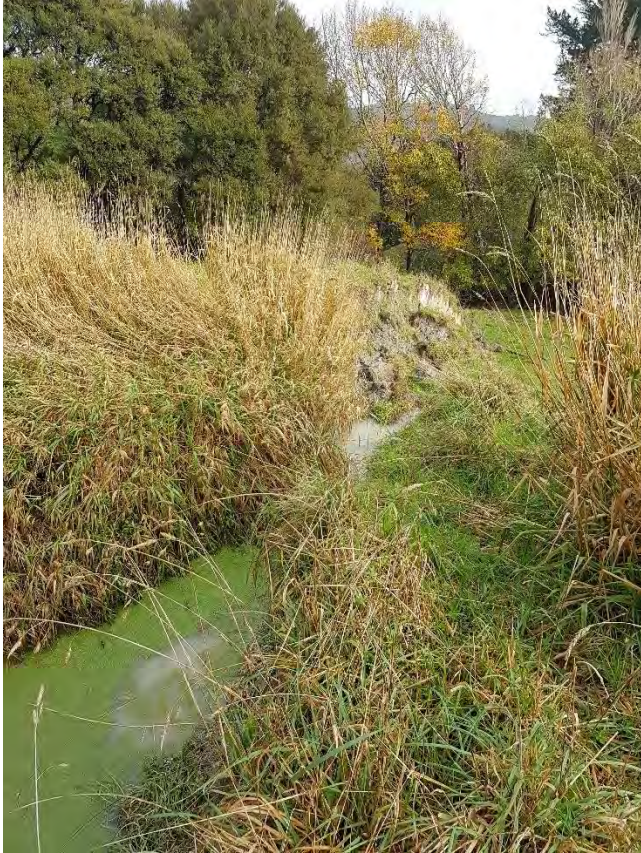
Water breaching dam along line of fissure (moderate flow) view downslope

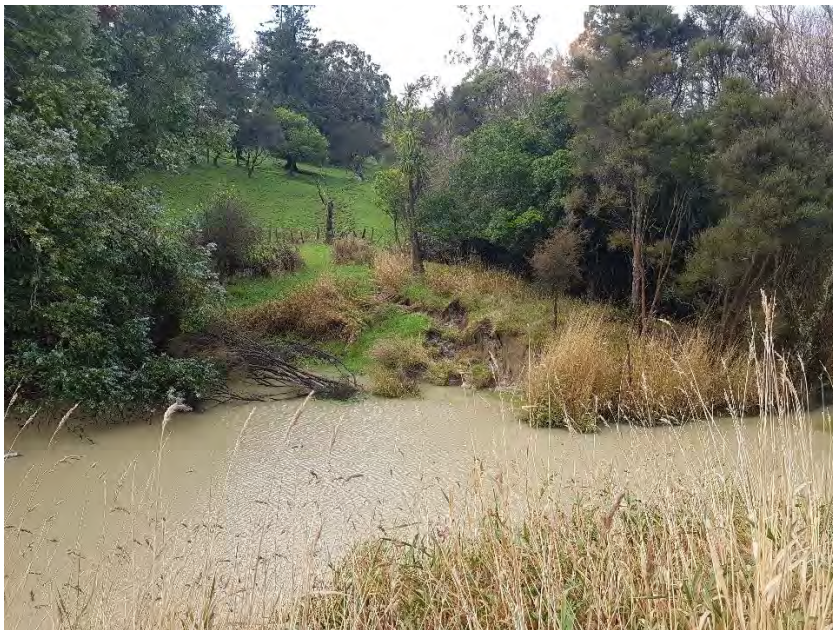
Fissure (western landslide margin) going upslope of dam

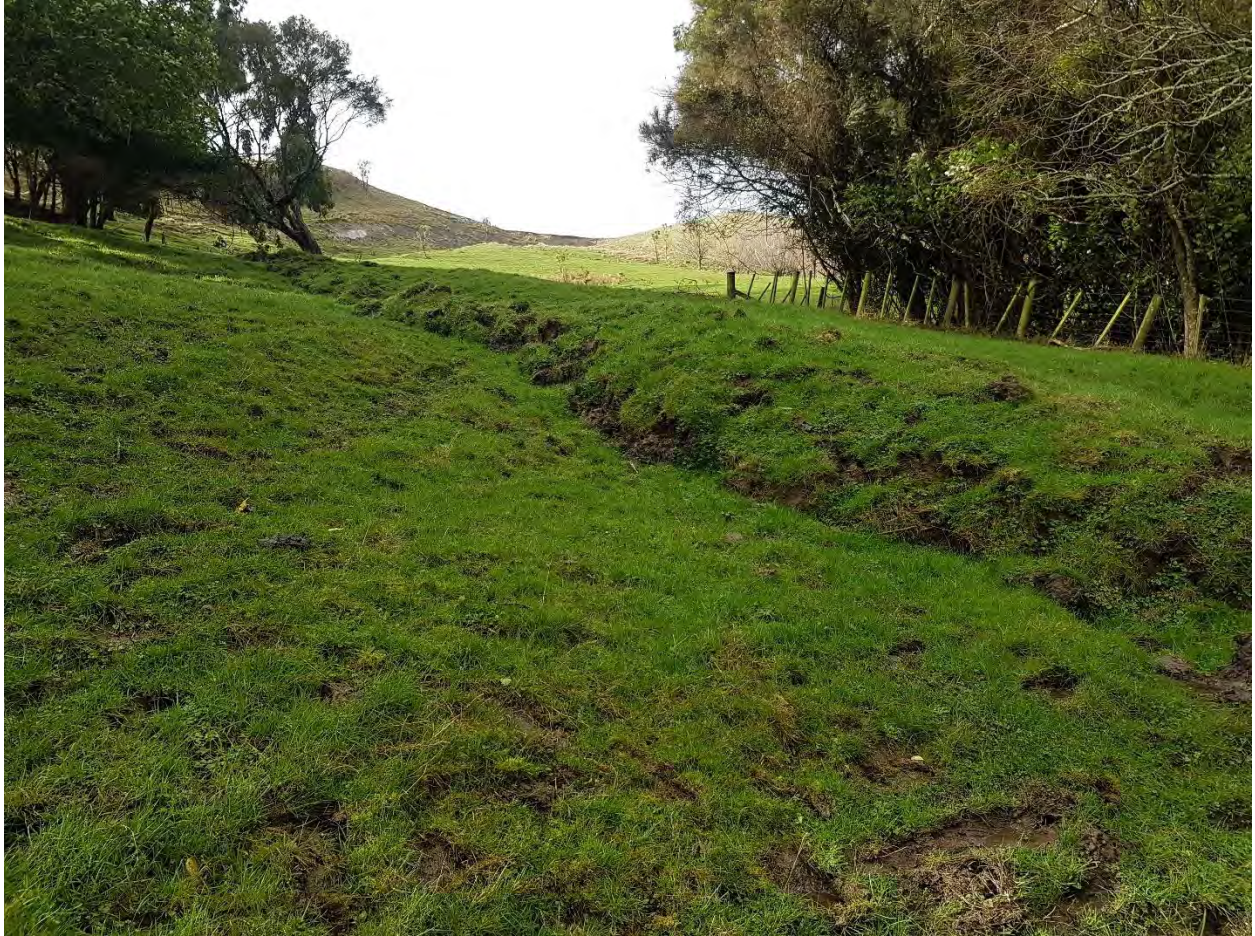
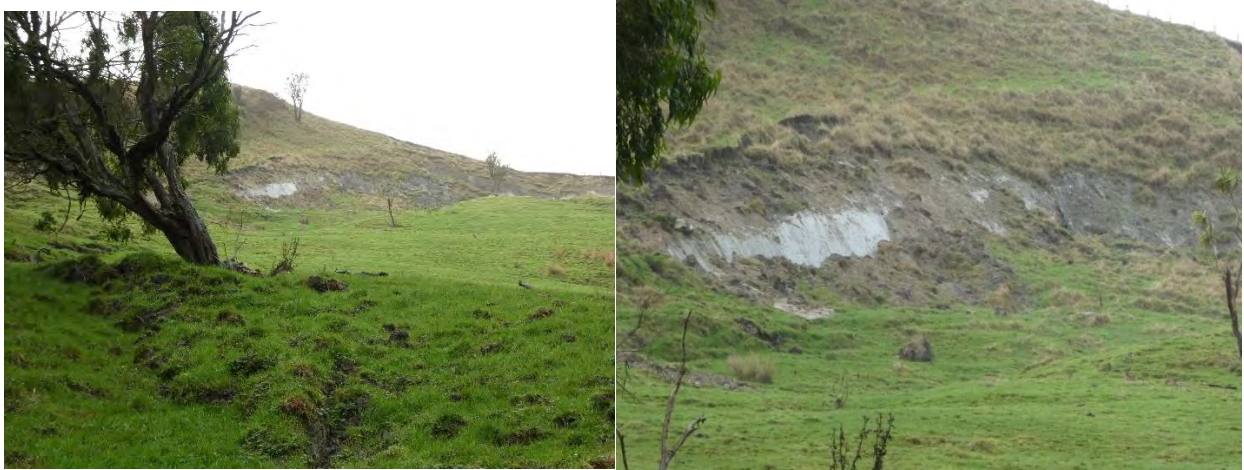
View of edge of landslide from above dam, toward headscarp

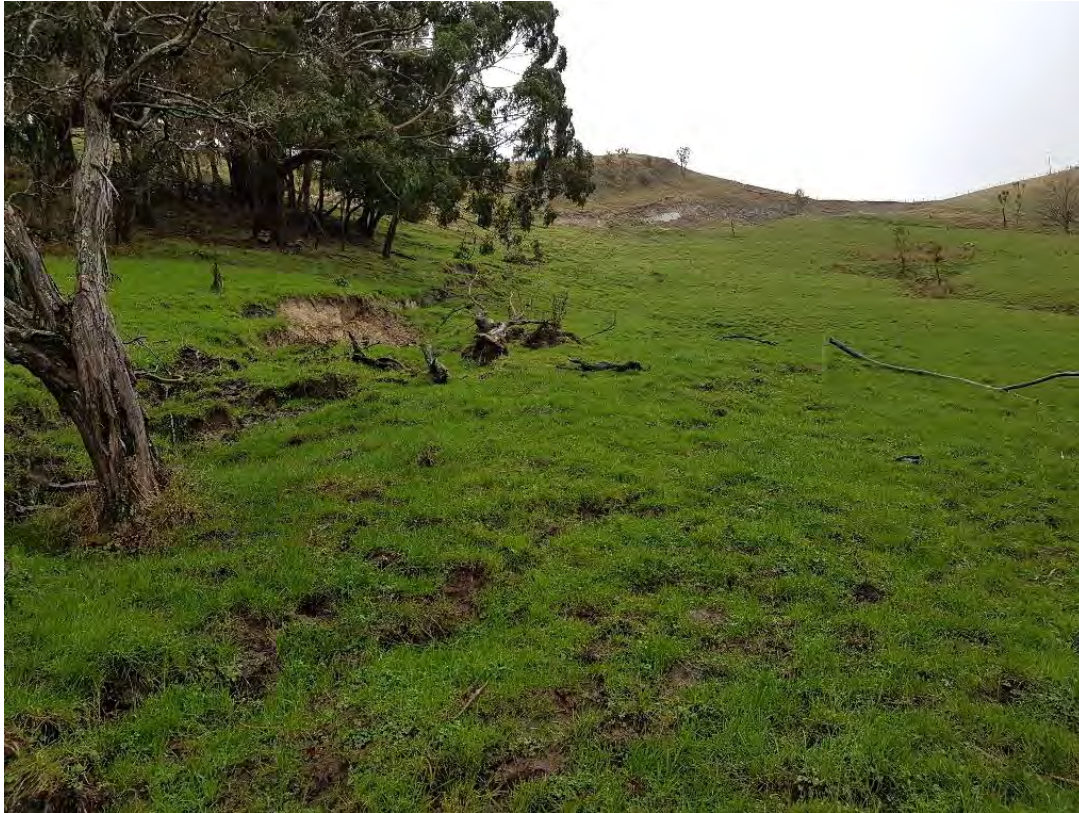
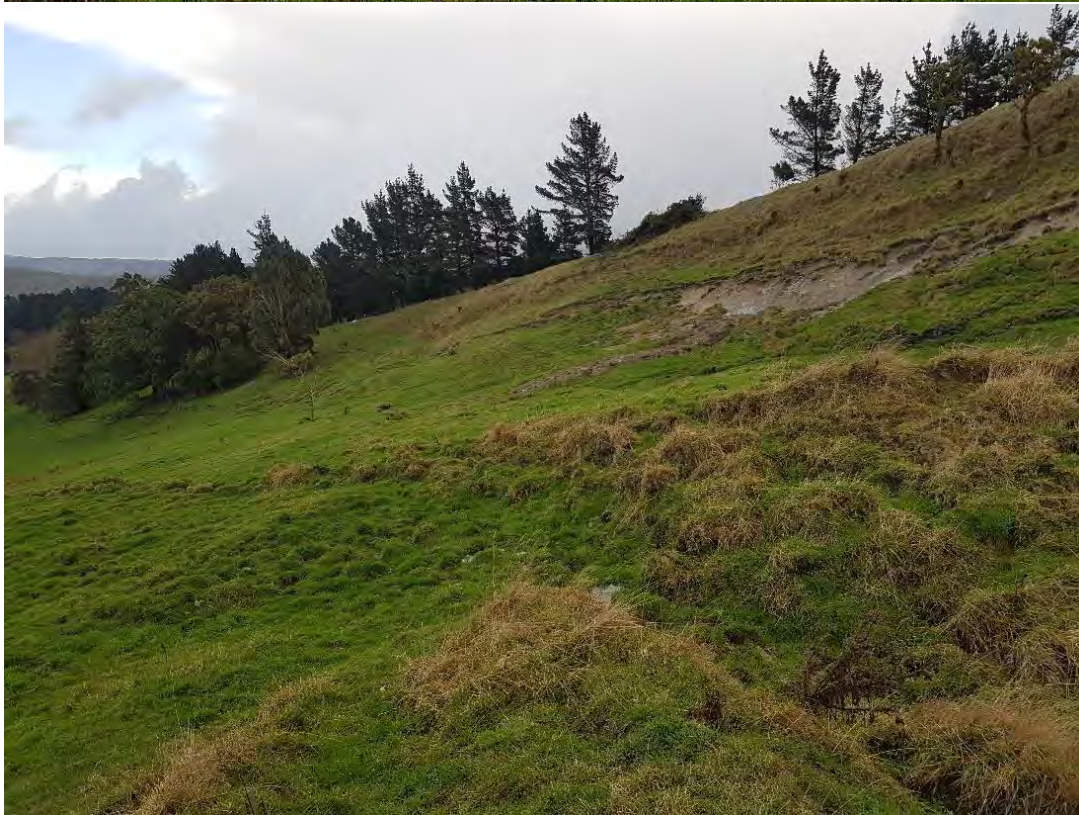
Central section of western (right looking down) lateral margin scarp

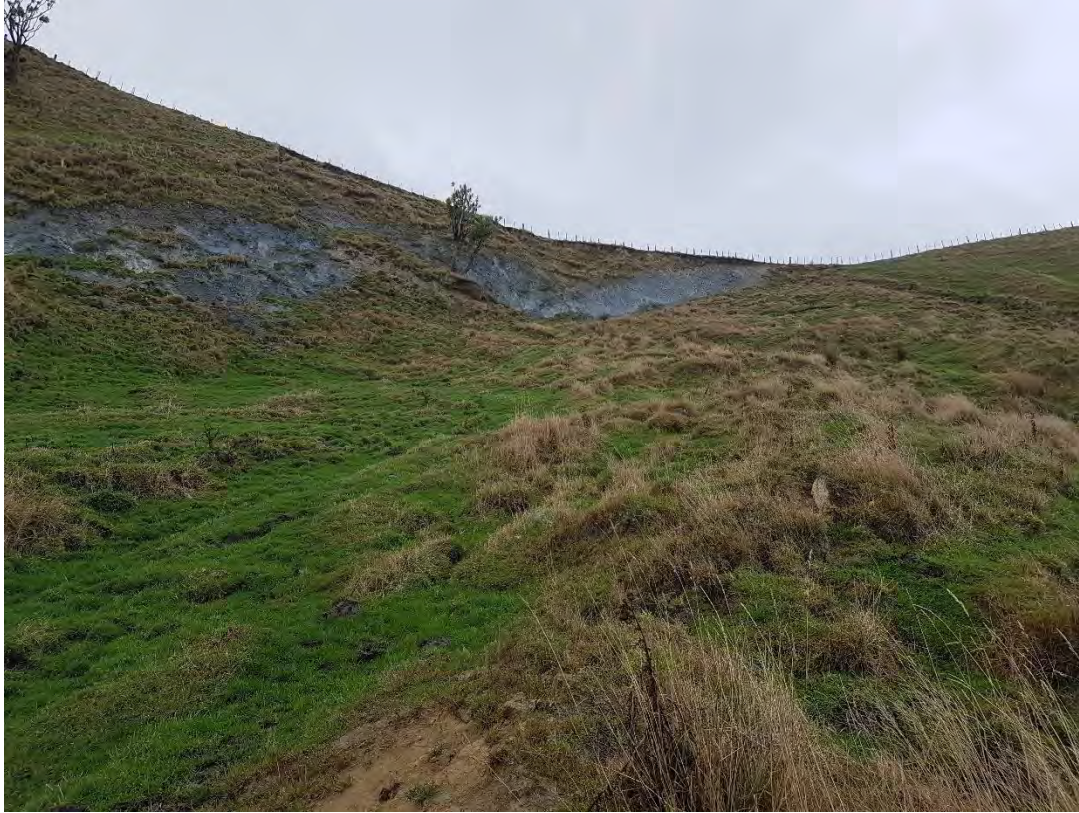
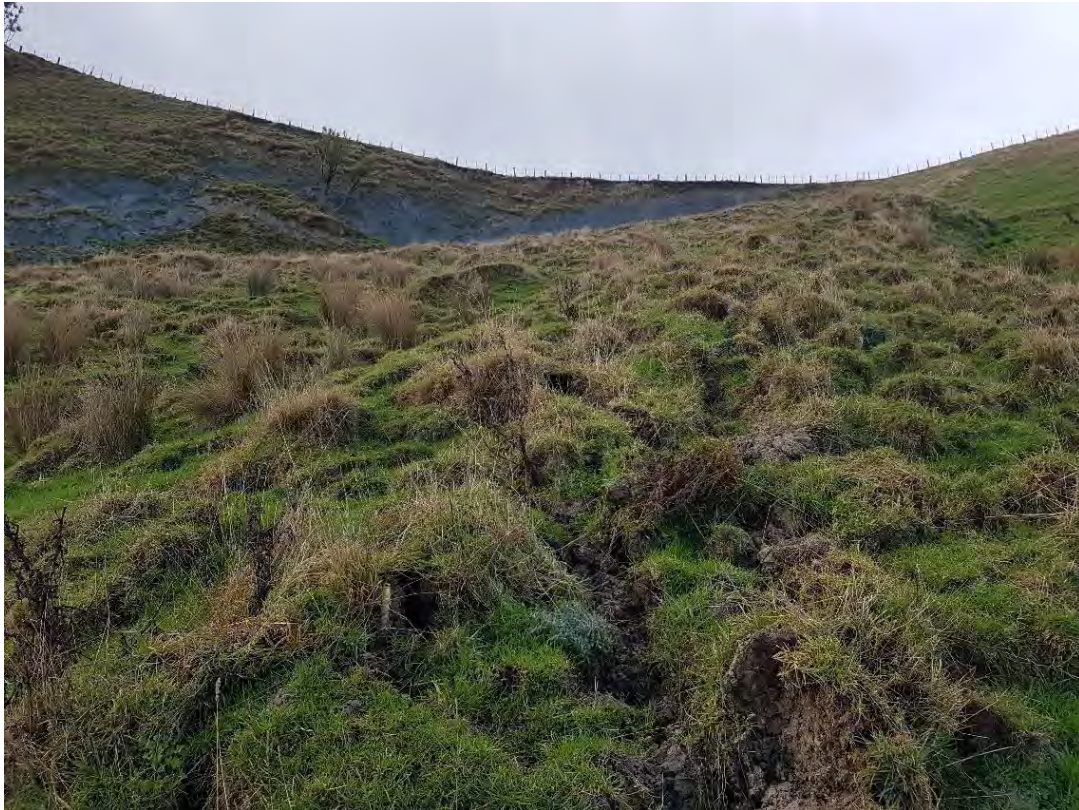
Head scarp with compression bulge on eastern (left looking down) margin

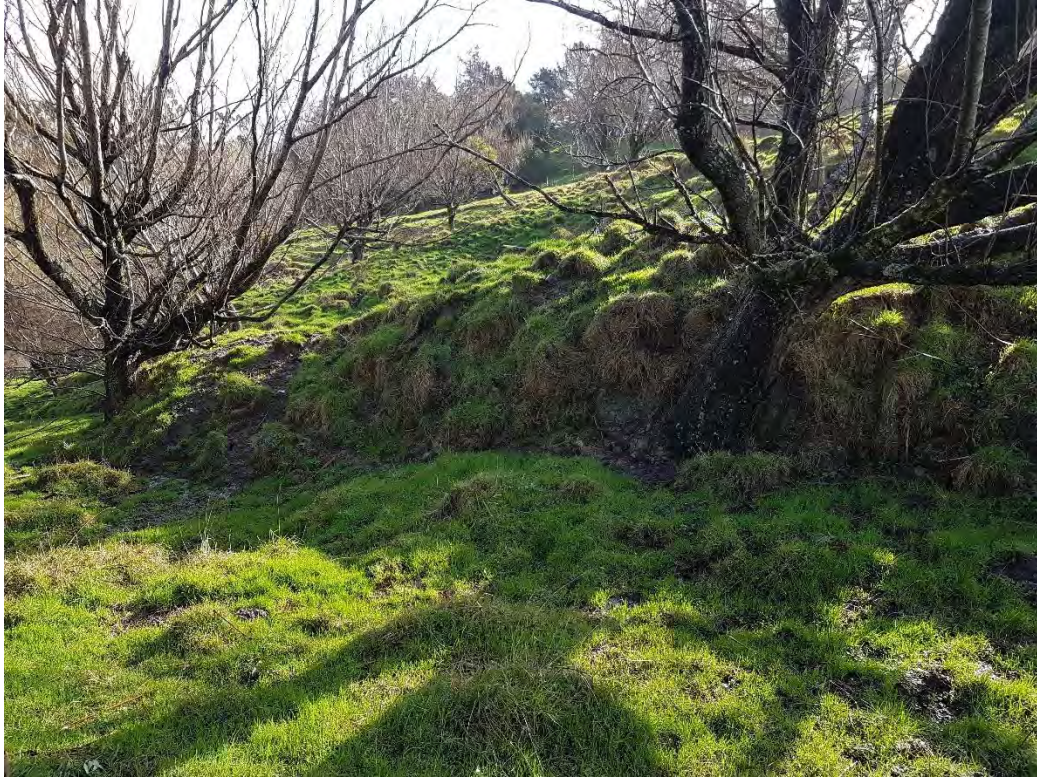
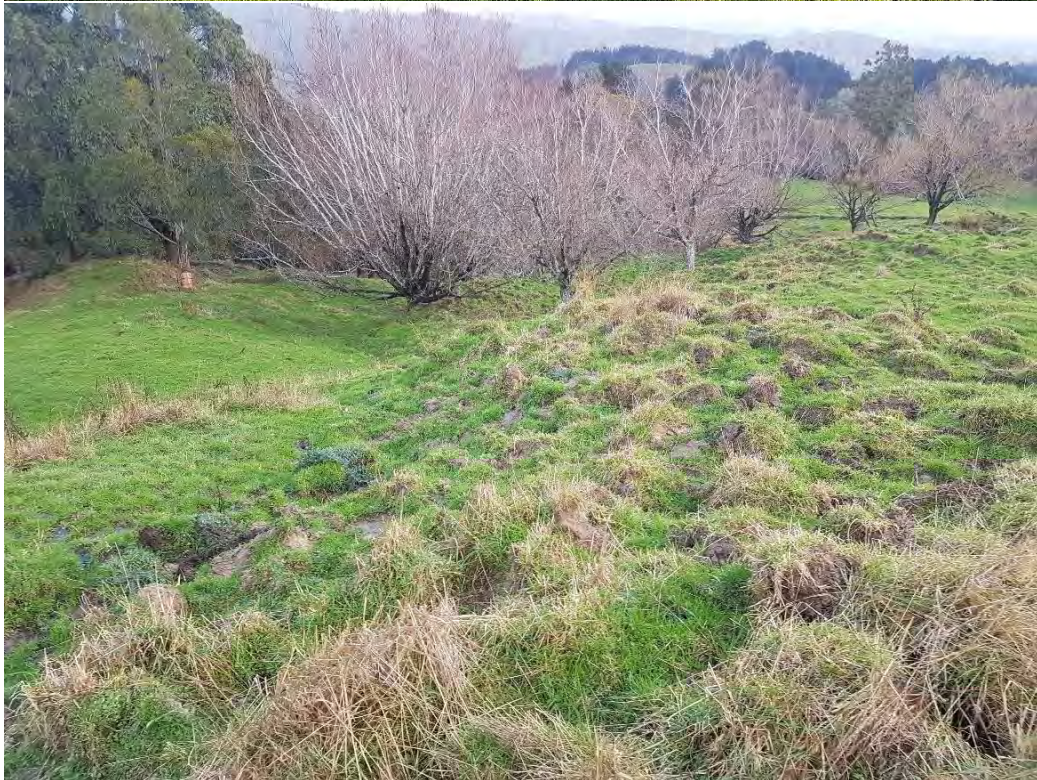
Eastern margin mid section with compression zone in foreground and trees buttressing edge of movement

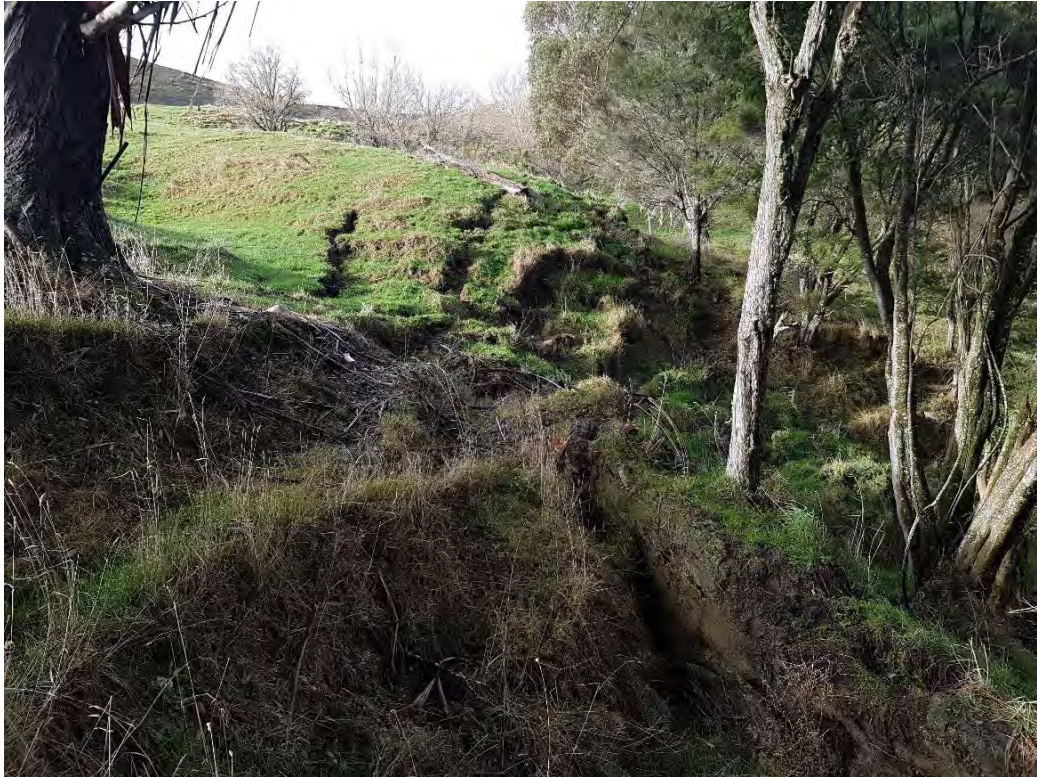
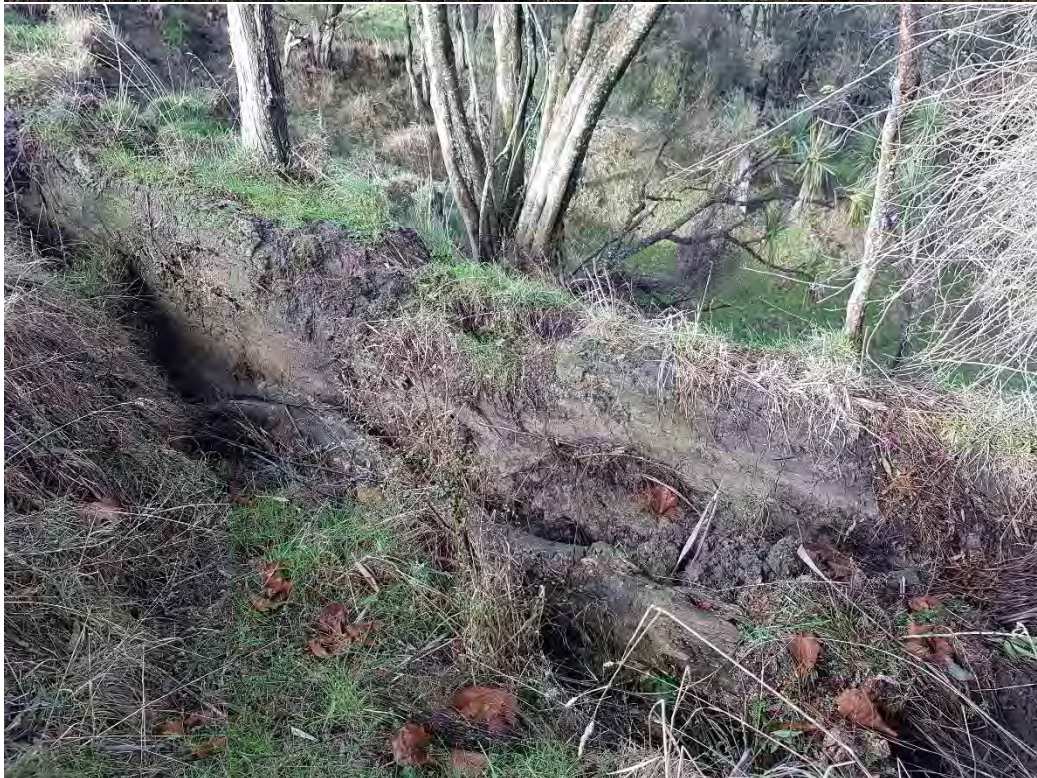
Eastern margin of landslide pushing steeper slopes below and causing secondary movement onto steeper slopes above road. Subhorizontal striae visible on both photos showing main movement is very low angle (near horizontal).
