HINEKURA ROAD EROSION AND LANDSLIDE REMEDIATION REPORT

HINAKURA HILL - RECOMMENDED EROSION AND LAND SLIDE REMEDIATION PLAN

To	Ben Turner, Tim Langley (South Wairarapa District Council)
From	Giles Farquhar, David Stewart
Office	Wellington
Date	16 August 2021
File/Ref	5-C4072.01; GER Report 2021/46
Subject	Hinakura Road Landslide July 2021 Assessment

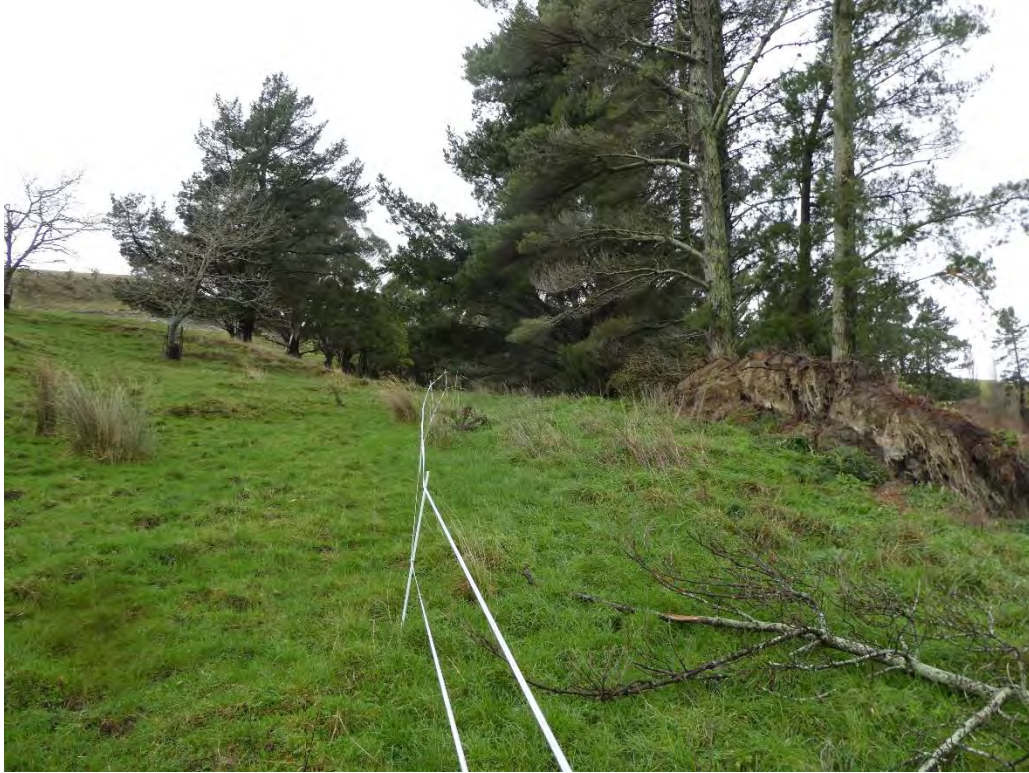
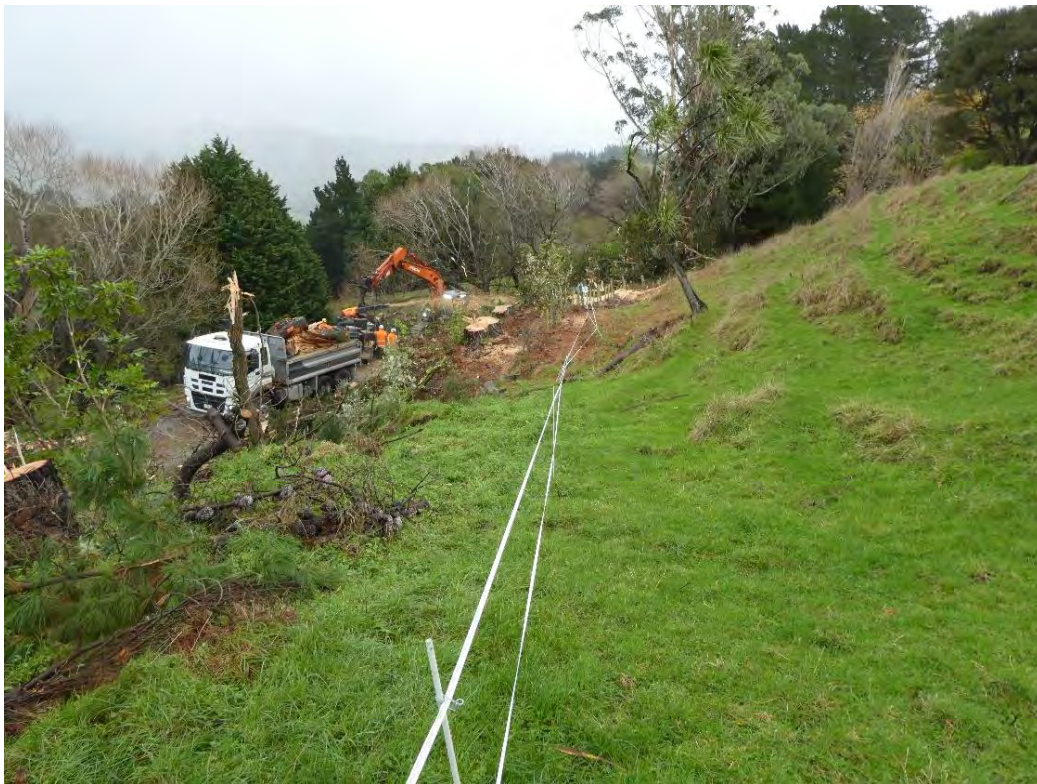
Lower slope above road landslide has pushed and tilted pine trees at top of steep slope above road (which have been cut down this week to the right – photo below)

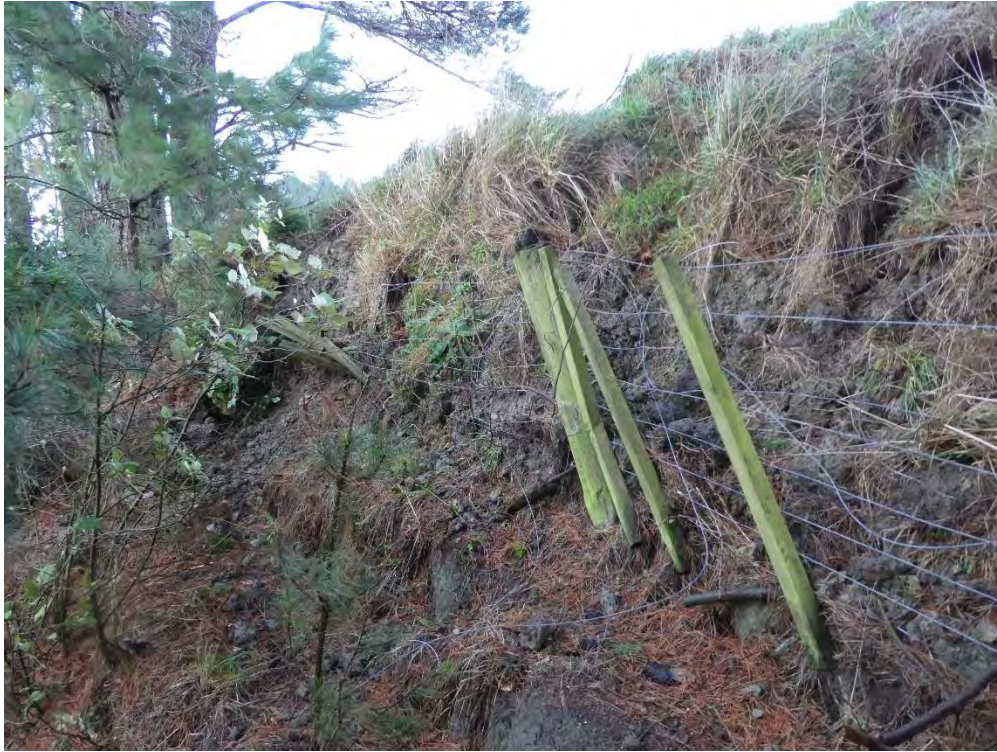
Bulging at eastern margin of landslide has just reached fence (and trees)
