HINEKURA ROAD UPDATE

Purpose of Report

To update the Committee on the current situation, progress made and plans to remedy the road drop at Hinekura Road.

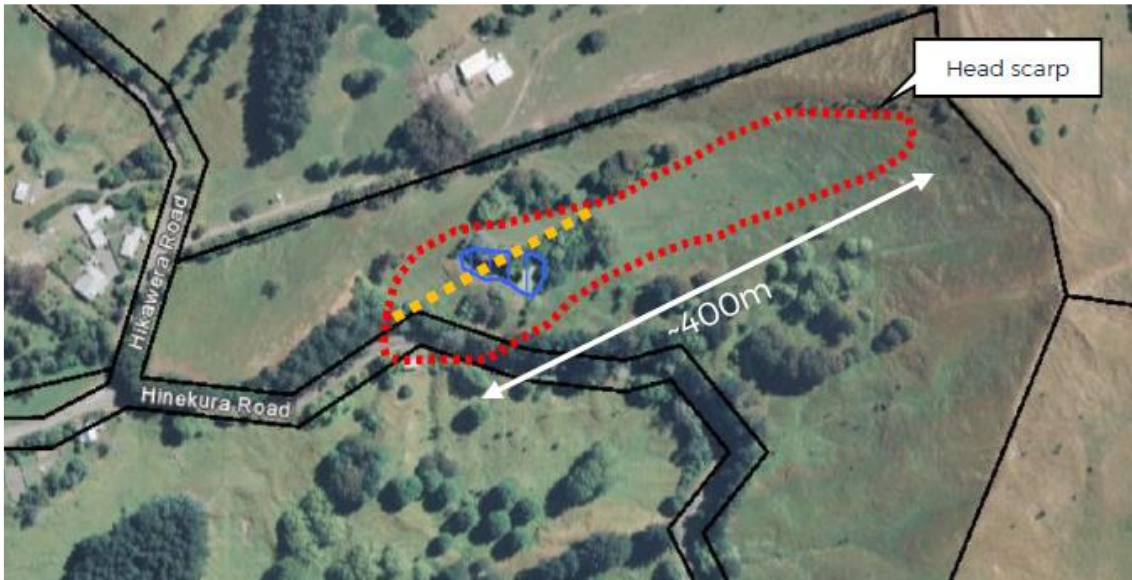
The area of the landslide is substantial (approx. 450m x 150m, shown in red, below) and includes the water supply for the property at 1673 Hinekura Road (shown in blue). The area requiring recent tree felling extends beyond this indicative red line.

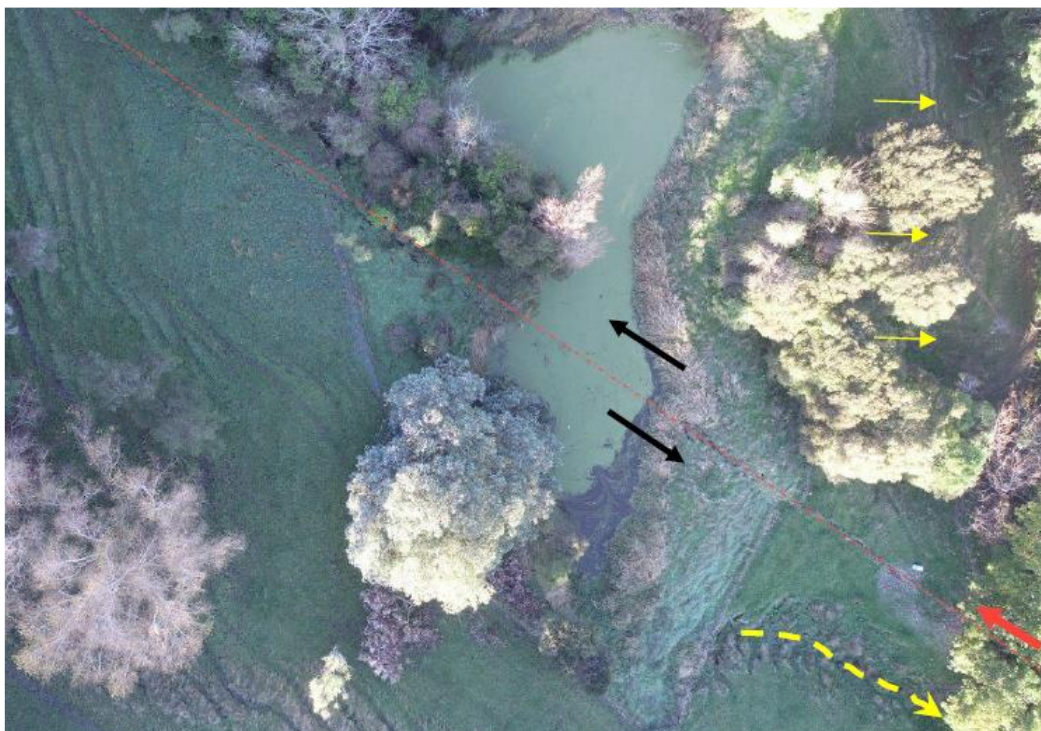
While some overflow from the dammed water supply is present (as identified by the yellow arrows), it is likely that water from above is also of concern, as shown by the tension cracking above the dam in the image, below. (The red and black lines identify a possible line of tension that may require further investigation.)

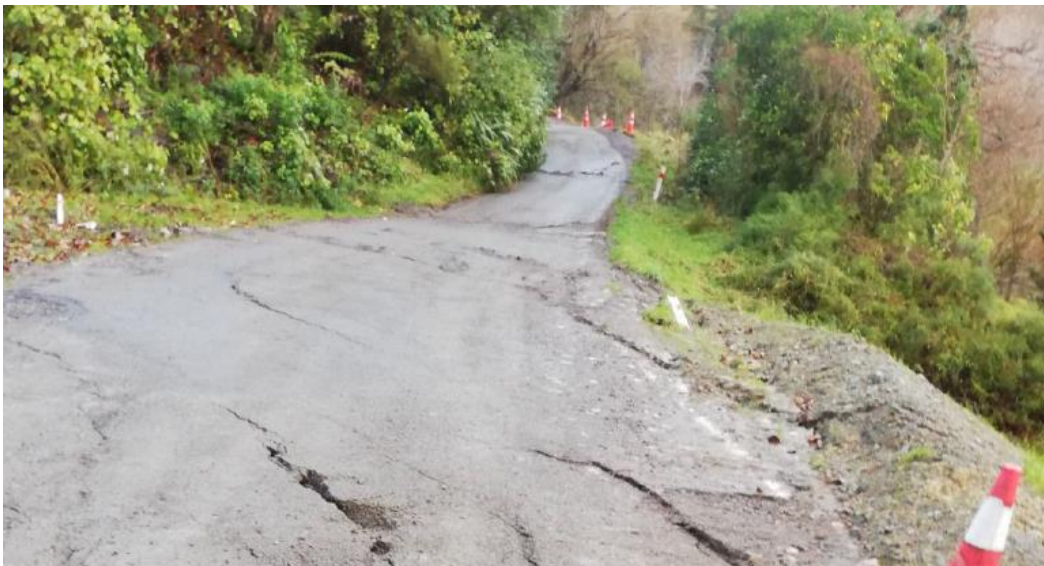
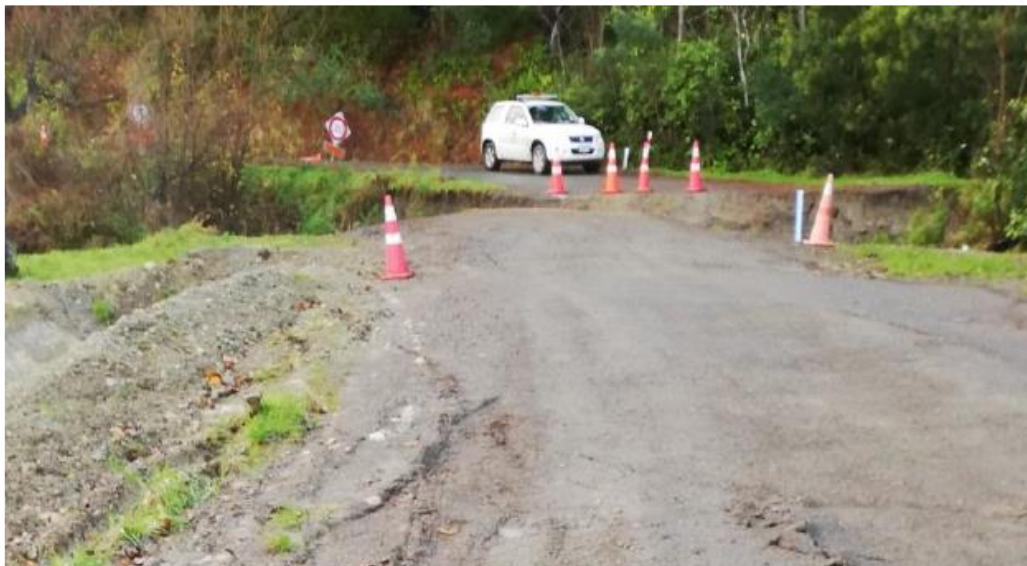
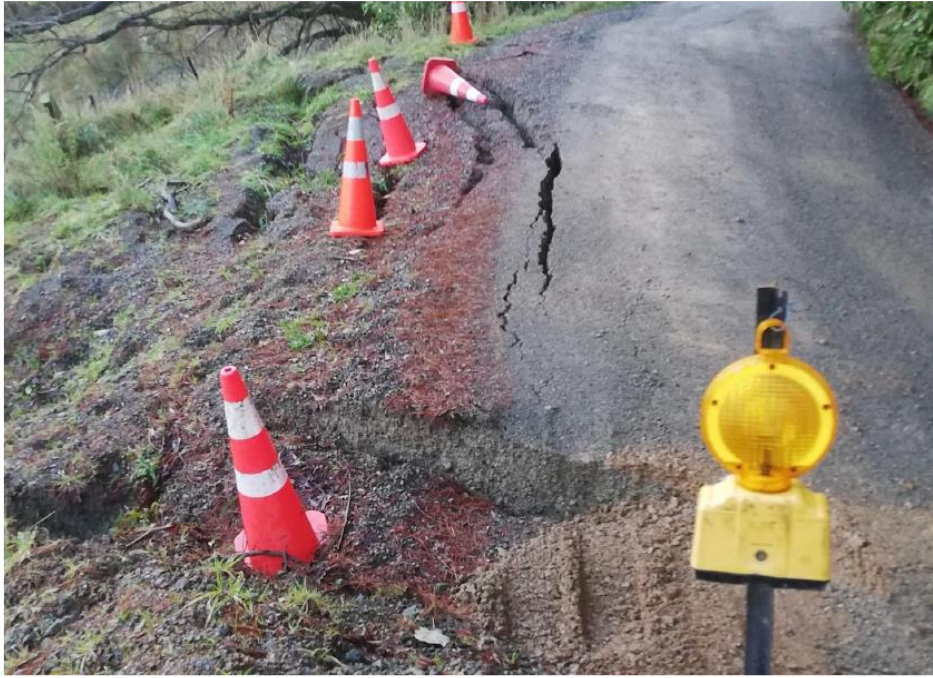
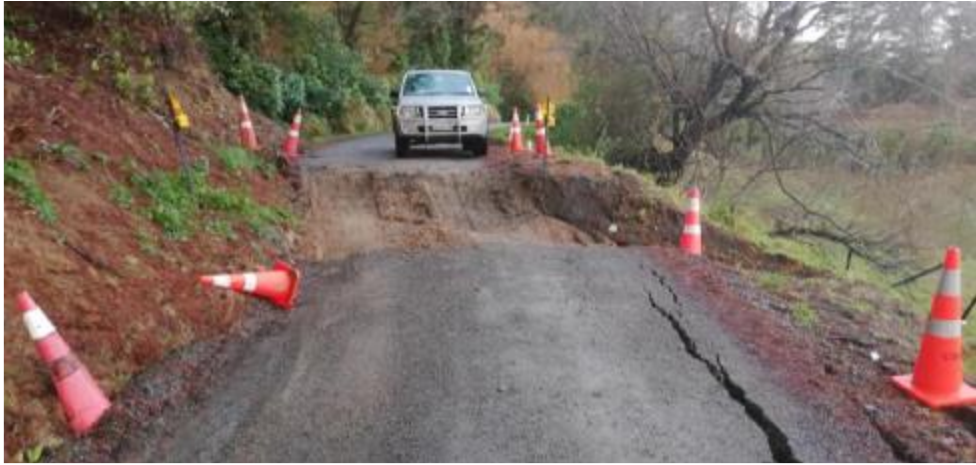
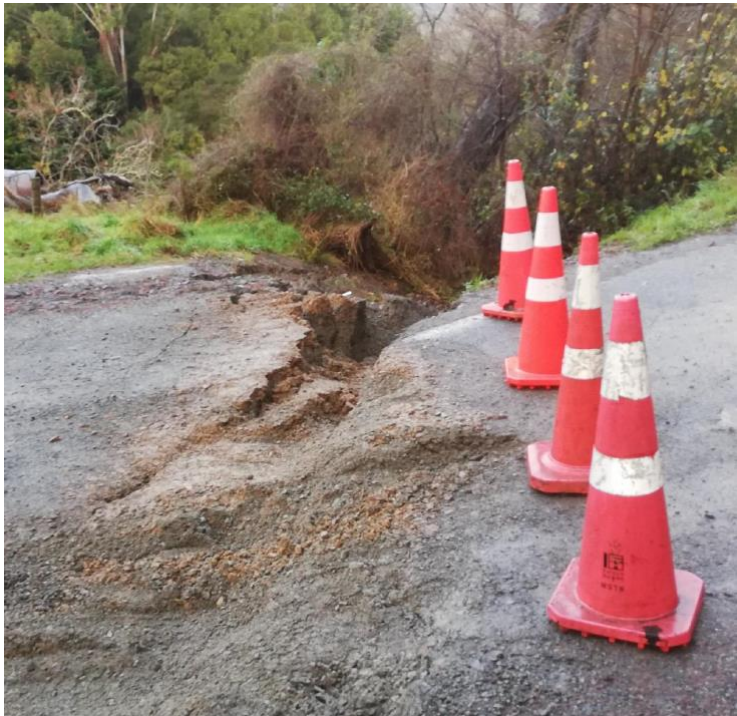
The survey marks were monitored and no movement was detected in the area. However, through the 21st to the 23rd of June 2021, the area experienced significant rainfall (160mm+) that resulted in the road area shifting by approximately a metre. The following images (23rd June) show that shift and cracking in the road surface:
