CONSERVATION AND MAINTENANCE PLAN

'The Old Library Building' and Kouka (Cabbage Tree) Cottage

> at Stella Bull Park Greytown GJ/RW/1515 November 2009

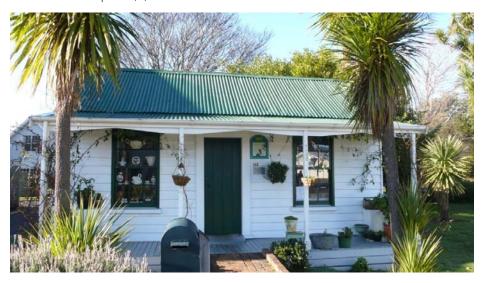
Front Elevation. Almost a classic 'miner's cottage.

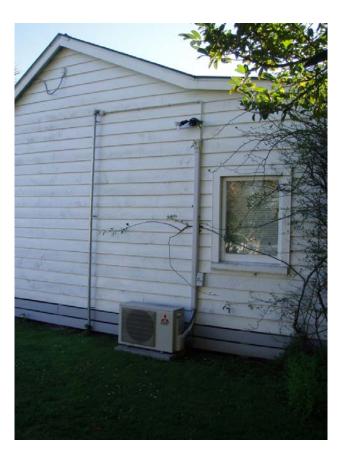
South Elevation- Unpainted sprinkler pipe. Wall needs cladding

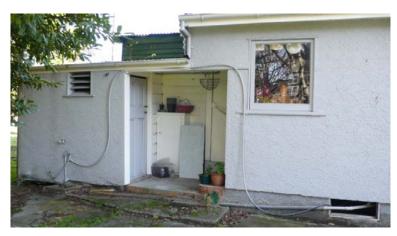
Back porch with nearly all the exterior maintenance items. Unpainted high level roof, untidy draped water piping, waste pipe, missing access door, old DP bracket.

The east wall has a recessed porch to the back door with a Toilet opening off it. This is the most disorderly area of the house with ad hoc cupboards fitted to the Porch and various other untidy features. Eg. Unpainted sprinkler pipes to the Porch ceiling (also to the south wall); sub-floor access door missing; irregular, messy looking roofing detail above the Porch; redundant, broken downpipe bracket; waste pipe running along exterior wall; water pipes 'draped' along the wall. All of these items need to be tidied up or repaired to be presentable.

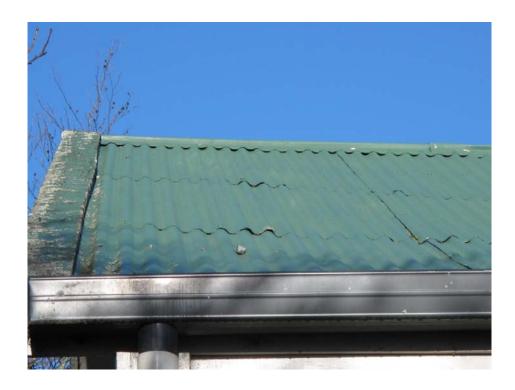
Roof, showing sheet overlaps, ridging and timber rear barge capping.

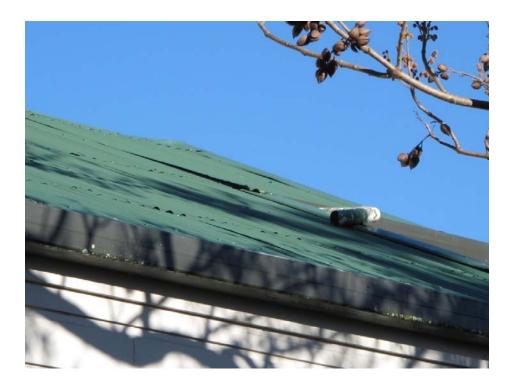
Roof, showing loose roofing sheet. (and (disgusting) downpipe detail)

The painted, corrugated galvanised roofing is old, pre-dating the use of long-run roofing. There are two, mid-run, end laps to each side of the roof which are likely locations for serious rusting although this was not able to be established without closer ladder access. On the north face the roofing is lifting at these end laps and is sitting up at several side laps. *Immediate remedy:*

Re-nail all lifting roof areas as soon as possible, to ensure that rain isn't blown into the building. Check the balance of the lead head nails fixing the roof, as these tend to lose their heads with age, and replace any that require it. Make a full, close inspection of the state of the roofing material to establish the extent of any rust.

If a measurable amount of rusting is present - replace the roofing with long-run 0.55 galvanised corrugate and paint.

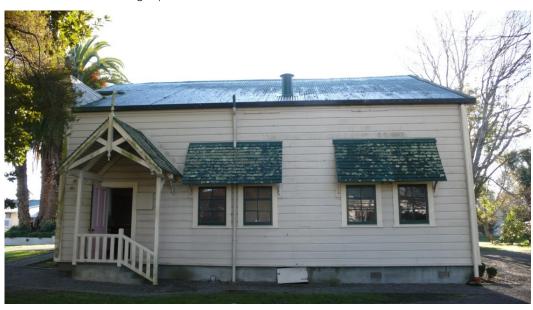
South wall, with mould and lichen growth, broken sub-floor access door.

Eg. The sub-floor access hatch has a broken hinge and needs attention.

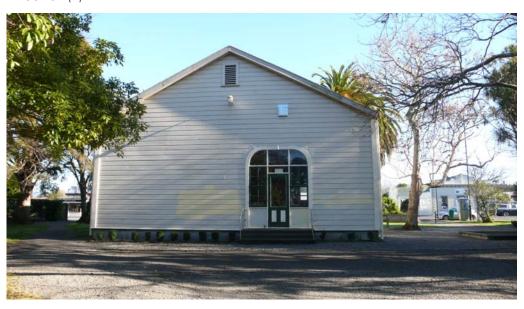
East wall with added door in glazed frame (this element is central in the 'big room'). (The modern extract fan is an intrusive item)

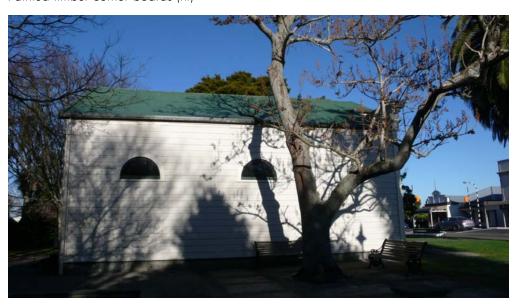
North wall with added windows.
