MARTINBOROUGH TOWN HALL

CONSERVATION PLAN

August 2011

The Conservation Plan has been prepared by David Kernohan BArch, MSc, FNZIA, Architecture Diagnostics, c/o Gladstone Vineyard, Gladstone Road, RD2, Carterton.

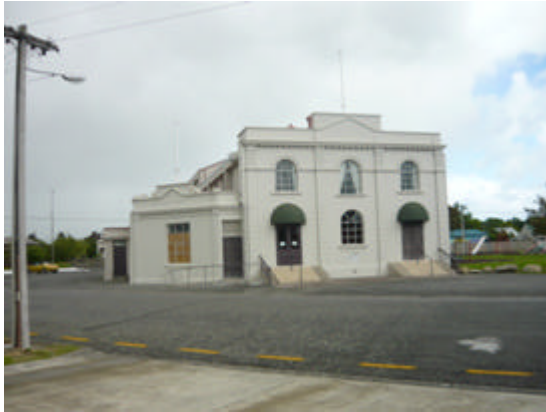
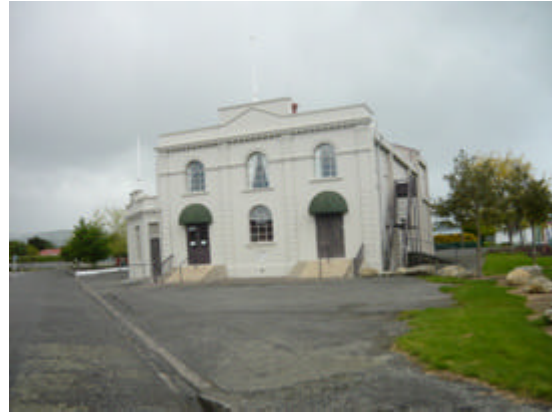
This is the building's principal façade. Constructed of plastered unreinforced brickwork it is in an essentially simple Classic style. The symmetry of the central portion is intriguingly challenged by the angled single storey annex to its left. This appears to have been dictated by the street line but provides an interesting asymmetry to the whole. Formerly, a balcony on posts sat astride the centre window as a significant central element of the facade. A balcony could be re-instated.

Entry to the foyer and auditorium is through the left hand door but was formerly through the two principal doors either side of the central window (that formerly sat below the balcony). The large door to the single storey annex at the side gave access to the Town Clerk's office and the Council Chamber but now provides access (blocked) only to the Ladies' toilet. Both doors each have a small canopy above, of unknown provenance. While these additions are not visually intrusive, they are probably ineffective in providing the intended weather protection and should be re-thought.

Despite having some unfortunate additions over the years, this principal façade is currently in a close to authentic condition. With a restored central balcony, the front of the building could be returned to its original appearance. The entry doors and the windows require repair and maintenance including re-painting but otherwise the façade is in good condition largely due to its refurbishment in 1997.

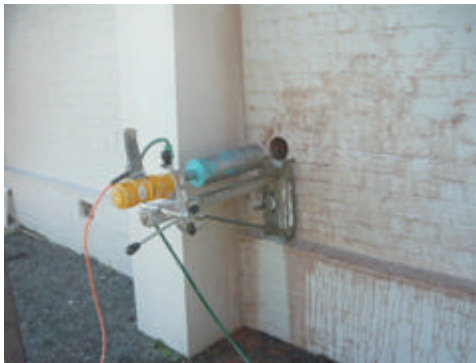
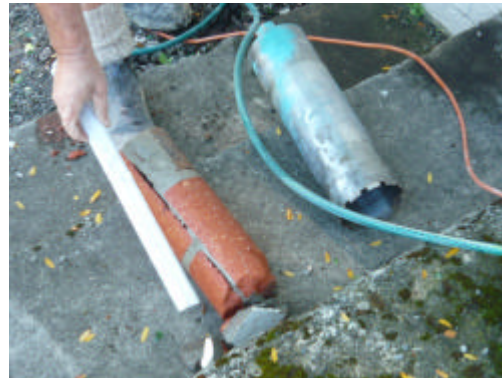
Core testing of brickwork – Auditorium wall, west face

The construction of the auditorium walls is of 13½ inch standard solid Silverstream bricks. The annex building on the east face and the lean-to storage building to the rear of the stage appear to be comprised of an outer and inner skin of 4½ inch brick with, unusually, a 4½ inch cavity. The course work of the brick in all areas is apparently random in terms of the runs of header and stretcher bricks. Certainly, no standard brick bond configuration has been employed. English Bond would have been appropriate. The use of a 4½ cavity is also unusual as traditionally a 2 inch cavity was used allowing both ventilation to the walls and for the outer and inner skins of brickwork to be tied. In this case it is unclear to what extent the inner and outer brickwork skins are connected. Generally, the condition of the cement mortar is good for a building of this age.

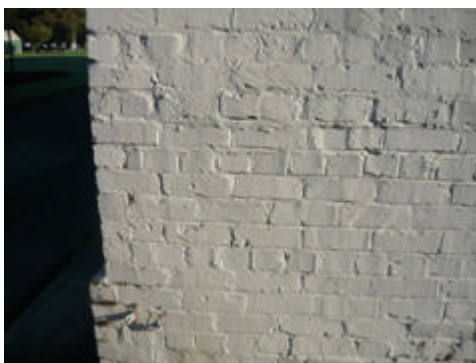
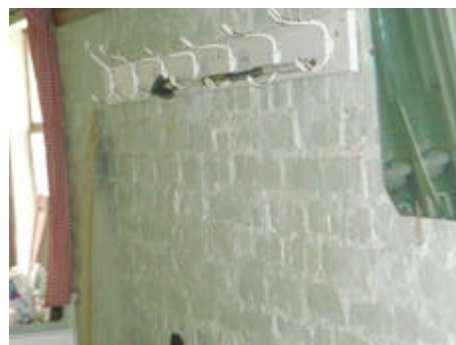
Brickwork configurations at lean-to storage building – outside and in

The brickwork is in generally good condition and is painted. It could be possible to remove the paintwork from the bricks without damaging the brickwork's glaze and thus endangering the brickwork to porosity. Several proprietary brands of brick paintwork remover are available. It may be appropriate to select some trial areas to see if the brickwork could be effectively and economically returned to its original appearance without undermining the weathertightness of the building.

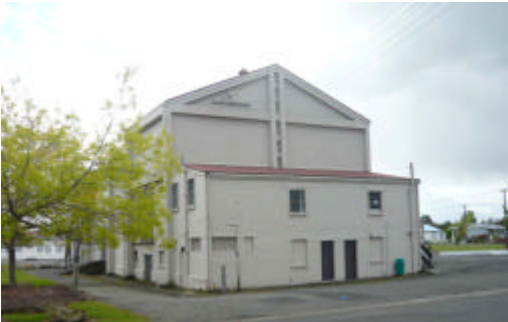
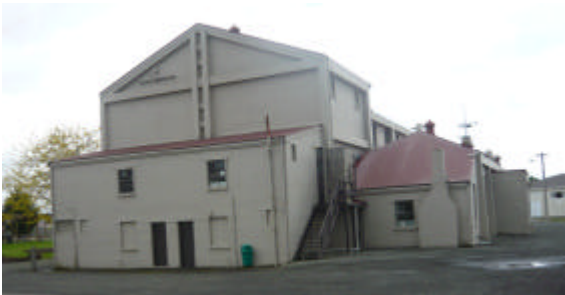
Constructed in painted un-reinforced brick masonry, this façade presents a utilitarian face to Cork Street. The brick is original and displays some deterioration and cracking. There is substantial cracking in the south east corner. The lean-to building sits under a mono-pitch timber roof with corrugated iron roofing. The Eastern Consulting report expresses some concerns about roof and wall connections in this part of the building.

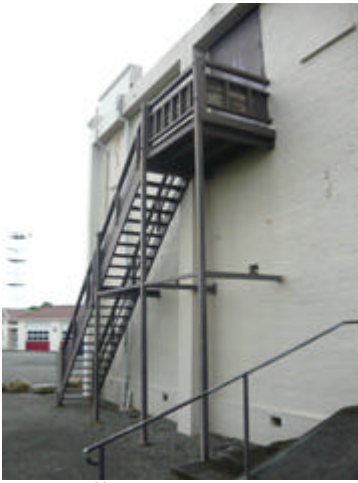
Escape/Access stairway

An external timber stair leads to, or rather from, the gallery inside. It is possibly original though it is unlikely its supports are. The stair is reasonably sound but it is a daunting element to scale. Formerly there was a 'run' of windows along the length of the auditorium at gallery level on this façade. These could be re-instated.

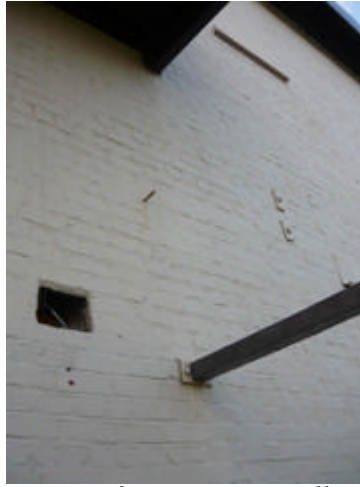
stairway fixing to main wall

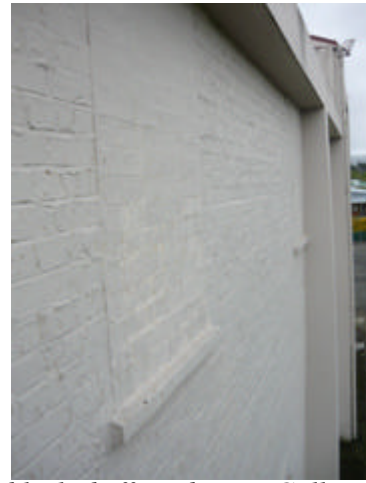
blocked-off windows at Gallery level

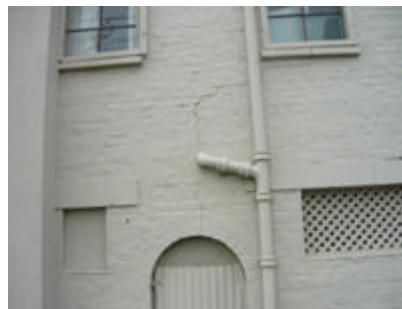
Door to public male toilet
note cracking of brickwork
down face of wall at angled
downpipe

There is clear slumping of the lean-to storage building. This is due most probably to a soak pit or similar having been located too close to the south-east corner of the lean-to, undermining the foundations.

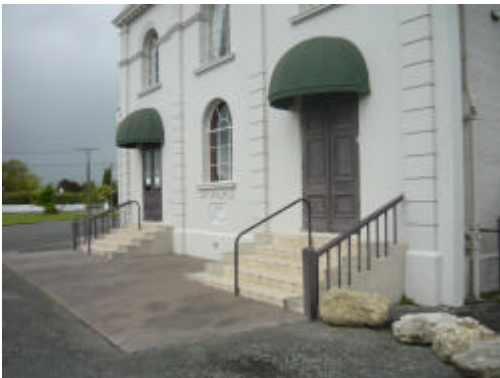
While this space remains essentially intact, it has undergone some unfortunate and inappropriate changes. In the first instance, it is no longer possible to enter the foyer through both principal external doors. Only one door remains in use while the other is blocked off within the male toilet that was constructed in 1977 at the western end of the foyer. At the opposite (eastern) end is access to a female toilet which is located in the area that, originally, was the entry to the Town Clerk's office and strong room. It is not clear that formerly there was a door or access between the foyer and the Town Board offices. The original stair to the balcony and an interim stair to the projection room have both been removed. The structural strengthening work of 1997 is self evident in so far as the steel bracing is exposed. That work also restored much of the space to its original configuration notwithstanding the absence of the original stair to the gallery and the locations and access to the male and female toilets. The original matai floor remains. However, wall and ceiling linings, cornices and skirtings all appear contemporary.

Access to Foyer through left hand door
Right hand door is part of male toilet

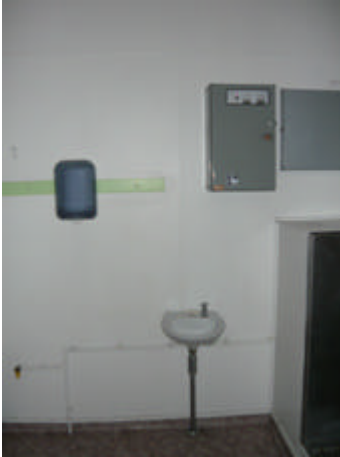
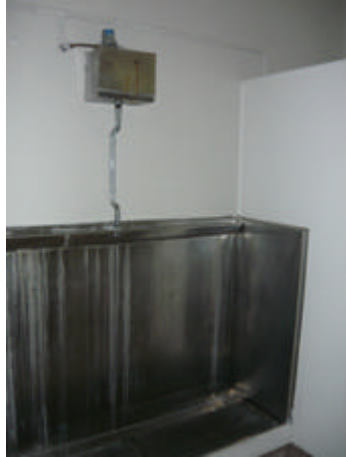
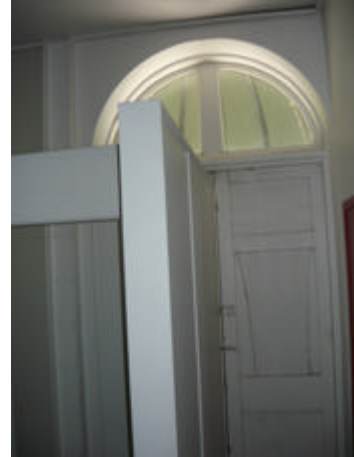
These facilities have little to commend them other than, perhaps, their functionality. Both are located unfortunately in areas of heritage significance and detract from that significance wholly. It is unlikely either toilet conforms with current requirements of the Building Act 2004 especially with respect to accessibility. Finishes and fittings are basic and inappropriate to the dignity of the building.

Men's toilets including, at right, original Town hall entrance door

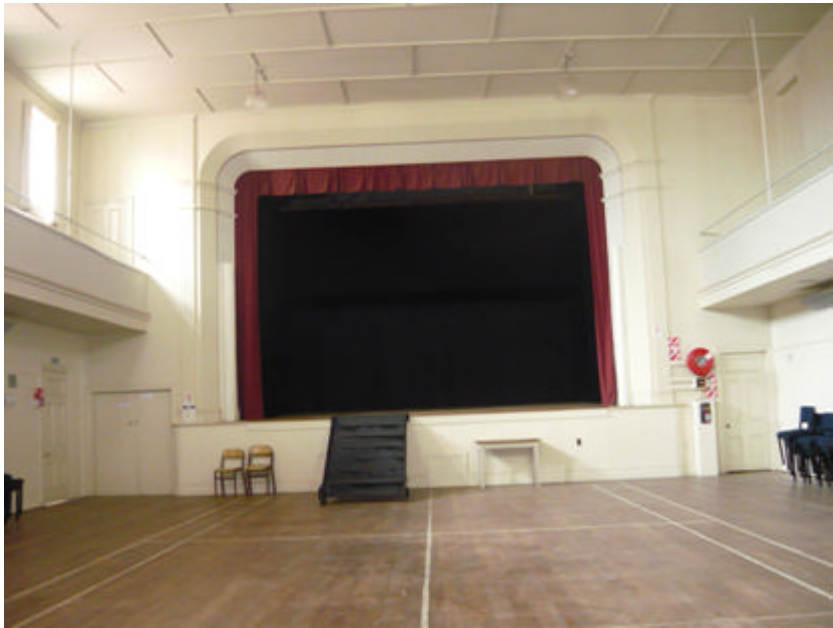
The auditorium is 34m long by 12.8m wide. It contains a mezzanine gallery, much reduced from the original, as well as a full proscenium stage with undercroft. The auditorium is an impressive space in largely authentic condition. Its acoustic qualities for musical and theatrical performance are of a high standard. The ceiling is of a fibre board of indeterminable age and could be original.. The walls are plastered. The paint regime is contemporary. The auditorium and foyer floors are heart Matai of strip timber construction. The timber floor is supported internally by 225 mm square concrete piles on a 1.5x1.7m grid. The floor is supported on 150x100mm floor joists at 460mm spacings that are generally of untreated Rimu. Floor plates are of heart Totara or Matai. The flooring is in generally good condition though there is some evidence of borer in the joists and bearers.

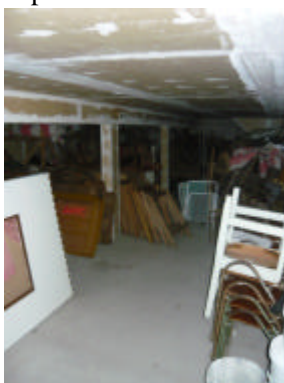
The undercroft sits below the stage. Formerly it had a dirt floor but this was concreted in the 1990s. Access to this area is awkward and haphazard and requires resolution to contemporary expectations.

general view
