TREE INSPECTION

PREPARED BY
PAPER STREET TREE COMPANY

• 54A WOOD STREET GREYTOWN •

REPORT DATED: 9/12/22

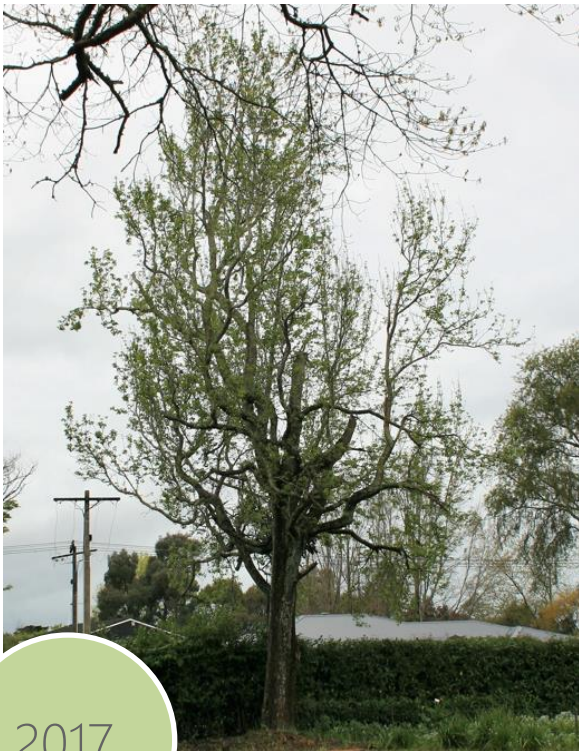
Fig.1

The liquidambar was evaluated as part of the district's notable tree review back in 2017. The tree is not noted to have any notability details (e.g., link to a historic event, person, or for rarity etc.). At the time of the assessment, it had lost a sizeable part of its canopy (as seen in the image to the left). The tree is located adjacent to the street frontage providing landscape appeal.

Notable tree review date	9.10.17
DBH (cm)	85.30
Estimated incremental growth (cm)	0.93
Height (m)	21.6
Canopy spread 1 (m)	12
Canopy spread 2 (m)	14
Canopy area (m2):	132
STEM:	150

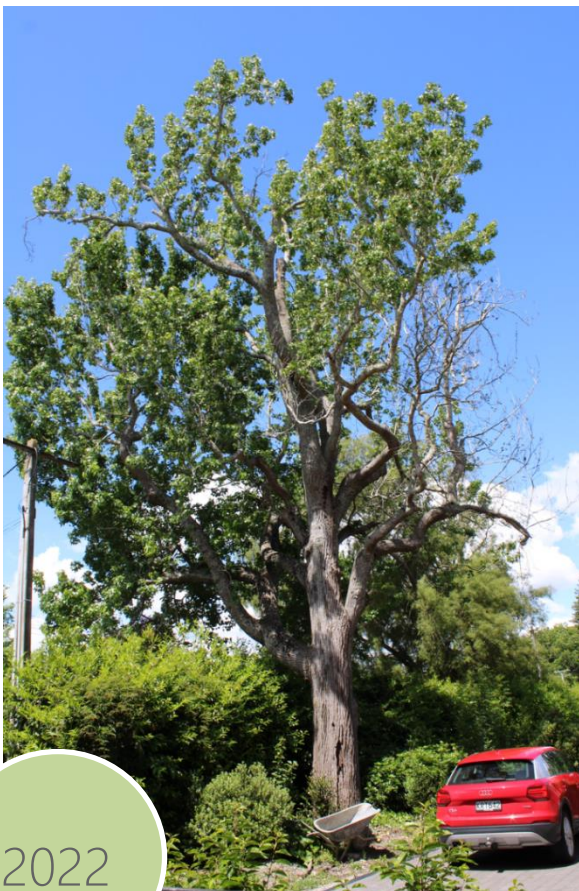
Fig.2

Date:	25.11.22	Percentage change since 2017	
DBH (cm):	88.2	+ 3%	↑
Incremental growth (cm):	0.92	-1%	↓
Height (m):	16	-26%	↓
Canopy spread 1 (m):	10	-17%	↓
Canopy spread 2 (m):	10	-29%	↓
Canopy area (m2):	82	-38%	↓
Canopy volume (m3):	280	-66%	↓
Potential new STEM:	102	-32%	↓

The data captured shows environmental and amenity values are declining (reduced canopy volume). The decrease in size and the assessed deterioration in condition (Section 3) will continue to reduce the tree's value as a landscape feature.

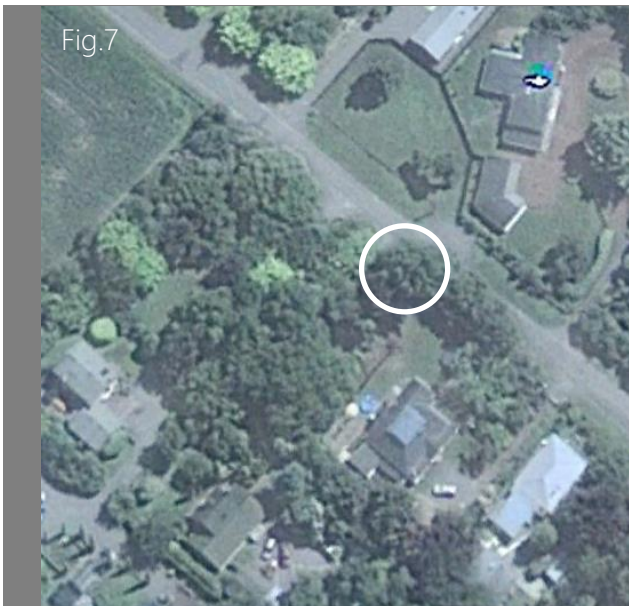
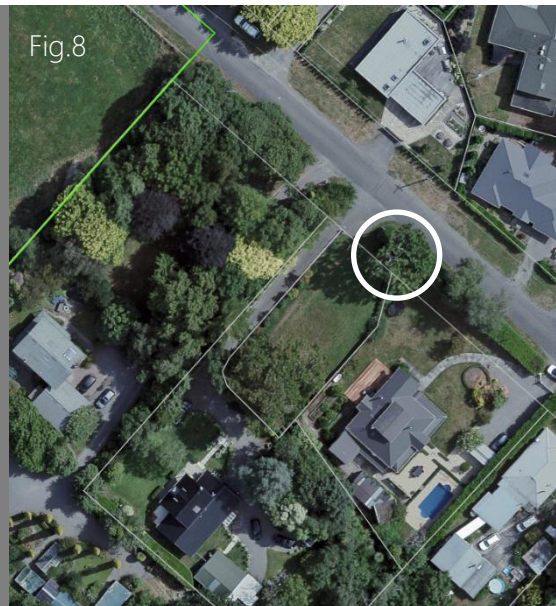
The image on the left is an aerial image of the site taken in 2010. The image on the right is an aerial image taken in 2021.

3.1.1 The site was cleared for development in around 2017. The development works have taken place southwest of the tree, approximately 2m from the tree's base. Dieback and density reduction correspond with the area where the development works have taken place.

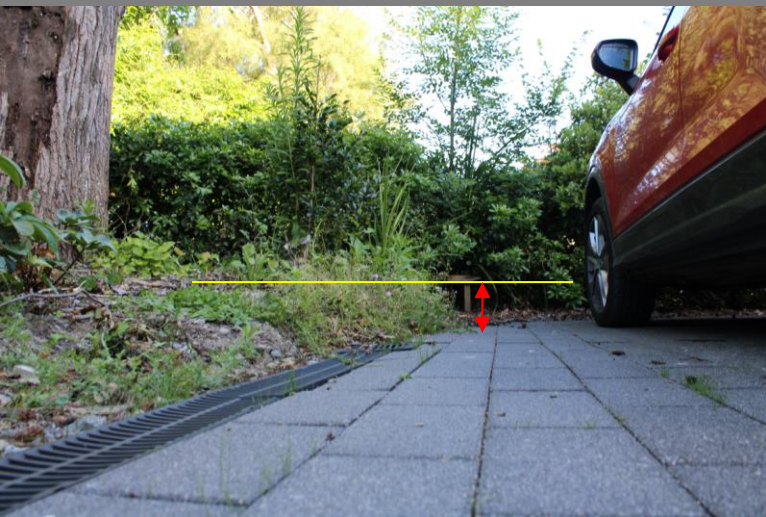
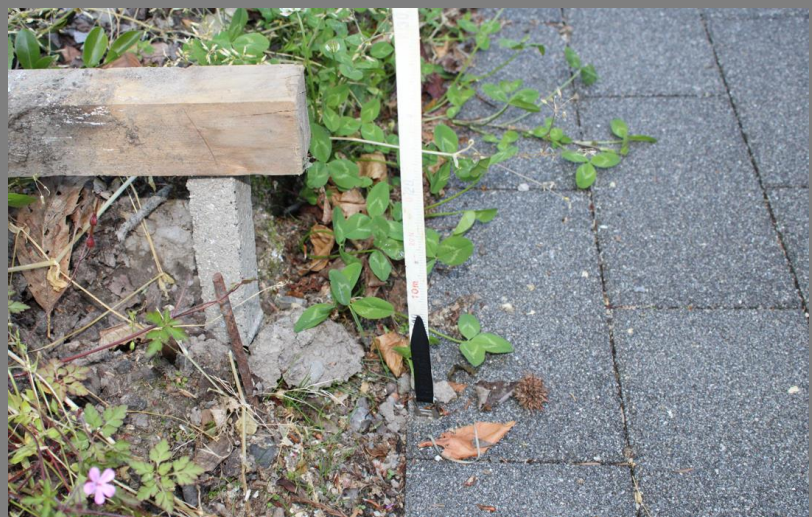
3.1.2 The above images show a level drop of 21cm to the new surface level. This, and the associated foundation works, are likely to have resulted in around a 40cm level change. As the left image shows, a drain is located along the driveway's edge. This may have involved installing a soak pit, where excavation is likely to have exceeded the 40cm level change.

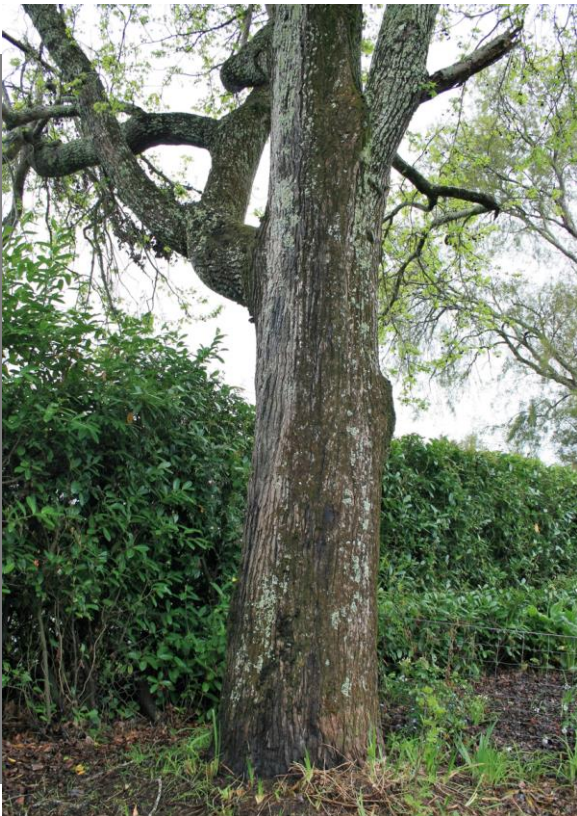
Fig. 12 Image of tree's base in 2017

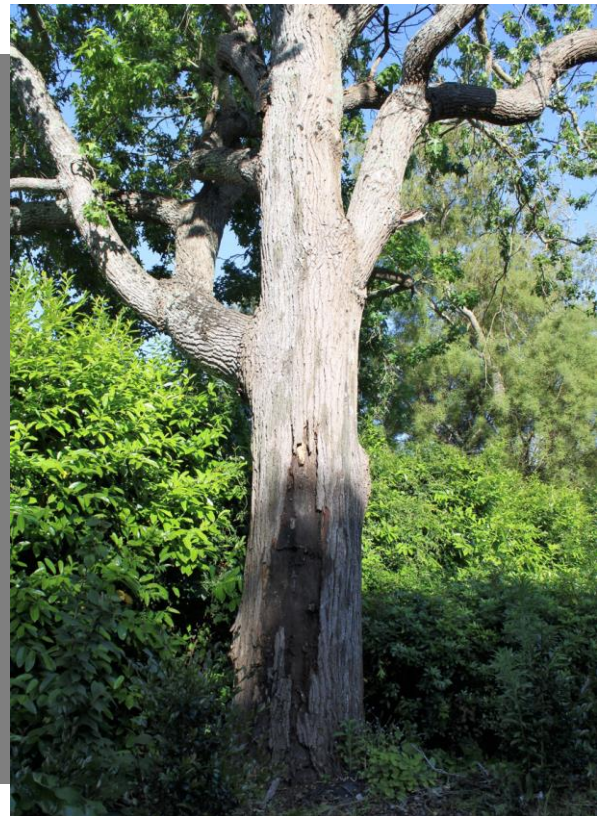
Fig.13 Image of base in 2022. Dieback of bark

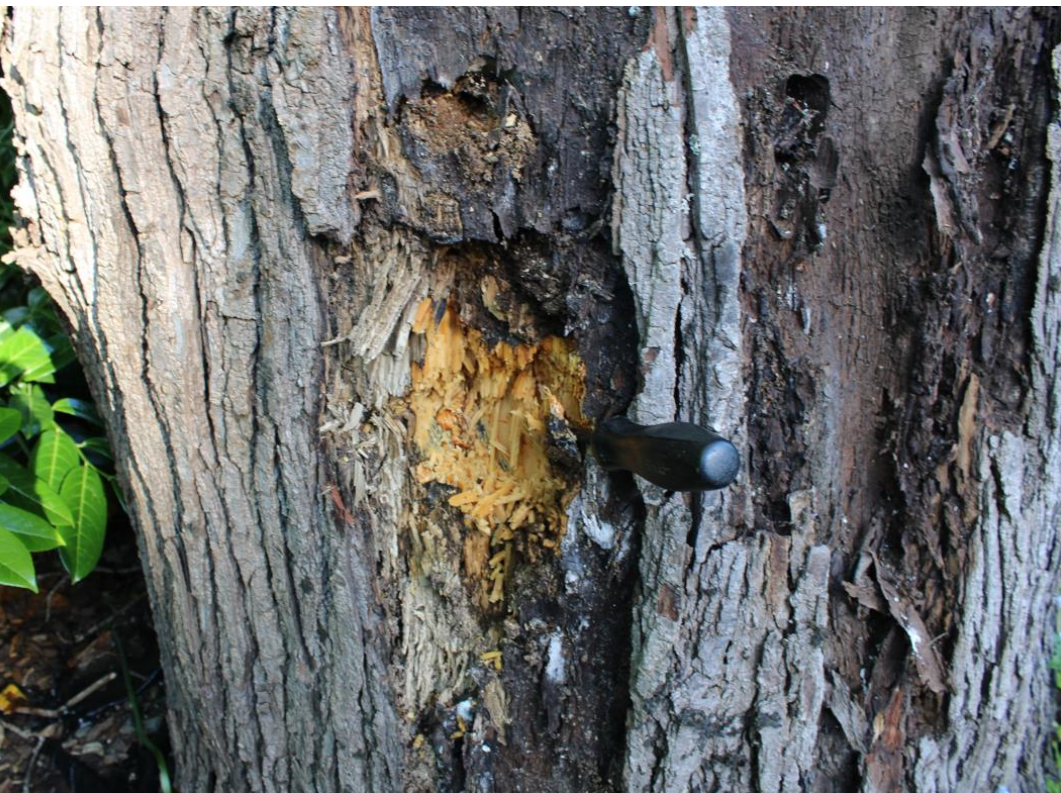
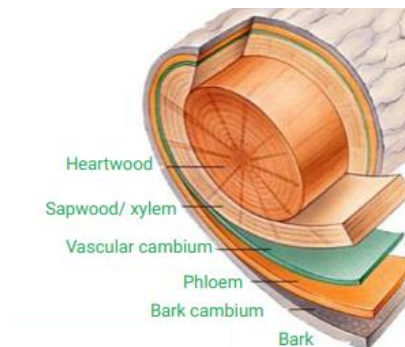
Fig.14

3.1.8 The above image show a considerable amount of wood dysfunction around the tree's base, compromising wood strength (wood is saturated and spongy), and its ability to transport water and nutrients. This could be seen as early white rot, but as there are thousands of different species of wood-decaying fungi a host could contain multiple wood-decaying organisms, and therefore identifying the type of fungi on site is not possible.

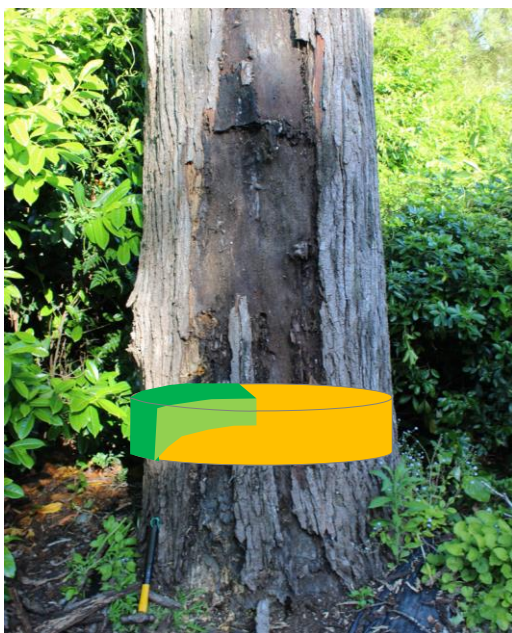
Fig.15

A sounding hammer was used to indicate areas of potential wood dysfunction. In this instance, the image on the right reflects the areas of the stem that is likely to contain dysfunctional wood. Only the portion of the stem to the northeastern side indicated functional wood.

Considering extent of the wood dysfunction, decaying organisms would have been present within the stem prior to the development works taking place.

However, the development works would have elevated tree stress, creating further opportunities for the fungal organism to spread, invade and compromise sapwood increasing the rate of decline.

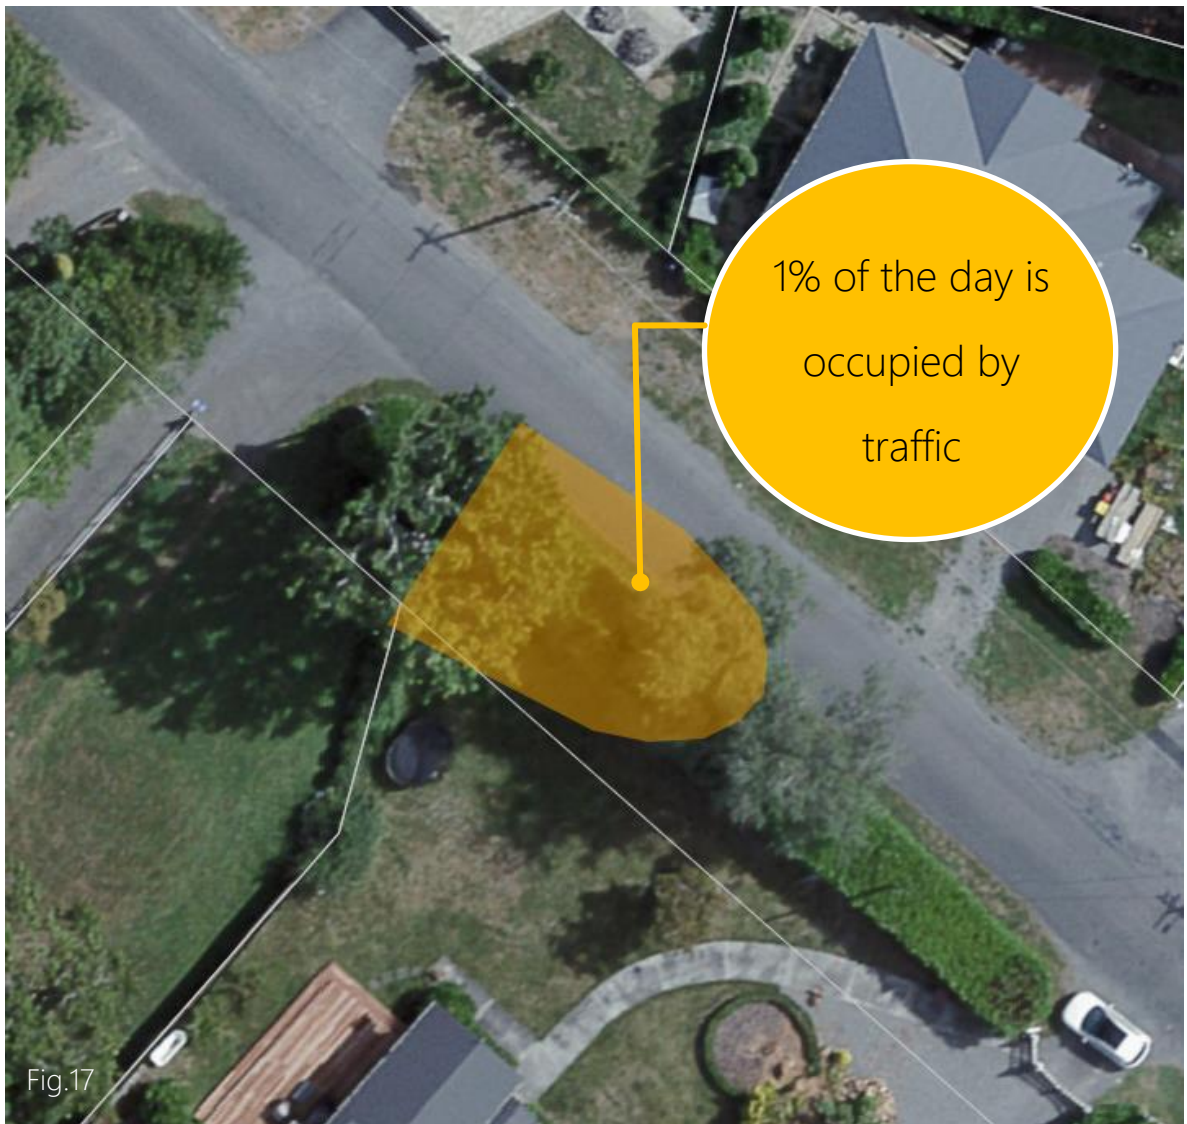
3.2.2 The tree has a mechanical weakness due to decay and possible weakness caused by root loss/damage. As the previous images shows, the decay area is at the base of the stem which will spread within its roots. It is assessed that failure of the weak point would result in whole tree failure.

3.2.4 If failure were to occur, it is considered to occur during a high-wind event. The prevailing winds would cause a torsional load at the tree's base. Due to dieback and past historical loss, the tree has developed a highly asymmetrical canopy. Considering the tree's structure, the predominant wind direction, the damage to rooting area, and the slight lean east, the tree is highly likely to fall in an easterly direction.

3.2.5 The main target area is Wood St which is regarded as a low-volume road with a Daily Traffic count estimate of 511 vehicles a day (NZTA). Considering the size of the part to fail the lean and the area of likely failure, the tree would land in the orange highlighted area, as shown above. Factoring in the speed limit and vehicle count, this would equate to 1% of the day that the orange area would be occupied. This would mean a low chance of a vehicle being under the tree when a failure occurs.

- 4.7 Therefore, I recommend removing the tree and planting a replacement tree.
- 4.8 Please do not hesitate to get in touch should there be any further questions or queries
