# SWDC - Whakatomotomo Road Slip – Remedial Options Memorandum

Prepared for:  
SWDC

Prepared by:  
Stantec New Zealand

Project/File:  
310206618

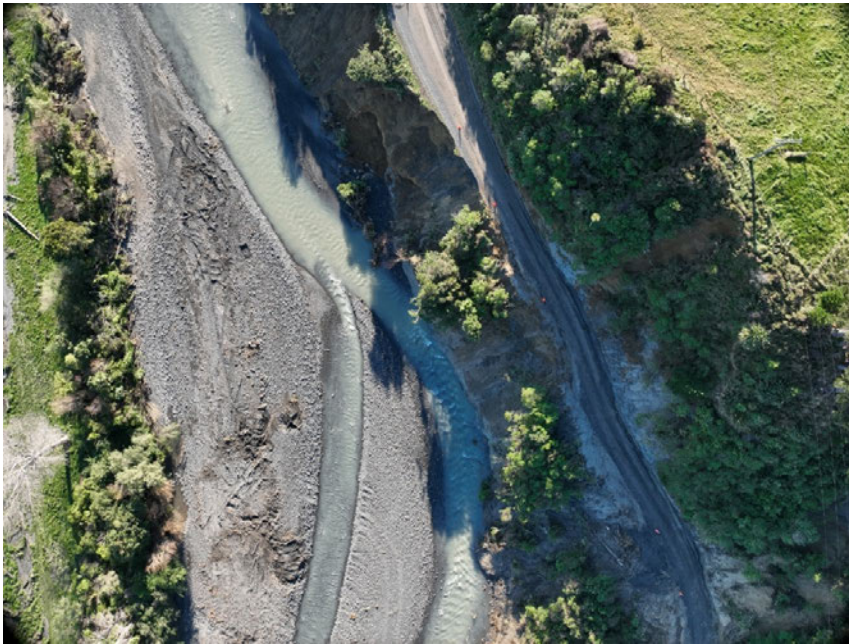
- The road is an unsealed gravel carriageway.
- Both upslope and downslope have experienced slope failures over an approximate impacted length of 200 m as shown in Figure 2.

*Figure 2: Landslide on both upslope and downslope at Whakatomotomo Road RP 2.650 to RP 2.850  
(Drone image taken 02/07/2026)*

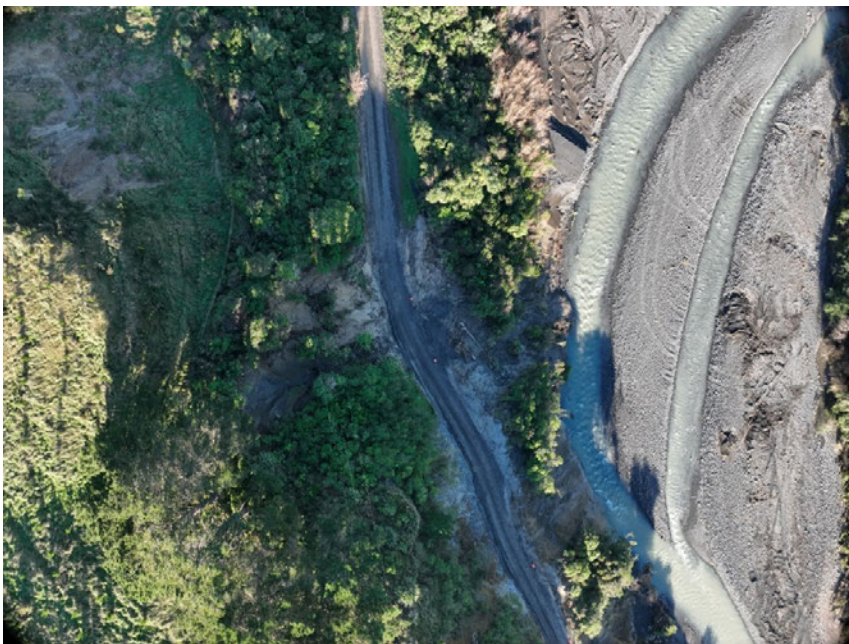
*Figure 3: Landslide on both upslope and downslope at Whakatomotomo Road RP 2.650 to RP 2.850  
(Drone image taken 02/07/2026)*

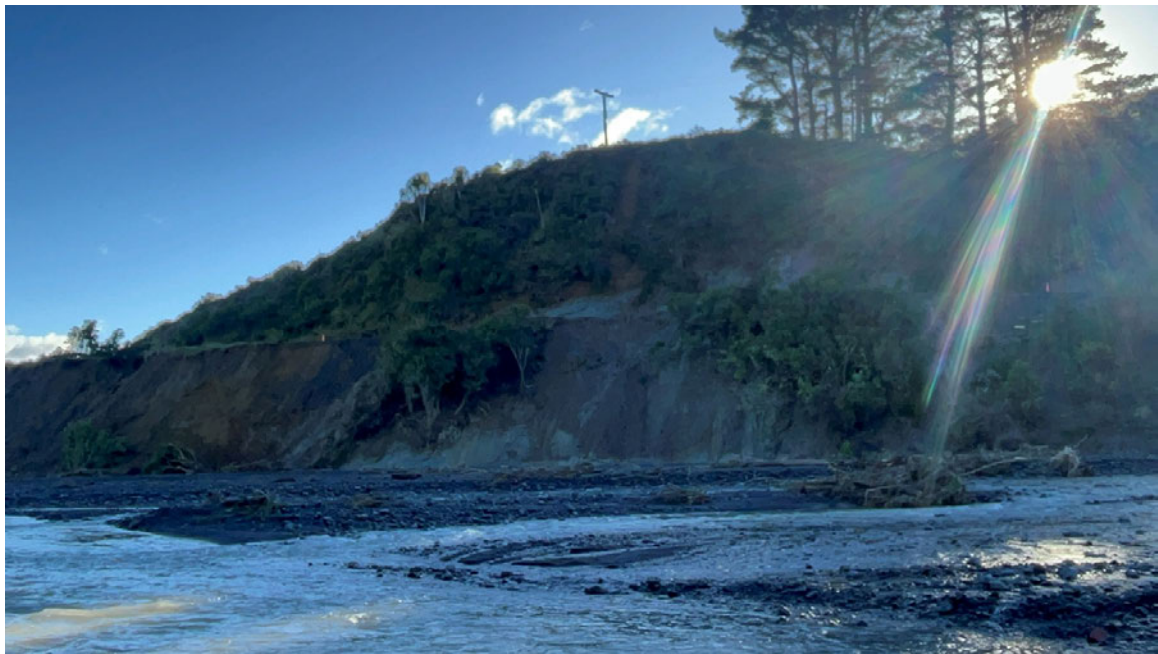
*Figure 4: Landslide on both upslope and downslope at Whakatomotomo Road RP 2.650 to RP 2.850 (view from Te Rata Road)*

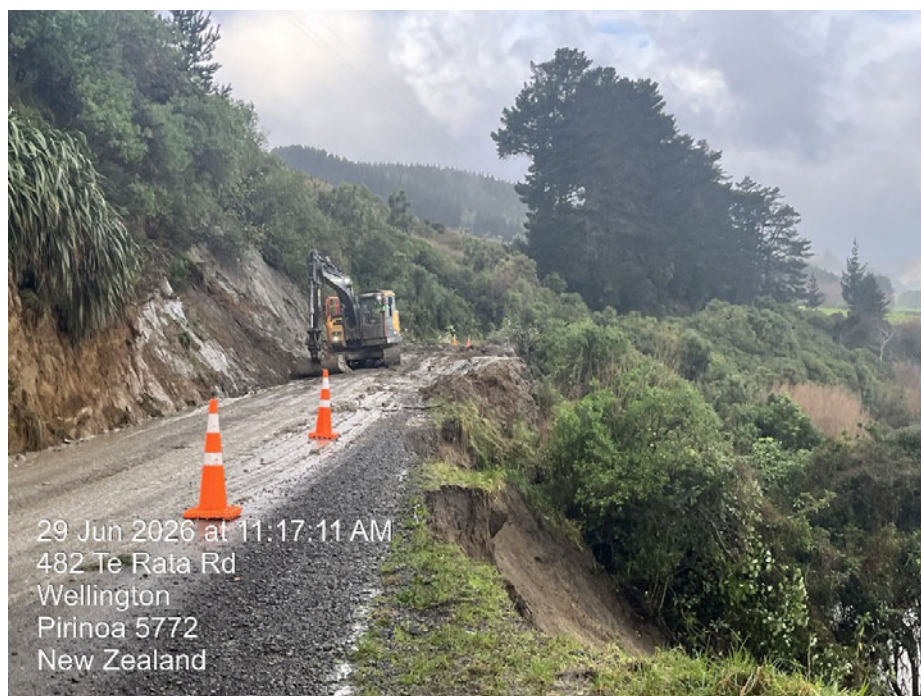
- The downslope materials predominantly comprise residual soil (Silty CLAY).
- Electricity poles are located on the upslope above the failed area.
- The existing road is approximately 4 m wide, based on Mobile Road data. However, the underslip has resulted in the loss of the road shoulder and outer edge of the carriage way at some locations, reducing the effective carriageway width (single lane has been affected).

*Figure 5: Road shoulder has been lost due to under-slip (Looking Southeast)*

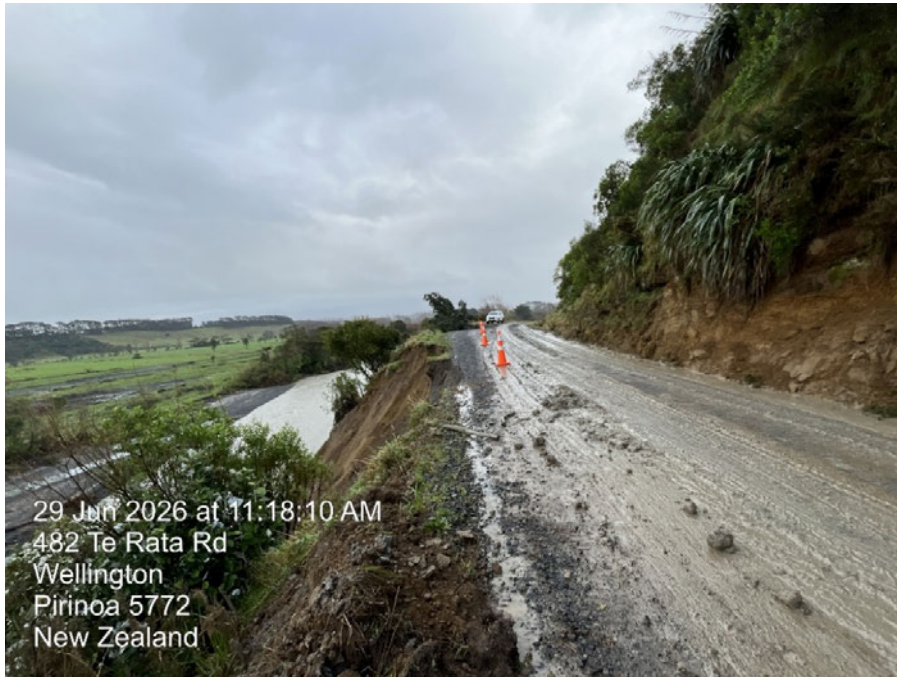
*Figure 6: Road shoulder has been lost due to under-slip (Looking Southwest)*

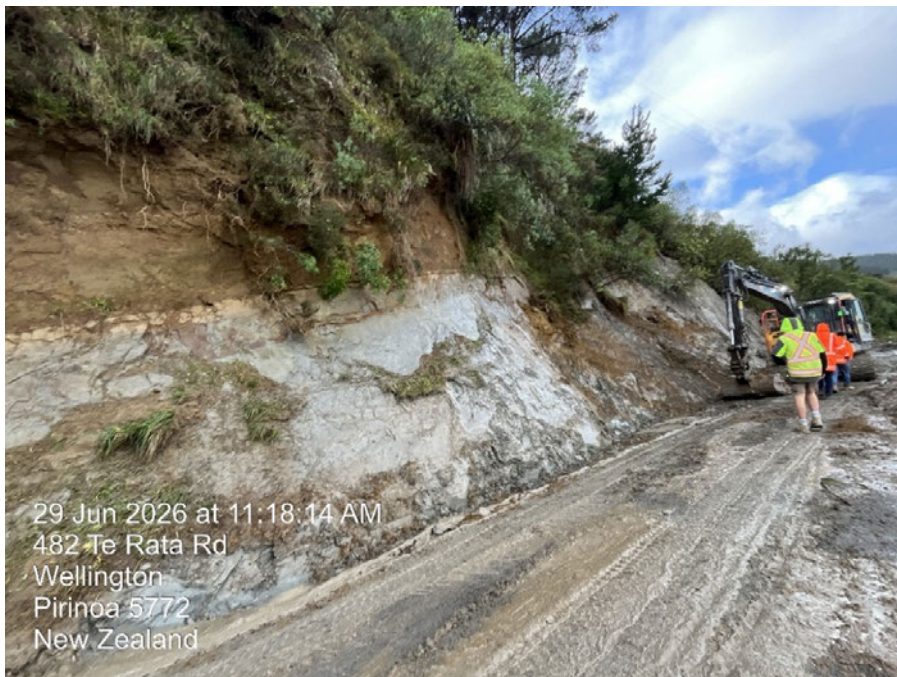
- Exposed rock was observed at several locations on the upslope as shown in Figure 7.
- The upslope materials comprise residual colluvial soils overlying highly to completely weathered rock.

*Figure 7: Exposed rock on upslope*

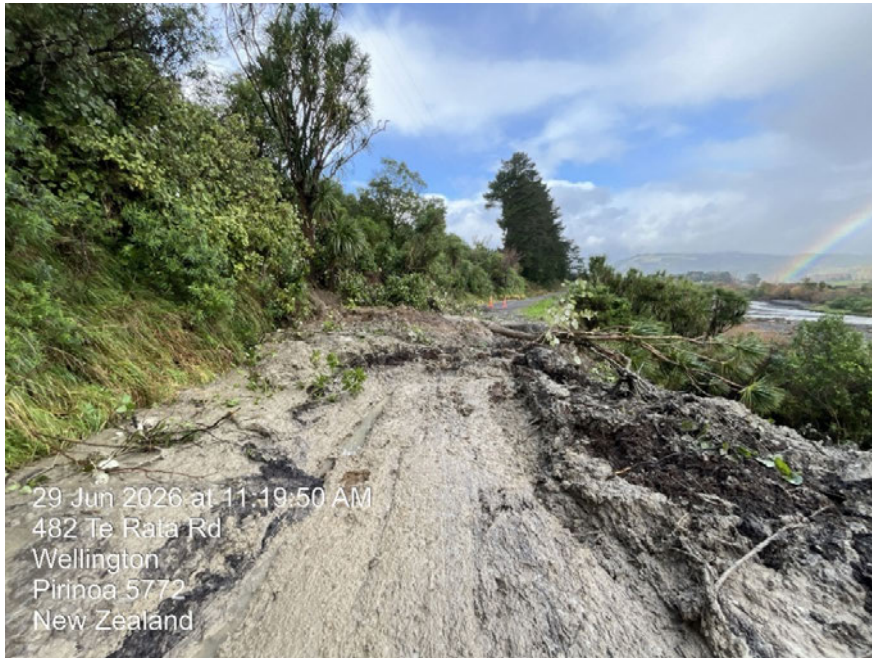
- Failure of the upslope has resulted in debris being deposited onto the road carriageway, blocking the culvert inlet and swale, and causing stagnant water to accumulate on the road surface, as shown in Figure 8 and Figure 9. The debris primarily comprises saturated Silty CLAY with rock fragments and falling trees.

*Figure 8: Deris from upslope deposited on road carriageway*

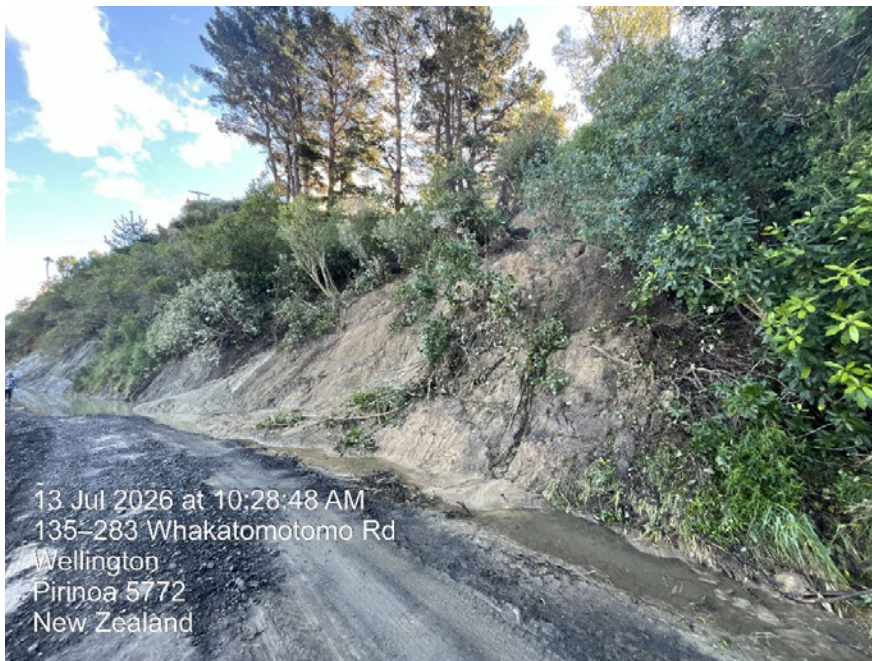
*Figure 9: Debris from the upslope blocking the swale and culvert inlet, causing ponding and stagnant water on the road surface*

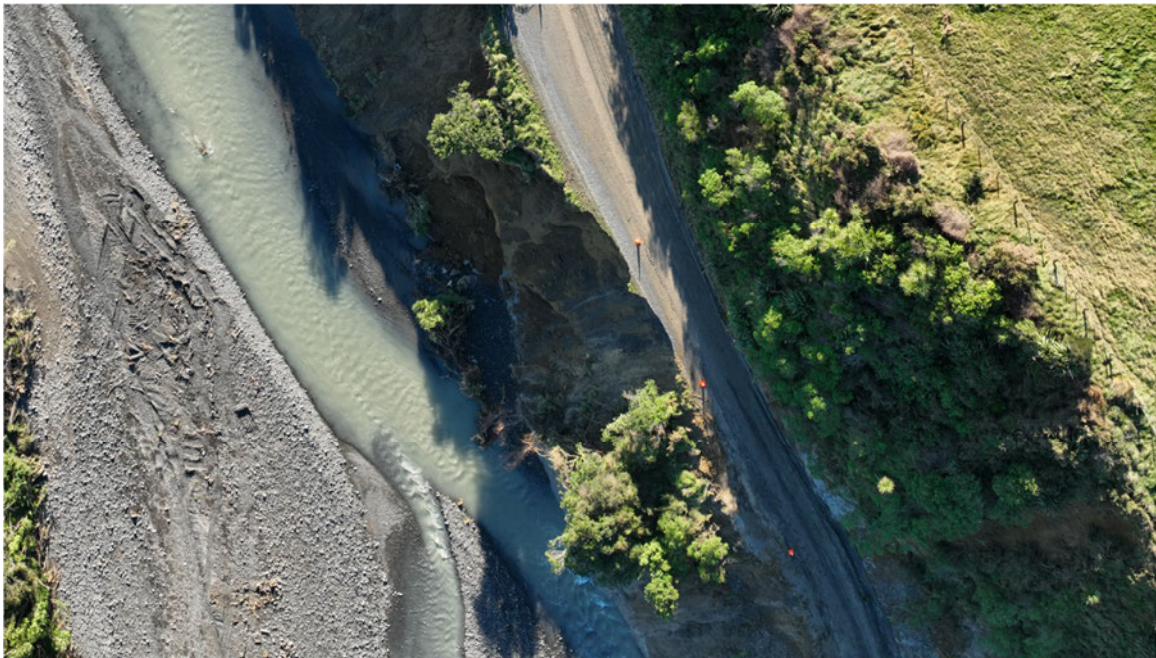
- The Turanganui River is located immediately below the downslope failure. **Active scour by the river has undermined the toe of the underslip, reducing toe support and increasing the risk of further slope instability and progressive failure affecting the Whakatomotomo Road.** The extent and severity of scouring (i.e., scour depth and extent, undermining and overhanging) at the toe of underslip is unknown.

*Figure 10: Toe of the underslip undermined by river scour (drone imagery captured on 2 July 2026)*

- **River scouring:** The Turanganui River is located immediately below the downslope failure. Active scour by the river has undermined the toe of the underslip, reducing toe support and increasing the risk of further slope instability and progressive failure affecting the Whakatomotomo Road. The extent and severity of scouring (i.e., scour depth and extent, undermining and overhanging) at the toe of underslip is unknown.

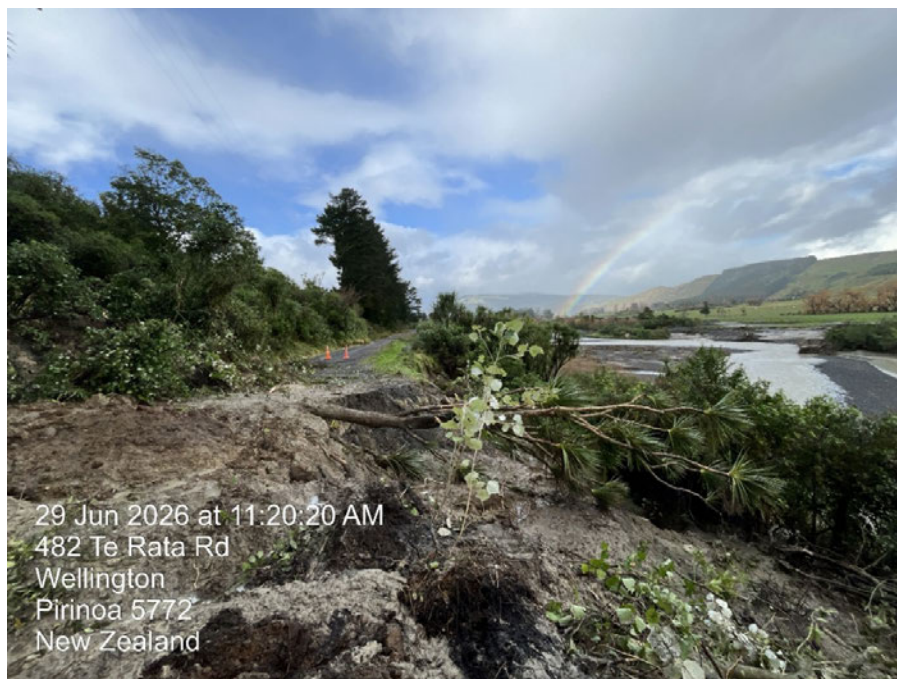
*Figure 11: Road carriageway has been lost approximately 1m due to under-slip*

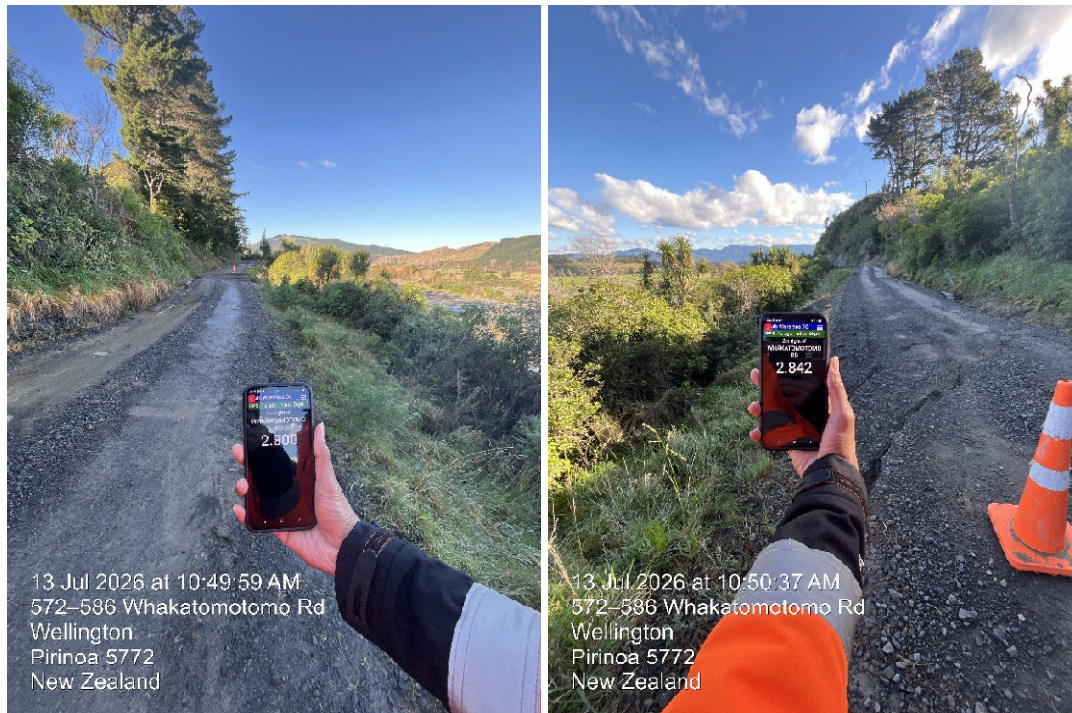
- During the site inspection undertaken on 13 July 2026, evidence of significant ground deformation, including cracking and slumping of the entire road carriageway, was observed between RP 2.800 and RP 2.840, as shown in Figure 12 and Figure 13.

*Figure 12: Cracks and slumping observed between Road RP 2.800 and RP 2.840.*

- **Extensive road damage:** Approximately 200 m of the road has been affected by slope instability, with loss of the road shoulder and outer traffic lane. Tension cracks and slumping are evident across the full carriageway width between RP 2.800 to RP 2.840, indicating that the

remaining pavement is progressively deteriorating. These observations suggest a high likelihood of a larger-scale underslip that could result in the loss of the entire carriageway during future triggering events such as prolonged rainfall or earthquakes.

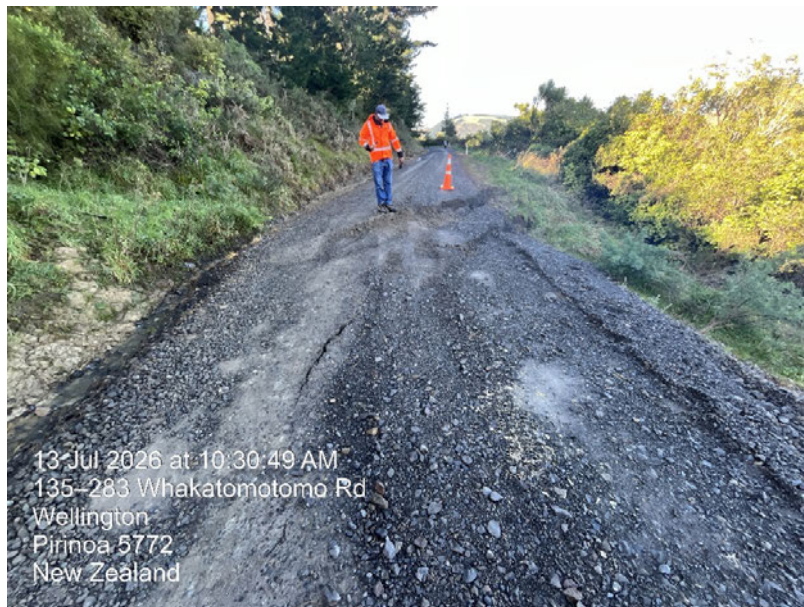
*Figure 13: Cracks and slumping observed between Road RP 2.800 and RP 2.840 (Looking South-East).*

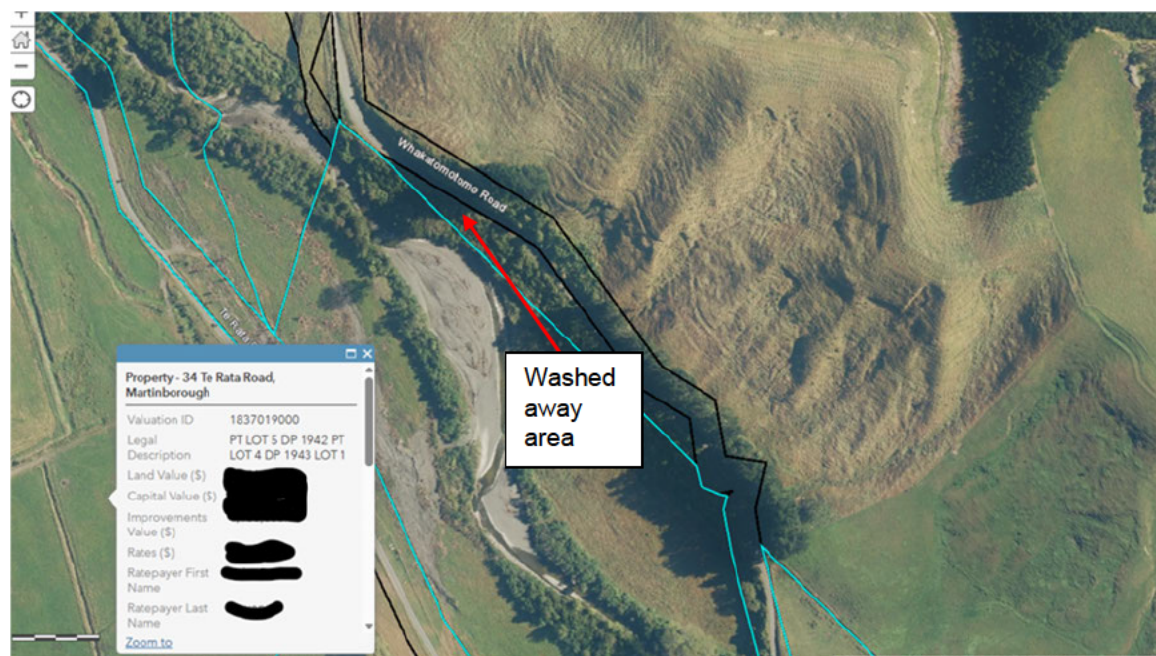
We note that the land area (Property 34) situated on the river has already been washed away as shown in Figure 20. **It is indicated that the active scour by the river has undermined the toe of the underslip, reducing toe support and increasing the risk of further slope instability and progressive failure affecting the Whakatomotomo Road.** The extent and severity of scouring (i.e., scour depth and extent, undermining and overhanging) at the toe of underslip is unknown.

Figure 20: A portion of Property 34 adjacent to the river has been eroded due to river scour
