Removal of elm trees from Wood Street

Information for the Greytown Community Board on the removal of trees from Wood Street in Greytown in November 2021.

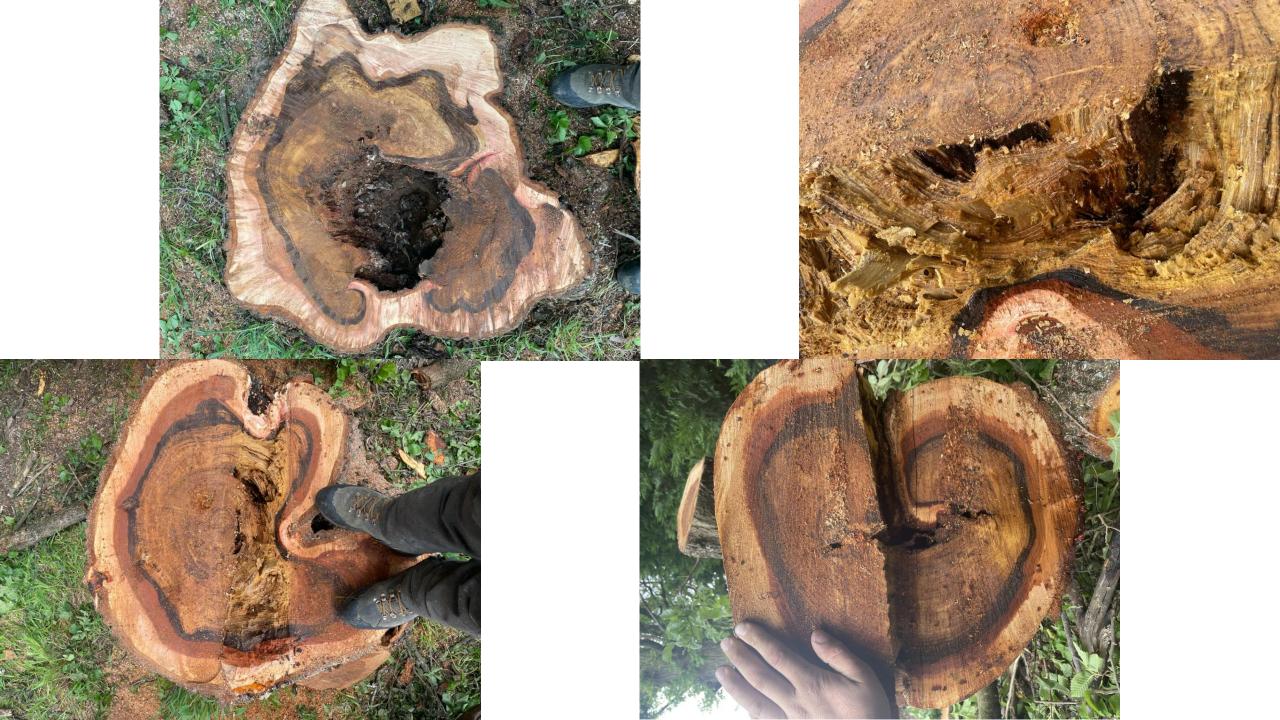
A visual inspection and historic information on the trees revealed that the trees have been poorly trimmed in the past and this has contributed to their deterioration. Their structures are stressed and unsound. There were holes in the limbs of varying sizes, with obvious large sections of rot at the base of the trees. There was evidence of considerable dieback, likely to have been caused by root disruption from the development of the adjacent carpark.

Six trees were eventually removed. The attached photos of the stumps of the felled trees demonstrate that the professional opinions were confirmed. The trees were found to be rotted to the core, with most of the bases being almost completely diseased or dead.
