# PEERS BROWN MILLER LTD

# ASSESSMENT OF PROPOSED WORKS AFFECTING COPPER BEECH TREE AT 134 MAIN ST, GREYTOWN

PREPARED FOR:	Kay Panther Knight – Forme Planning
	cc: Victoria Knobloch - Woolworths NZ
BY:	Richard Peers
DATE:	19 September, 2022

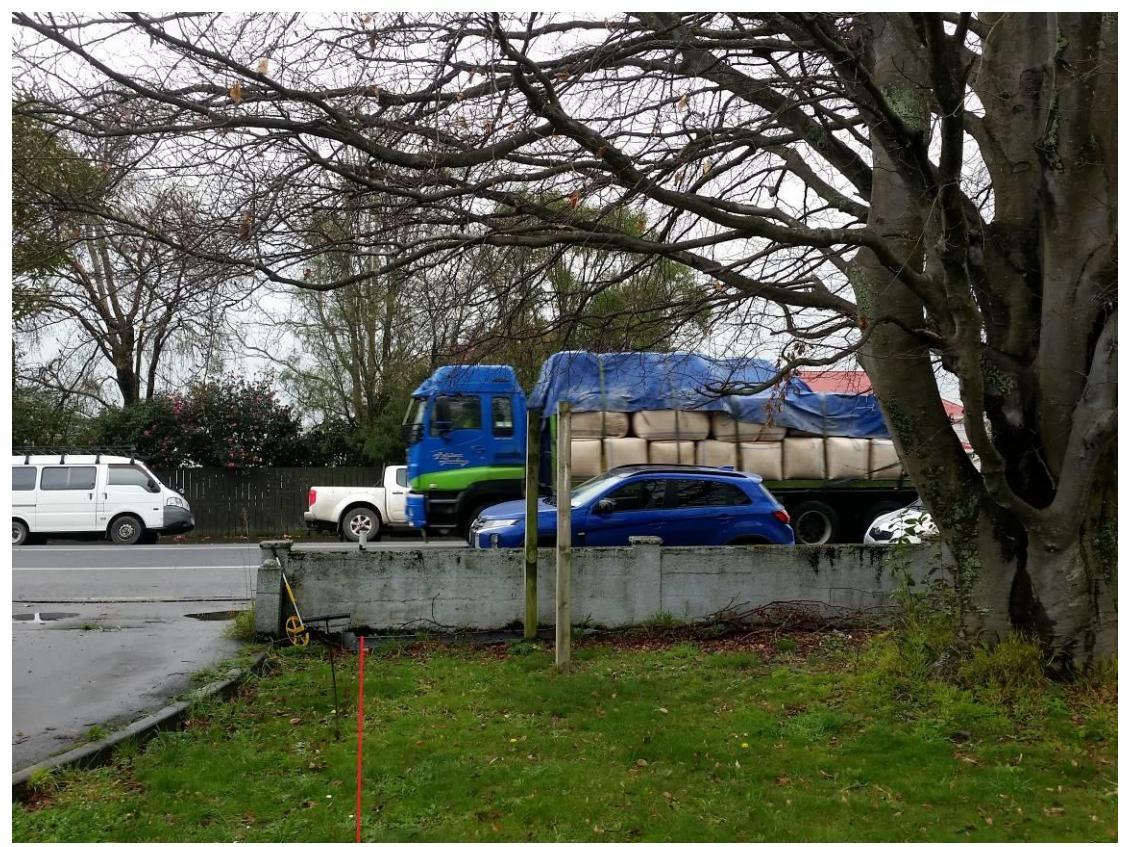
The current site plan shows that the new driveway is 9m in width at the footpath. It is offset 2m from the northeast boundary, so there is a distance of 11m to the edge of the driveway closest to the tree. As measured on site this width extends 650mm into the open ground between the tree and the existing driveway (see Fig. 1 below).

Figure 1 – red line indicates edge of proposed new driveway

I probed to depths of 400mm along the alignment indicated in Fig. 1 above and did not strike any woody root from the beech tree. Despite that, I would expect there to be root mass from the tree beyond the red line and I would be uncomfortable in supporting any driveway design that involved impermeable surfacing at that proximity to the tree. Indeed, it would be preferable if even a permeable surfacing were not that close to the tree.

- (a) Reduction of width of driveway entrance off the street at least by 650mm maintain that clearance from the tree for as long as possible.
- (b) Eliminate the carparks altogether
- (c) Construct driveway with the Geoweb system proposed by Treecology until 10m past centre of tree – from there it can convert to standard concrete. This system should be endorsed by engineers. It is noted that it is not available in New Zealand, but the product website shows that it is distributed in all main Australian cities

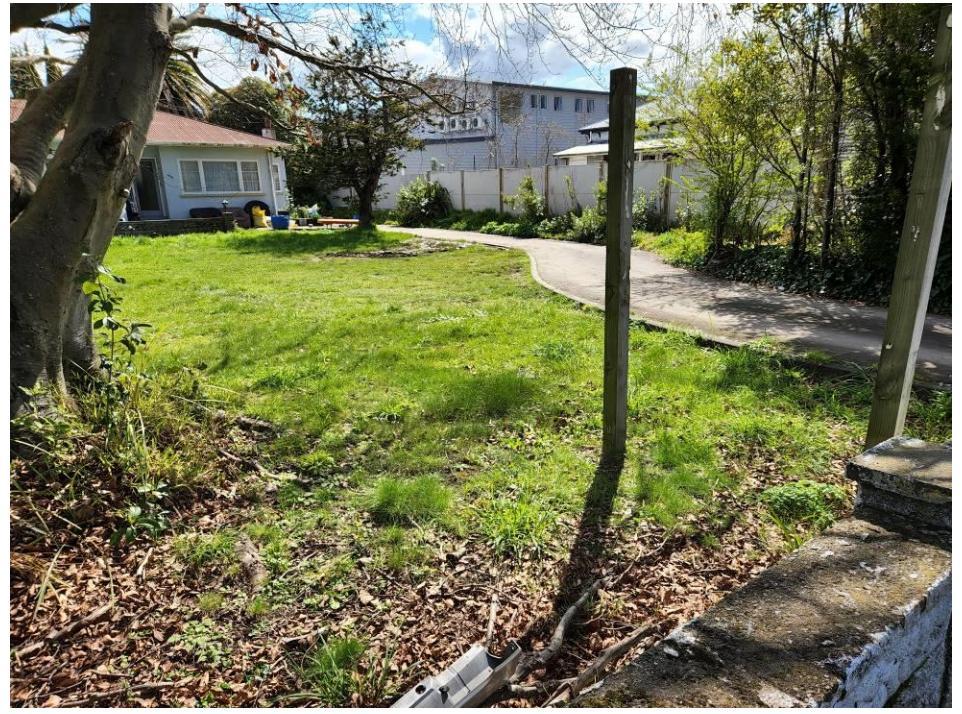
It is clear that the existing driveway curves northwards away from the tree (see Fig. 2 below). However, the proposed new driveway commences a curve towards the southwest boundary after running in a straight line immediately past the base of the tree. It appears that this situation cannot be avoided, due to the proposal to create a loading area and a separated roadway as shown on the site plan.

Figure 2 – showing front yard and existing driveway as viewed from the footpath. Note the area of lawn compacted by the occupant's use of the area for car parking and manoeuvring

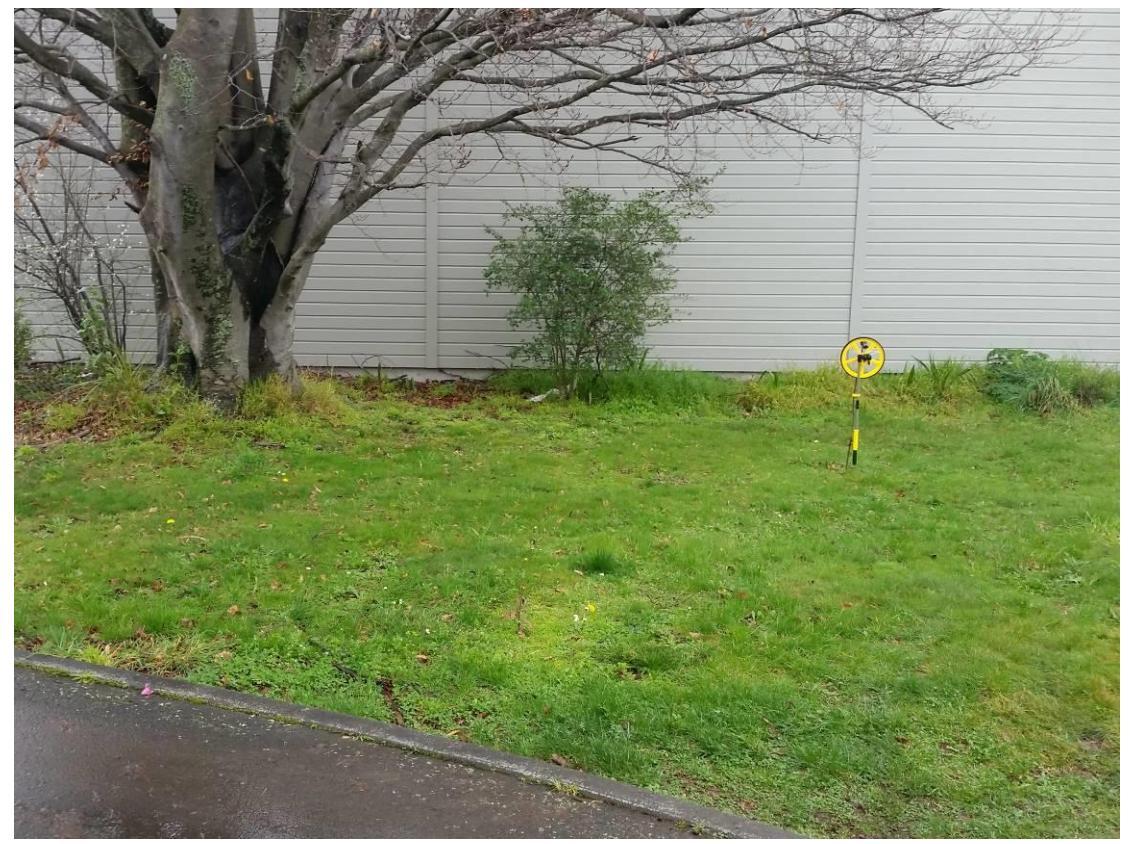
Figure 2 – measuring wheel at 5m from centre of base of tree – closest edge of carparks to tree

It has been suggested in (b) above that the carparks could be eliminated. This would allow a significant area of the tree's root zone to remain unaltered – with an opportunity for enhancement of the ground to take place.

However, if it is deemed to be absolutely vital that those carpark spaces must be provided, it is strongly recommended that a raised timber car deck should be constructed – preferably on screw piles. An on-ground paving system – even of a permeable product, should be avoided. Two examples of timber car decking are provided over the page.

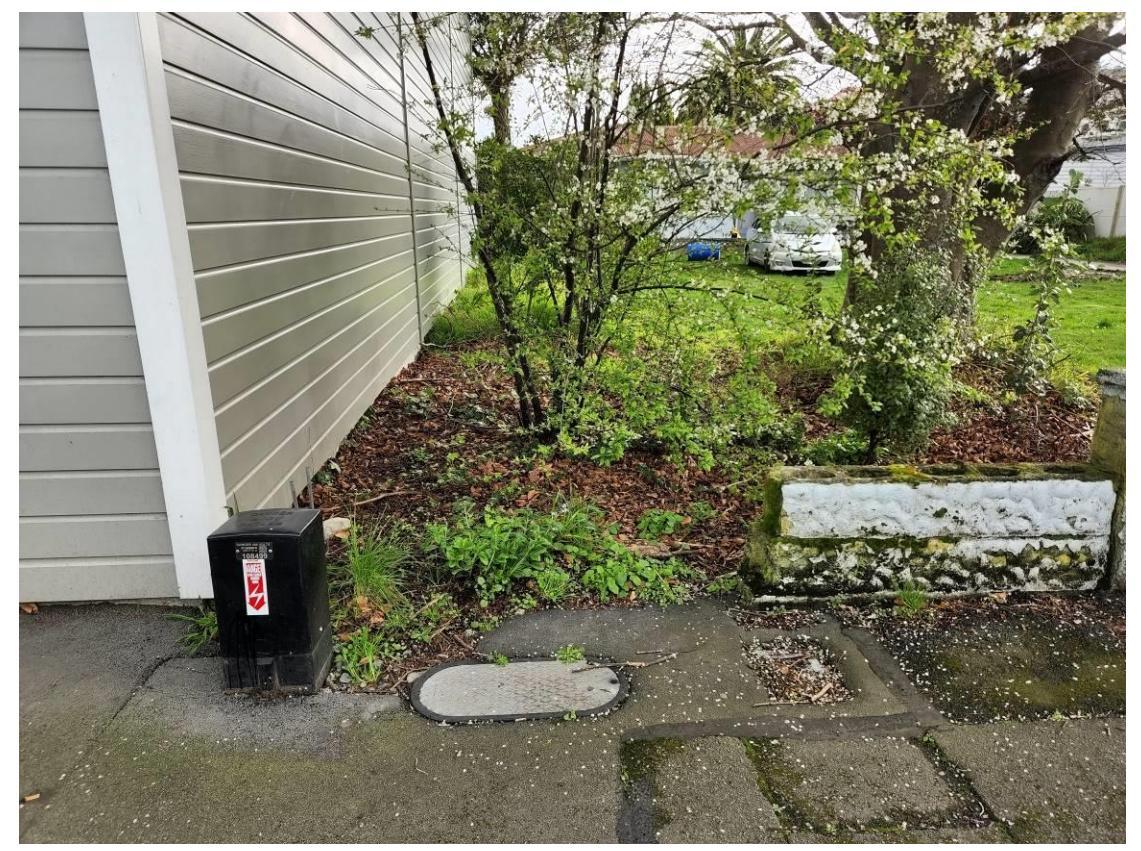
Figure 6 – showing strip where pathway is proposed. Note utility plates and plinth

It is proposed to form a pedestrian path of 2m in width alongside the southwest boundary out to the public footpath. I probed the ground between the base of the tree and the boundary and found that the ground is very light – it having been a garden bed in the past. I did strike one woody root at 200mm depth. There is also hard material buried in that strip, and there is a coppicing plum tree stump (see Fig. 6) that will need to be ground out carefully (not extracted by machine) However, I do consider that there is an ability to scrape off a layer of this loose friable soil to create a bed for the following suggested path construction options (concrete being unacceptable where passing by the tree).

- (a) A wooden boardwalk to 10m past the tree. Consideration would need to be given to the interface with the footpath, as, despite the ability to lower the ground level, the need for some degree of ground clearance and the emplacement of bearers and the timber planking may result in a higher level at the interface with the footpath – thereby requiring a step or ramping – an issue for wheelchairs, elderly, etc. Worth investigating though.
- (b) Hoggin. See Figs. 7 & 8 below for examples. Also specifications and information accompany this report
- (c) A gravel-type solution
- (d) Any of the range of Firth pavers mentioned in 4.1(d)

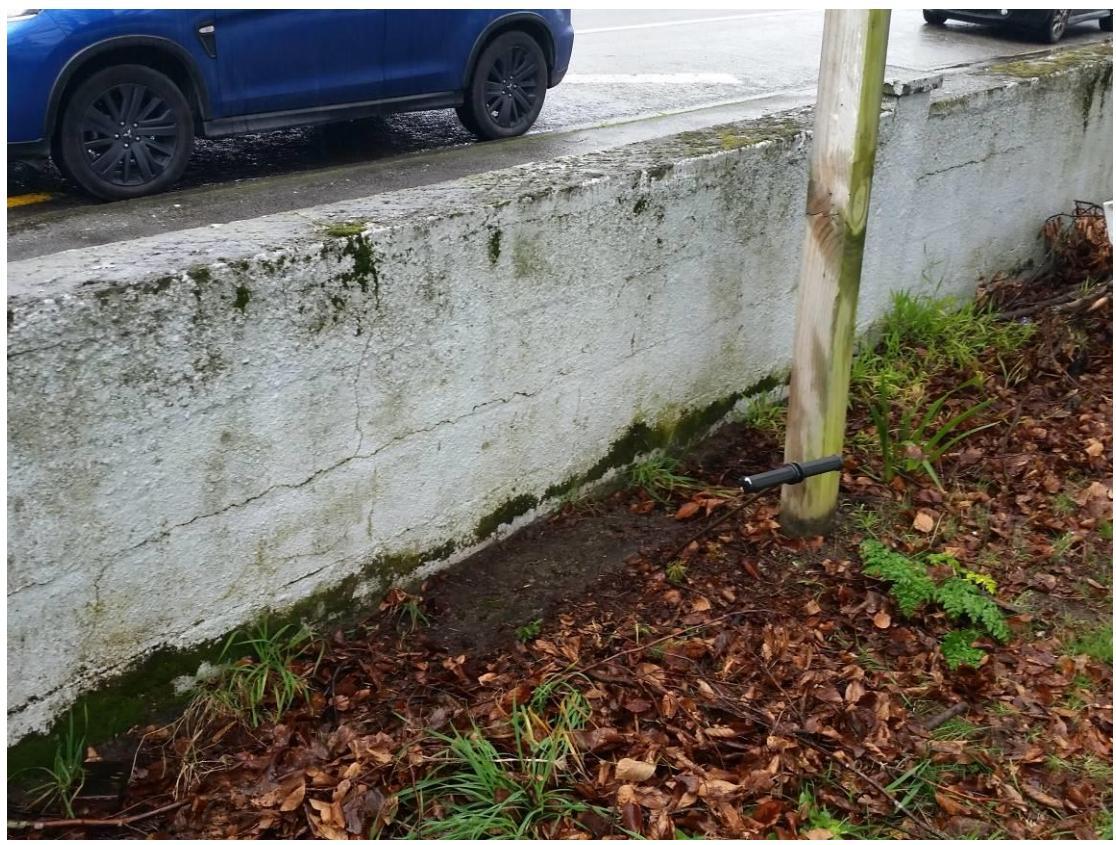
The removal of the existing wall may provide a strip in which the new wall can be installed. To gain an idea of the depth of the footing of the existing wall, I probed in an attempt to ascertain its base. There is a concrete mowing strip at the base of the wall and I was able to probe laterally under that (Fig. 9 over page). The wall is actually not footed that deep into the ground and it is rather narrow. Therefore, it is likely that the new wall, if it were to be designed to have a strip-footed base, would require a deeper and wider excavation than the trench that would be made available after the removal of the existing wall. This would not be desirable, given the close proximity to the base of the tree and the likelihood of roots being bunched at the base of the wall, as is typical in such situations.

Figure 9 – showing base of existing wall and probe under its base

(a) Do not finalise the design of the base of the new wall until the old wall is removed (carefully). The exposed trench can then be inspected with a view to whether there can be some excavations to provide a suitable trench for a strip-footed base without causing excessive root damage.

- (b) Build the new wall on ground beams supported by piles. Pile locations would need to be selected carefully so as to avoid severance of any significant roots.
- (c) Do not build a wall, as such. Rather, consider a fencing option.

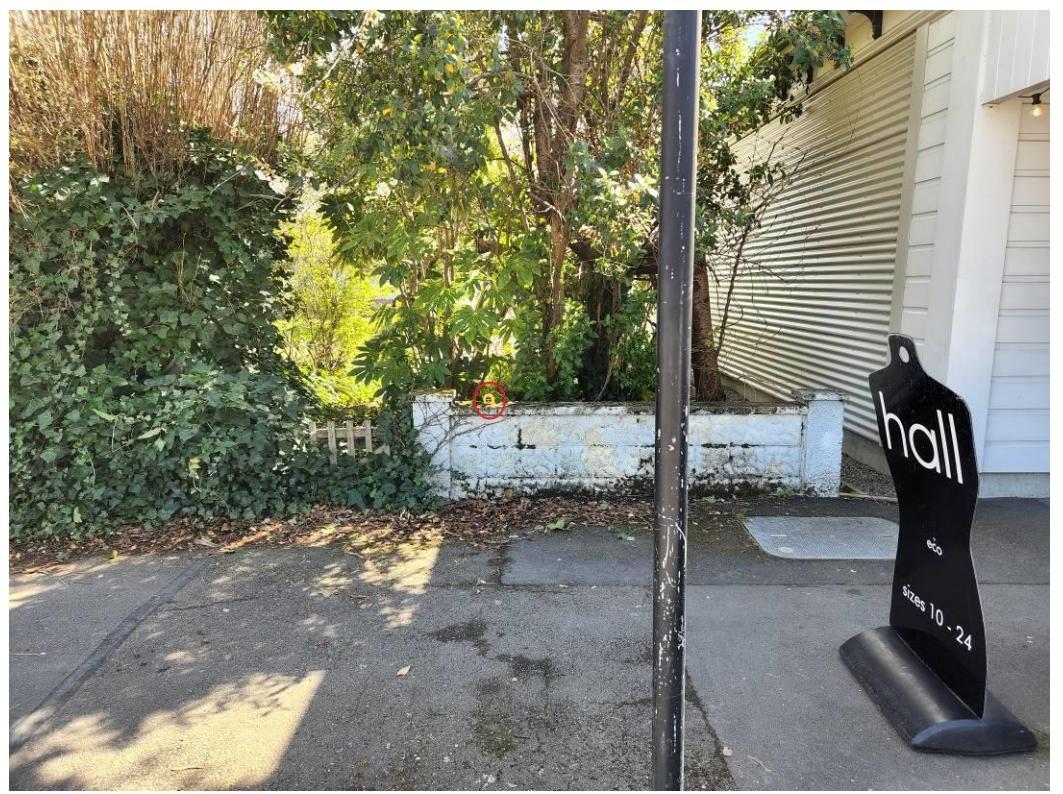
The observation pertains to the open water course that flows down through the site adjacent to the northeast boundary – then curves away to enter a channel under the footpath. There is a distance of 2.35m between the eastern boundary point and the centre of this stream (see Fig. 10 over page) – which means that it is covered by the proposed new driveway. Furthermore, the pylon sign is shown as being erected lengthwise along the edge of the 2m offset from the northeast boundary – with a low stone wall at the street boundary. This will take place right over the stream. On the site plan there is no mention of this water course and how it is to be treated. Local residents told me that these water course throughout Greytown perform an important function in terms of drainage and irrigation.

Figure 10 – red circle indicates centre of stream

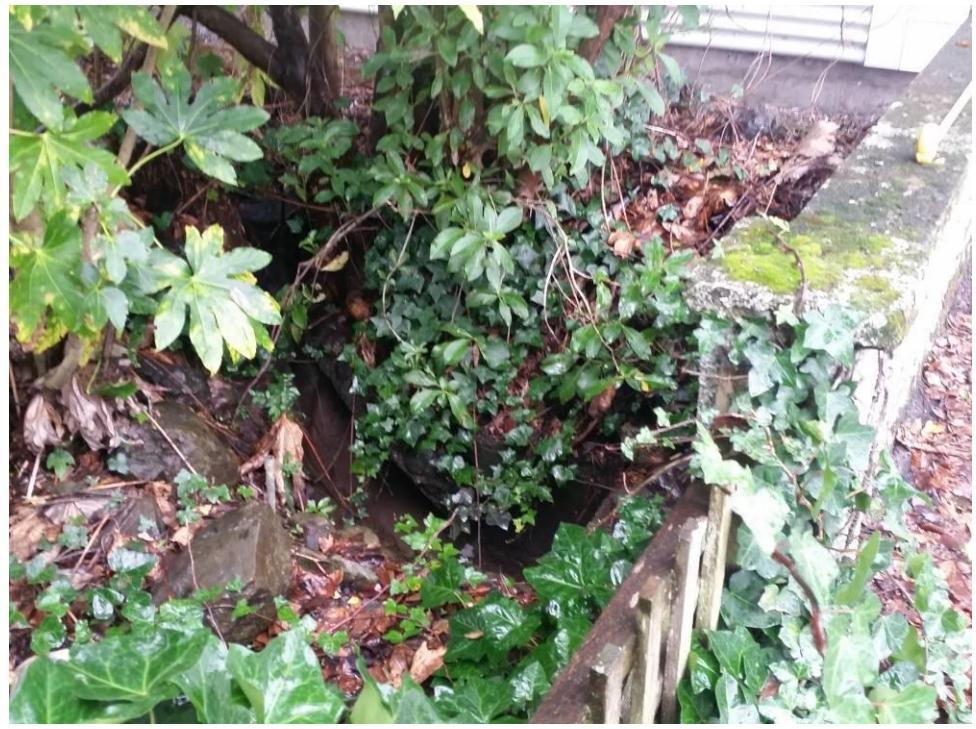
Fig 11 – water course entering pipe under footpath

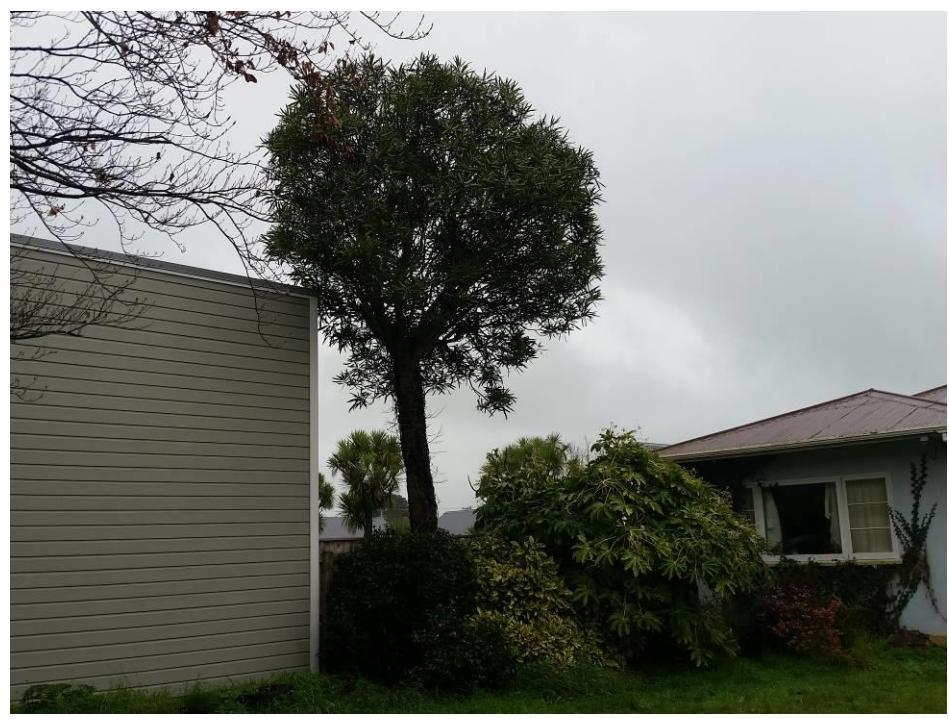
Figure 12 - the Lancewood

My suggestion involves the well-grown and tidy Lancewood tree that stands adjacent to the southwest boundary. Although it is acknowledged that this tree stands directly in the alignment of the proposed pathway, I would like to suggest that some consideration should be given to the retention of this tree. It is unusual to see such a large specimen of this native species in an urban environment and it would be regrettable if it were to be removed - if that can practicably be avoided.
