Appendix A Historic Cliff Crest Alignment Plans

Appendix B Site History

Appendix C Site Hazards

Appendix D Site Geology

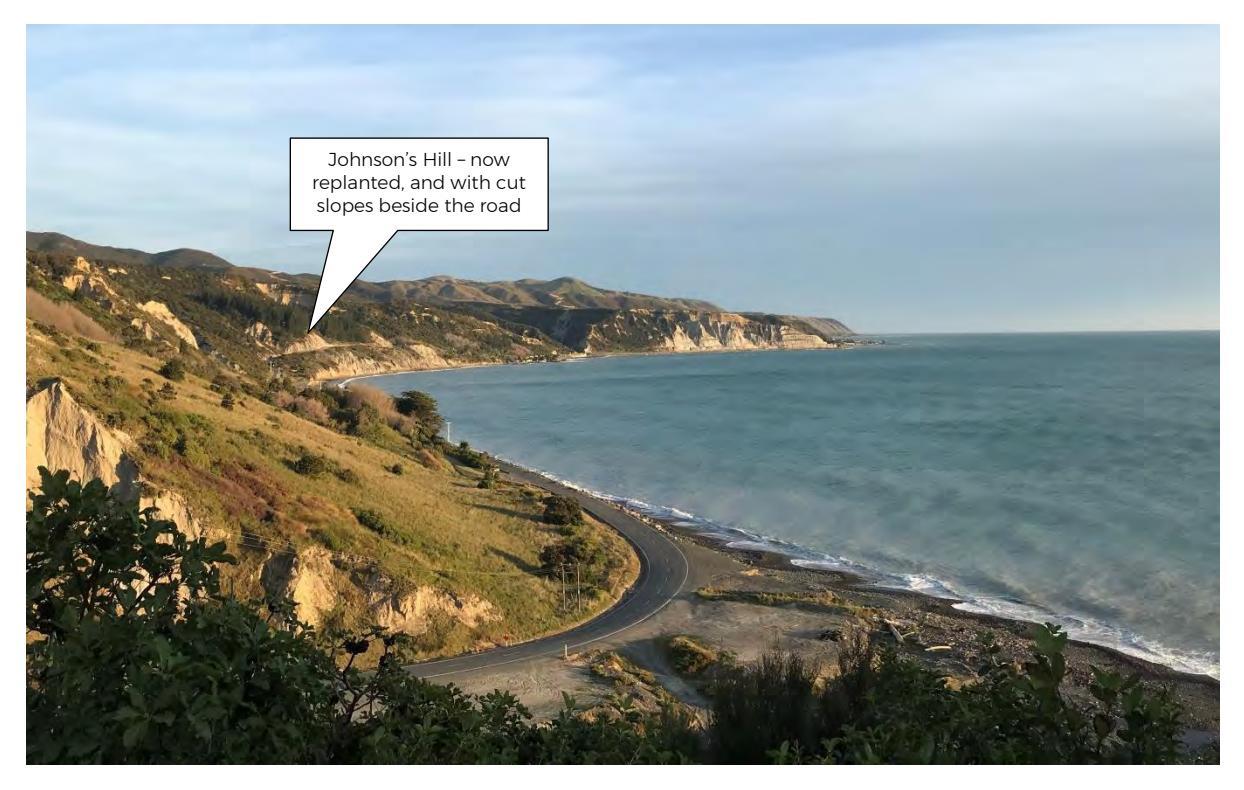
Ongoing coastal erosion also affects the road elsewhere within the study area. By comparing a 1964 photo that overlooks the site (Figure 11) to an image from August 2020 (Figure 12), it can be seen that the width of the beach in Section 1 has been reduced significantly over the past half century. The 3D model produced from WSP's 2020 UAV imagery allows this perspective view of the study area to be seen in more detail (Figure 13).

These perspective views across the study area show that land use around Cape Palliser Road comprises small settlements and farmland, plus areas of bush and forest. One notable change in land use has occurred at Johnson's Hill. There is a significant active slump in this area, which has been reactivated from old landslide material and is likely to have been moving slowly since the sea level reached its current position and began eroding the slope below the road (Perrin, 1995). Figure 11 shows that the land upslope of the road at Johnson's Hill was not forested in 1964, but has since been replanted with trees (Figure 12); this replanting was undertaken in the 1990s, to address the slope stability issues (Braaksma, 2020). Some of the replanted trees have been undermined by cuttings into the slope above the road (Figure 12), which were necessary to reinstate the road following landslide movement.

Figure 12: Cape Palliser Road in August 2020, looking across the study area.

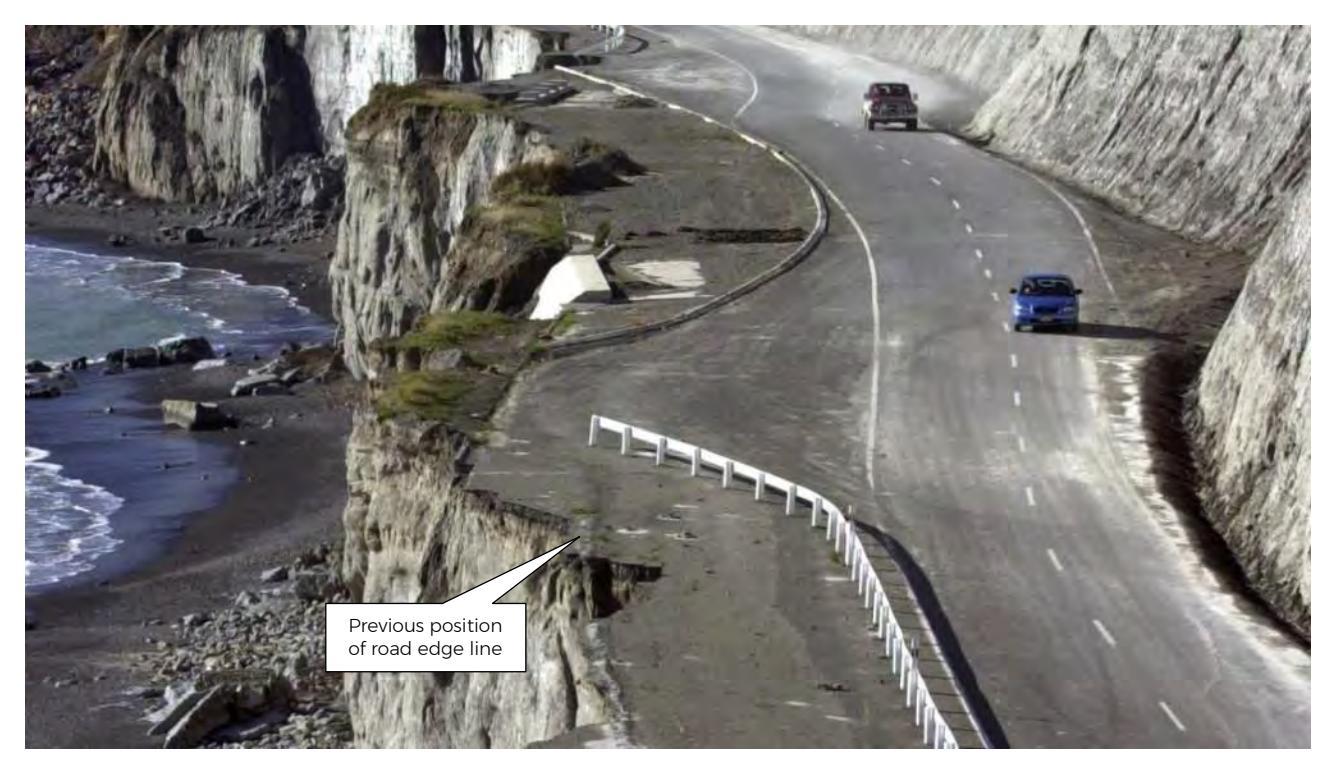
Road realignment has been necessary on several occasions in the past, throughout the study area, due to erosion and slumping of the coastal cliffs that undermines the pavement. At Whatarangi Bluff, abandoned sections of road can still be seen in recent imagery (Figure 14).

Figure 14: Cape Palliser Road at Whatarangi Bluff, showing abandoned road alignments (Stuff, 2016).

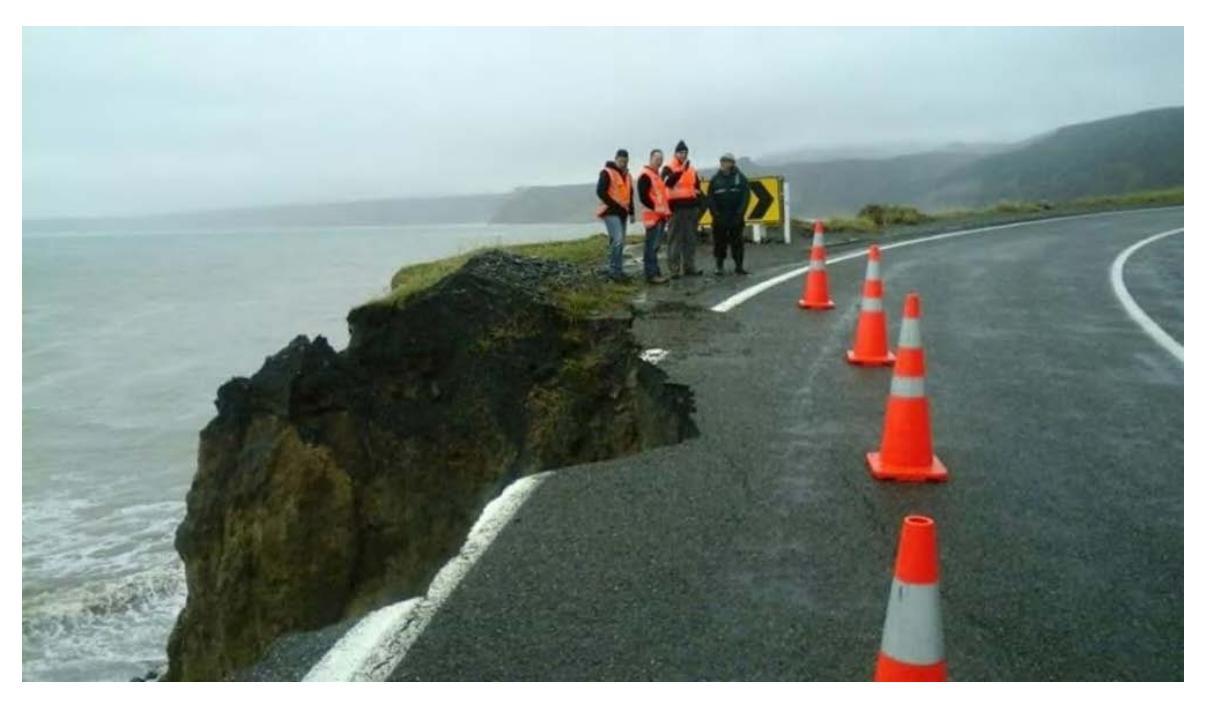
Coastal hazards in eastern Palliser Bay are significant, with repeated previous occasions of undermining along Cape Palliser Road related to coastal erosion (Figure 15). These hazards have been considered in several past studies. Historic cliff retreat rates are presented by King (1930), and there have been more recent investigations at residential areas in Whatarangi (Tonkin + Taylor, 2018) and Te Kopi (Perrin, 1995).

Figure 15: Road damage at the southern end of Whatarangi Bluff, due to a coastal drop out following erosion during a storm (Stuff, 2015).

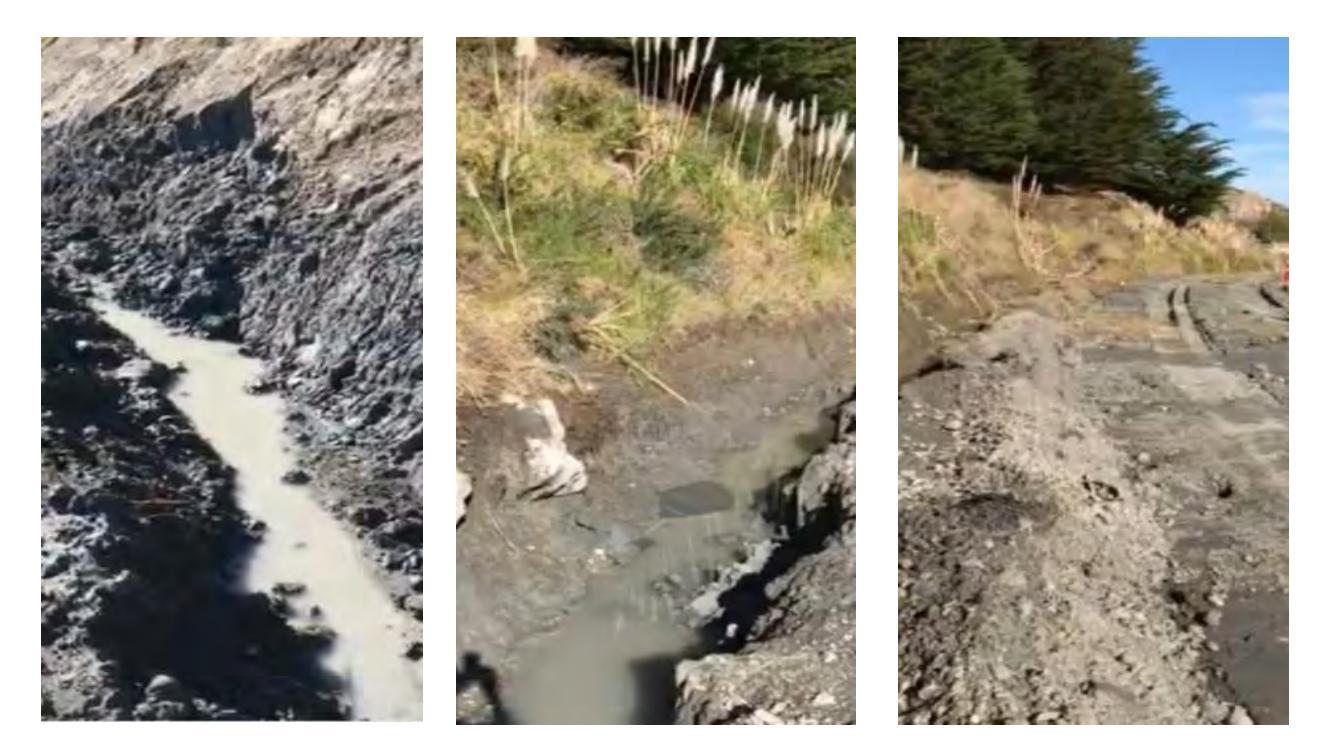
- Water seepages as shown in Figure 16 are apparent immediately above the road. SWDC arranged subsoil trench installation in May 2020 and found significant seepage flows at shallow depth.
- There were *n*o signs of seepages on the slope above the road in an (extensive) walkover in the 1990s (Stan Braaksma, pers comm).

Figure 16: Snapshots from a video of a groundwater spring encountered by Fulton Hogan on 7 May 2020, during excavation for a subsoil trench associated with roadworks.

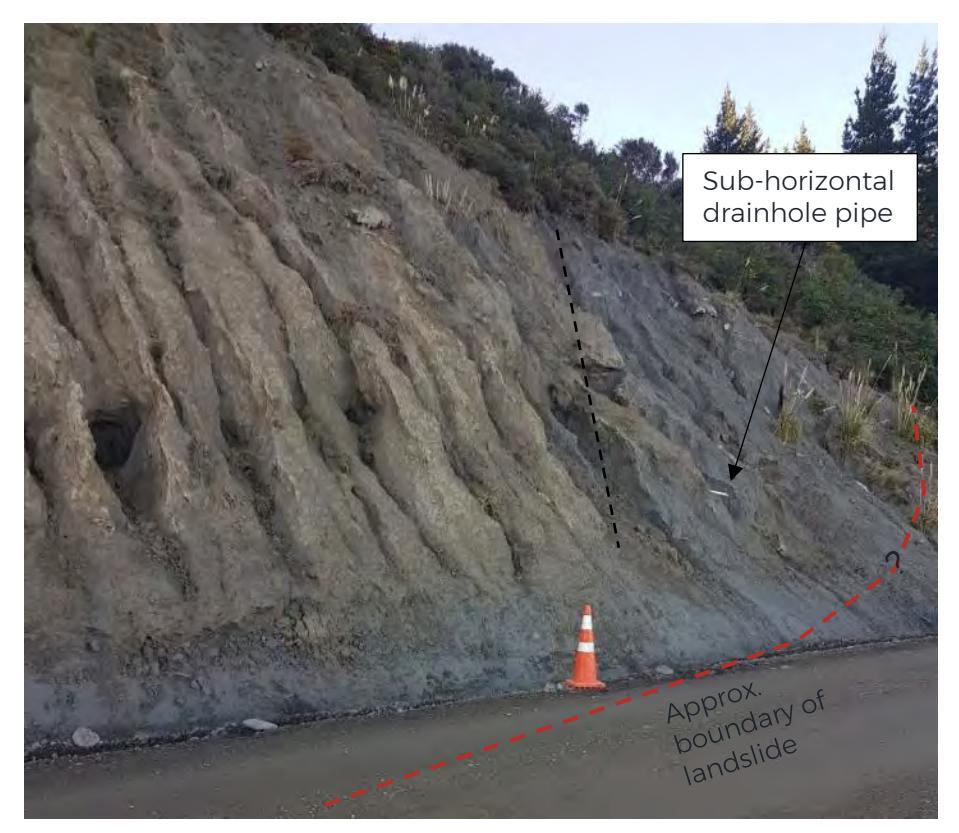
- Surface drainage on the slope above the road will act to prevent infiltration of rainwater (Perrin, 1995).
- Numerous drilled drains have been installed in the past (>10 years ago) only one of these is still visible and is not flowing (Figure 17).
- Installation of a 'French drain' was carried out in May 2020 to intercept the spring discovered just upslope of the road (Figure 16), with no movement noticed on the road since (Tim Langley, personal communication).
- At least one culvert / subsoil outlet pipe discharges to the slope below the road (introducing water into the unstable lower slope).
- Previous drainage socks and pipes have been left behind below the road (Figure 18) while none of these were noted to be flowing when we carried our June 2020 drone flight.

Figure 17: Erodible cut face near the northern edge of Johnson's Hill Landslide. An indicative position of the edge of the landslide is shown. The contact between brown sandstone (left) and grey mudstone is evident. June 2020 photo.

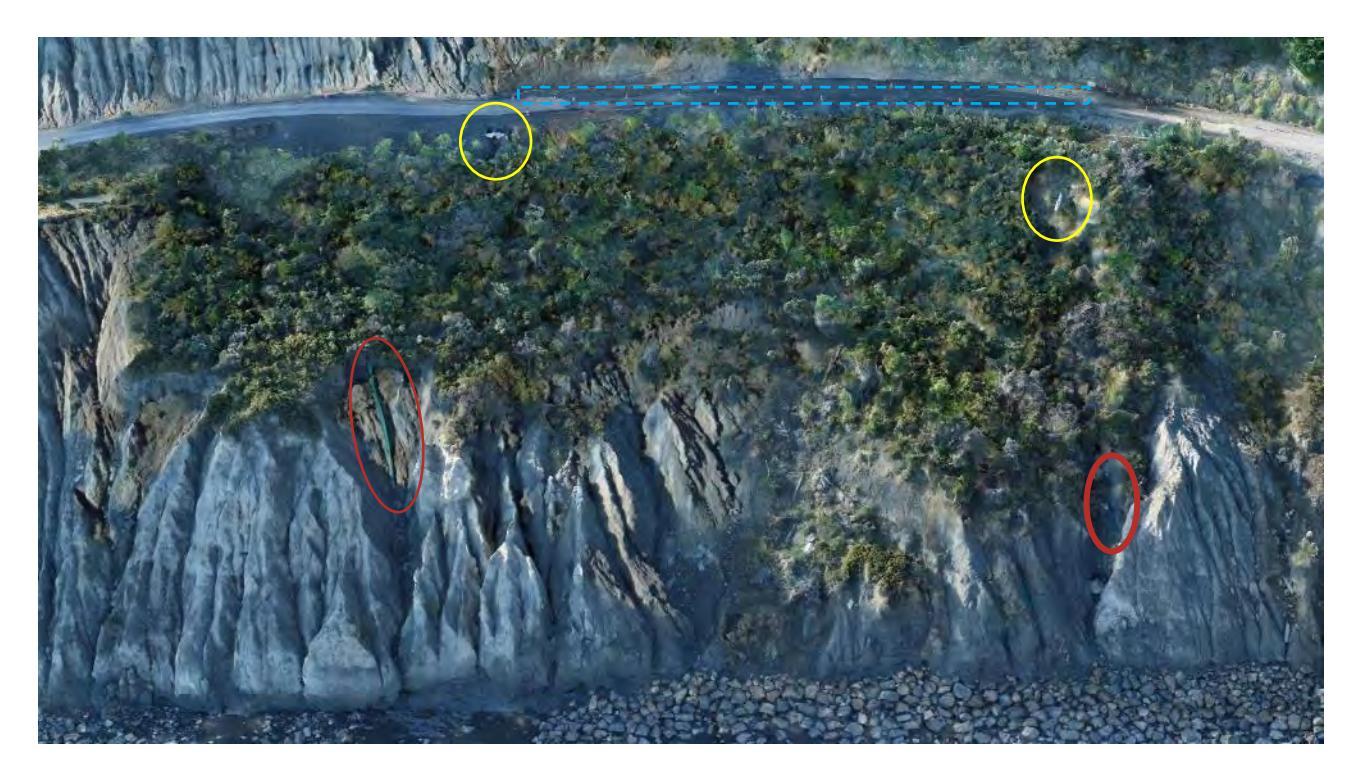
Figure 18: Drainage at Johnson's Hill landslide. Drainage outlets below the road (green), French drain location on the upper side of the road (blue), and redundant green culvert extension socks (red).

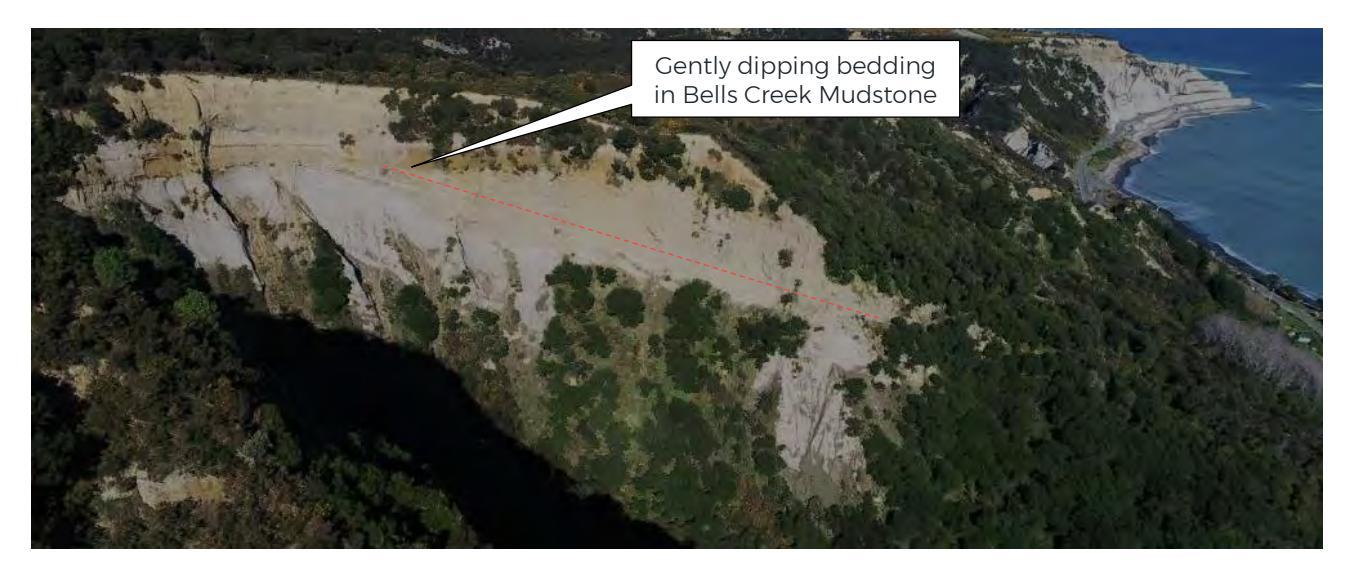
Figure 21: Dipping beds in an outcrop of Bells Creek Mudstone (Msb), with horizontally-bedded brown conglomerate unconformably overlying.

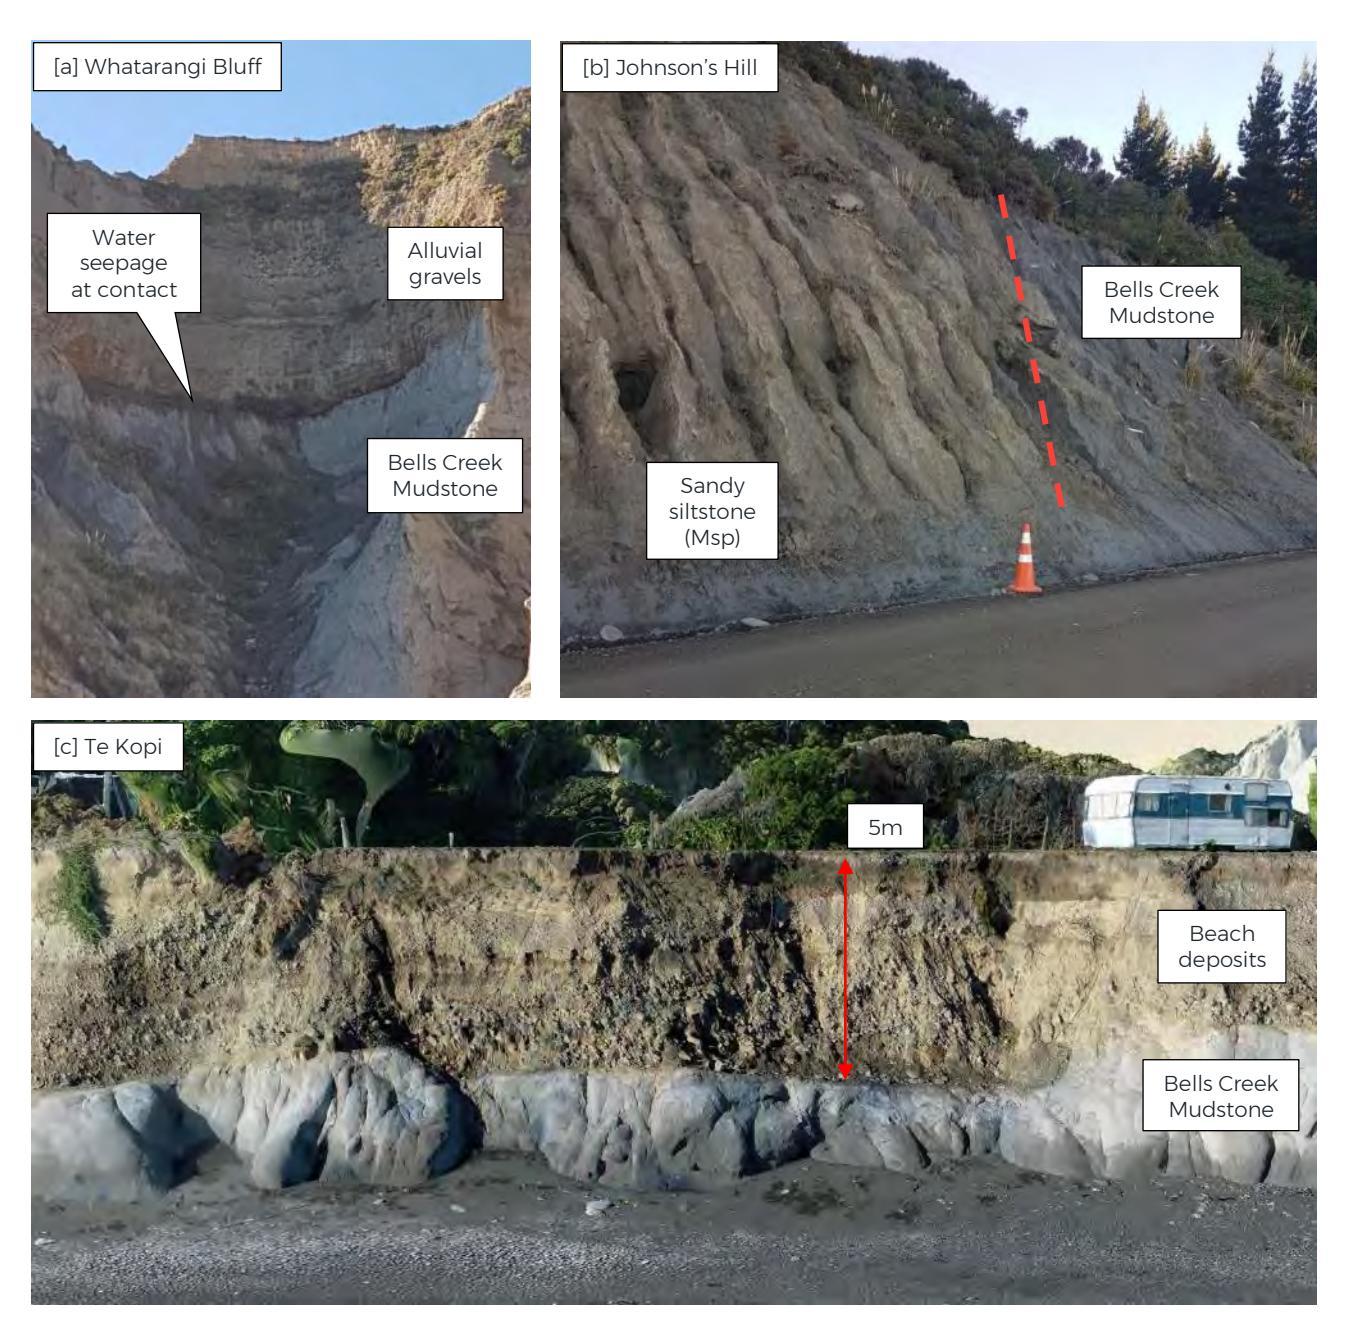
Geological contacts were observed in several locations throughout the study area (Figure 22). In a gully at Whatarangi Bluff, a contact between Bells Creek Mudstone deposits and overlying alluvial gravels was observed. At Johnson's Hill, a contact between sandy siltstone deposits (Msp) and Bells Creek Mudstone is visible in cut slopes above the road. In the beach cliff at Te Kopi, the boundary between Bells Creek Mudstone and overlying beach deposits is exposed.

At Whatarangi Bluff, water seepage was observed at the contact between Bells Creek Mudstone and overlying alluvial gravels (Figure 22). Multiple localised water seepages were also seen throughout the Bells Creek Mudstone in cut slopes at Johnson's Hill, with channels formed by surface water run-off indicating that this rock is easily erodible.

Figure 22: Geological contacts observed within the study area, at [a] Whatarangi Bluff, [b] Johnson's Hill, and [c] Te Kopi.
