## AGENDA ITEM D5

### MARTINBOROUGH GROWTH AREA UPDATE

Martinborough urban development feasibility

# **Preliminary Site Investigation Report**

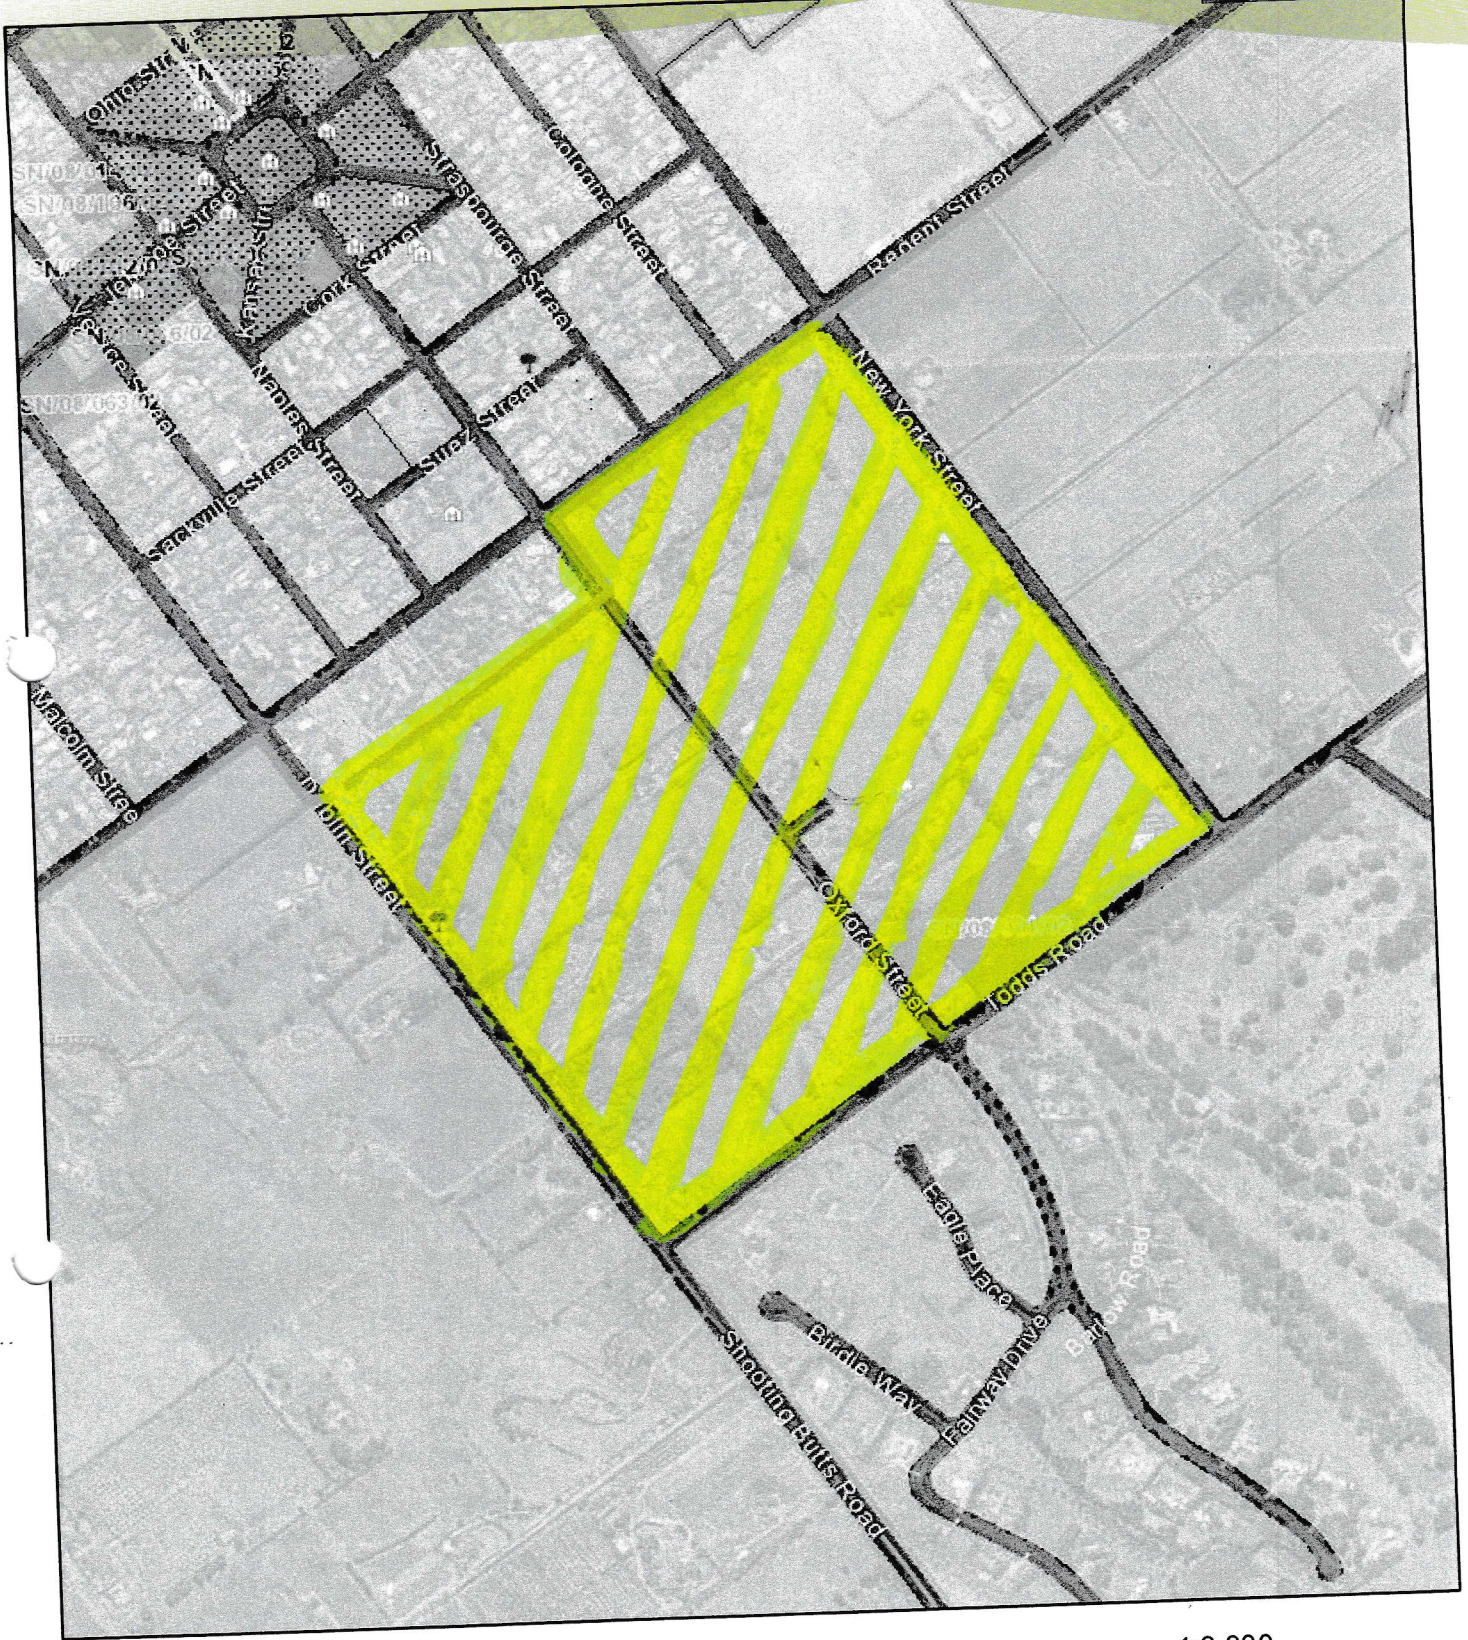
The 2017 Kaha Consultancy report identified the large block of land at the southern fringes of Martinborough (between New York Street, Todds Road, Dublin Street and Regent Street) for further investigation. The area is shown on the following map.

The total area of this Martinborough South block is approximately 36 hectares. It is currently divided into 68 land parcels, varying in size from small ¼-acre type sections to an allotment of 3.7 hectares in area. Many of the land parcels contain one dwelling and associated outbuildings (particularly fronting the existing roads), however the area is predominately still in pasture with some sites in small vineyards and lifestyle orchards.

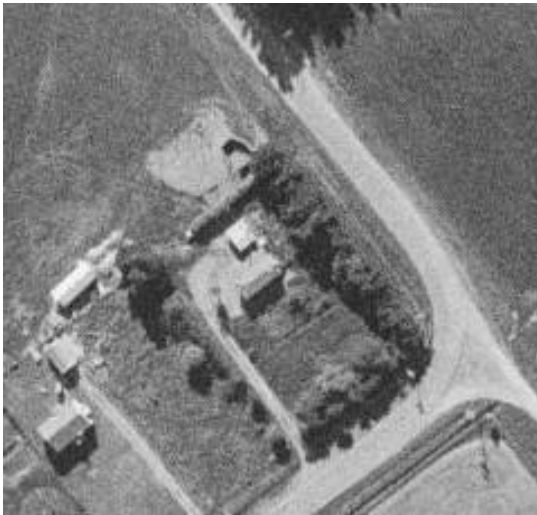
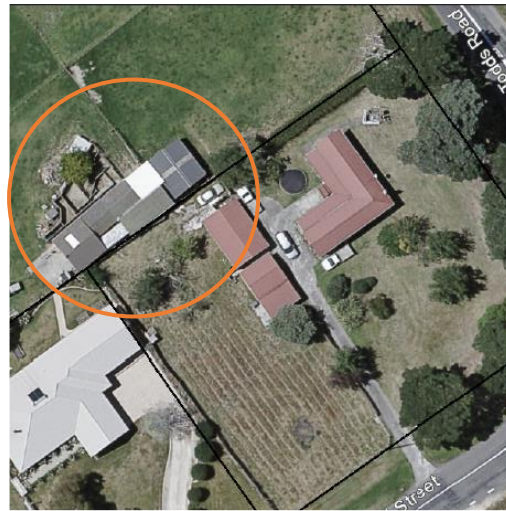
**Abattoir at 71 Oxford Street (1961 left, present right). Yards are found inside the orange circle.**

**Figure 3 – details of aerial photographs of the Martinborough development area**

Yards and a series of sheds are visible at 71 Oxford Street. Some of the old sheds at the Town supply (132 New York Street) are also still visible (figure 3).

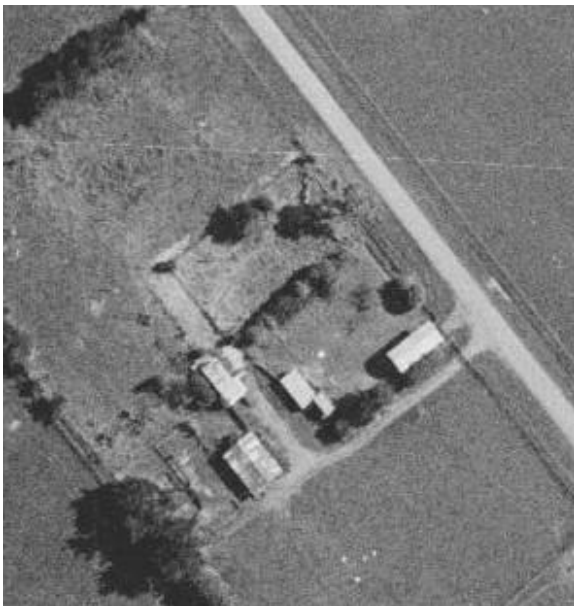
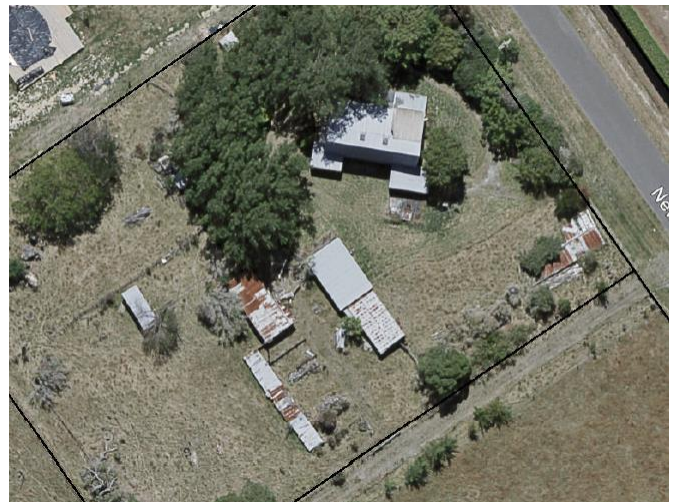
**Town milk supply along New York Street (1961 left, present right). The current address for this property is 132 New York Street.**

**1961** – This photograph shows some smaller blocks along Oxford Street. Otherwise mostly as paddocks or land used for cropping. The dairy sheds and yards for the town milk supply are visible along New York Street (figure 3). The property with the abattoir as described in the SLUR is visible on the corner of Oxford Street and Todds Road. The Golf Course is also clearly visible.

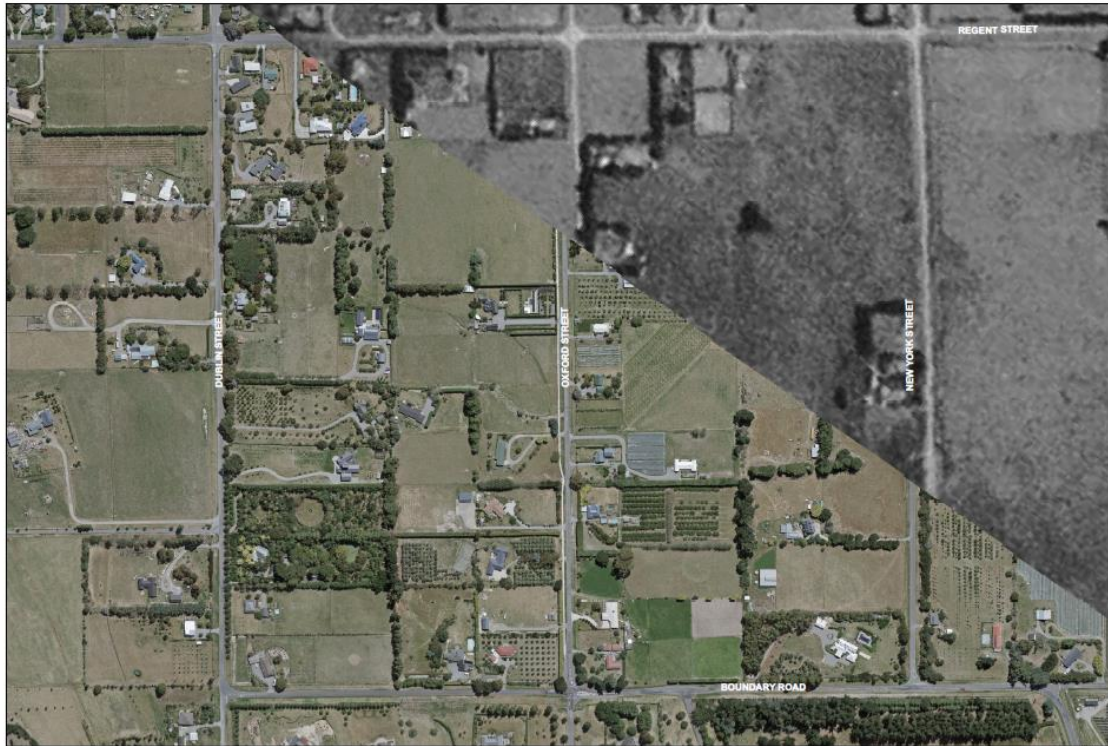
Martinborough 1941-1944

**1944** – The earliest photograph is from 1944. This aerial photograph only shows the site at the corner of Regent and New York Streets. It is mostly as a paddock. Some smaller blocks are developed along Regent Street.
