SOUTH WAIRARAPA DISTRICT COUNCIL

THREE POOLS REVIEW PROJECT

FEATHERSTON POOL

GREYTOWN POOL

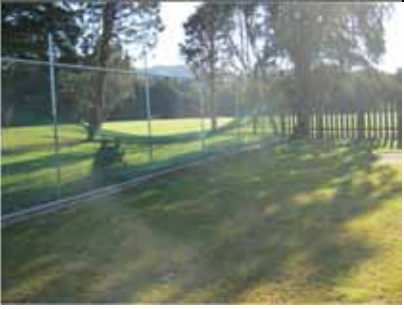
Component Group	Component Type	Component Name	Condition Evaluation	Recommendations	Estimated Quantities	Unit Rate	Maintenance Programme	General Notes	Photos
	Fencing	Galvanised Steel chain link and timber paling fencing	Overall good condition. Galvanised steel chain link fencing in very good condition. Wind break material is loose from the chain link fence. Timber fencing bounding the reserve beyond is in adequate condition.	Mino maintenance works to re-fix the wind break material to the chain link fence.			Monitor the condition of the fencing on at least an annual basis and make repairs as necessary.	We note that the security wire on the road boundary is pitched the wrong way for preventing break-ins.

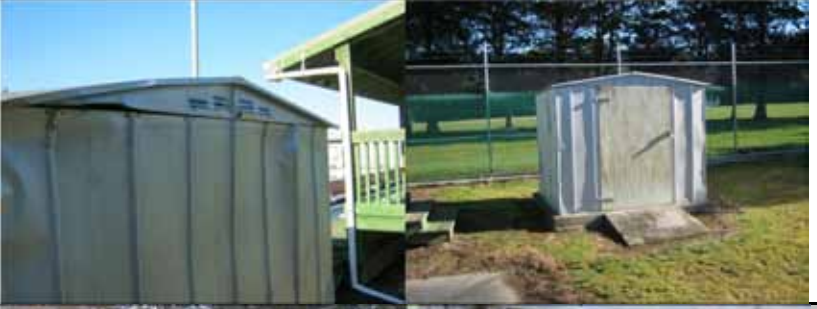
Grandstand	Timber seats	Very good condition. Grandstand completed in 2008. All timber noted as being CCA H3.2 treated.						
	Ancillary Building	Steel garden shed	Poor condition. Colorsteel cladding is warped and dented. Original door is missing – replaced with plywood sheet.	Replace the garden shed with an off the shelf like for like replacement.	Lump Sum	\$1,000.00	2-5 years

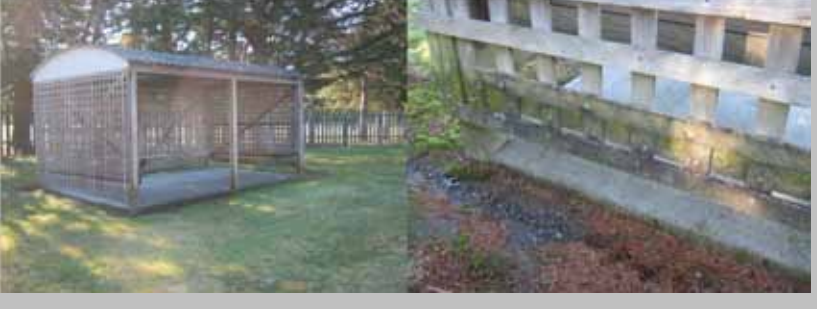
Ancillary Building	Trellis Gazebo	Generally good condition. The lack of spouting from roof is accelerating degradation of timber posts and bottom of trellis cladding. Shaded location has allowed significant lichen growth	Monitor condition of trellis and timber posts. Repair popped nails etc and replace trellis cladding as required. Chemical wash down of roofing to remove lichen	24m ² Trellis reclad Lump sum 12m ² Roof chemical wash	\$1,100.00 \$5.80/m ² Total: \$69.60	5 -10 years 1 year

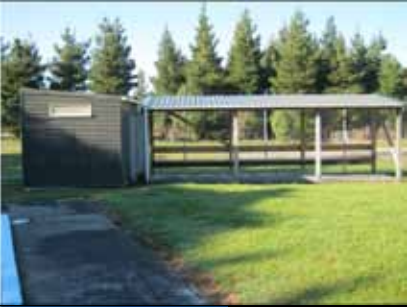
Component Group	Component Type	Component Name	Condition Evaluation	Recommendations	Estimated Quantities	Unit Rate	Maintenance Programme	General Notes	Photos
	Ancillary Building	Covered Seating and Chemical store	Appears in very good condition

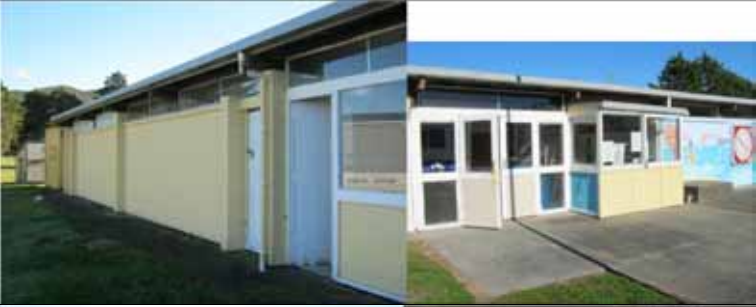
Changing Sheds and Office	Cladding and Joinery	A mix of concrete masonry, fibre cement sheet, corrugated iron and timber weatherboard. Average condition overall. Timber doors on the west face of the changing shed are especially poor.	Timber joinery requires addressing in the near future. The cladding paintwork is adequate for the next few years.	180m ²	\$18.60/m ² Total: \$3,348.00	2-5 years	The age and type of sheet cladding is unknown. Therefore there is a risk it may be asbestos bearing and further testing may be warranted if work affecting the cladding is proposed.

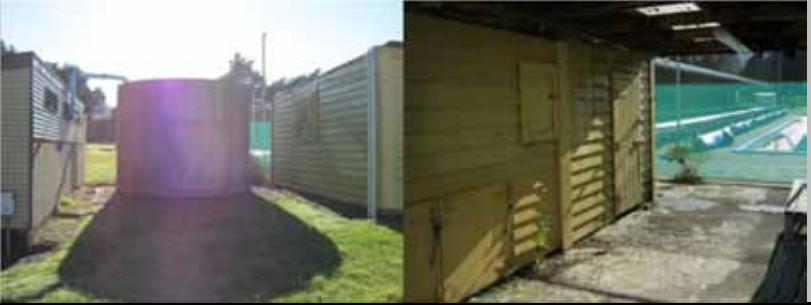
Outbuildings	Cladding and Joinery	A mix of concrete masonry, fibre cement sheet, corrugated iron and timber weatherboard. Average condition overall. Timber weatherboard cladding is in the worst condition.	Weatherboard cladding should be repainted within a two year timeframe to minimise risk to integrity.	200m ²	\$18.60/m ² Total: \$3,720.00	2-5 years

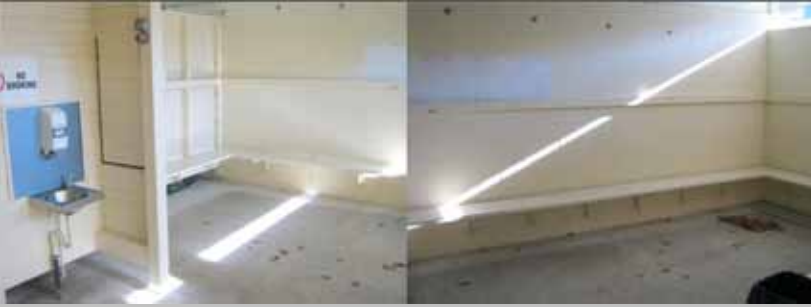
Internal									
	Changing Sheds	Walls/Floors/Ceilings	Painted timber sarking partitions and concrete masonry walls in average overall condition. Bare concrete floors, no ceiling linings. Vandalism on many walls.	Repaint prior to season opening to remove vandalism. (only offending walls may be necessary) Provide on-going monitoring of condition and repaint as necessary.	240m ²	\$17.80/m ² Total: \$4,272.00	1 year	NOTE: Rates provided are worst case to allow to repaint all internal walls. There was evidence of break-ins and associated litter and vandalism. Overall security measures could be addressed further outside of these recommendations.

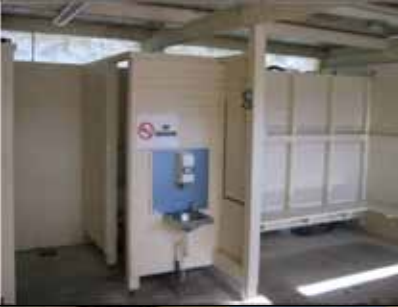
Component Group	Component Type	Component Name	Condition Evaluation	Recommendations	Estimated Quantities	Unit Rate	Maintenance Programme	General Notes	Photos
		Fixtures	Timber seating; 1 x male shower, 1 x male WC and 1 x urinal. 1 x Female shower, 2 x female WC all in fair condition. Appear 'fit-for-purpose'.				Monitor condition of fixtures and fitting regularly and replace or repair as required	Fixtures were not tested during inspection.

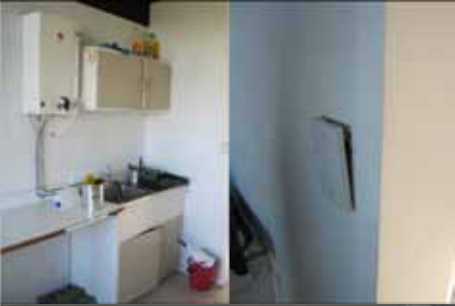
Sick Bay	Linings/ Fixtures	Timber joinery units are in poor condition reflective of their age. Masonry block walls and paintwork in fair condition.	Replace joinery unit in the long term. Minor maintenance to repair loose power outlet.	3m	\$206.00/m Total: \$618.00	10 years

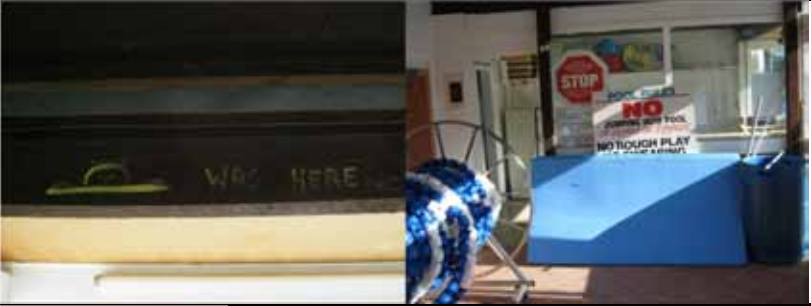
Site Office	Internal Linings	Average condition in keeping with age and use.

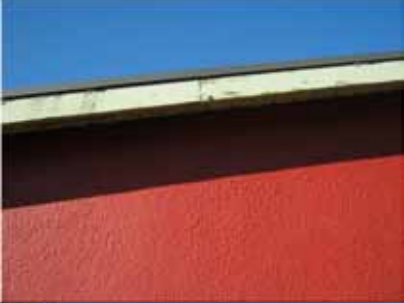
Component Group	Component Type	Component Name	Condition Evaluation	Recommendations	Estimated Quantities	Unit Rate	Maintenance Programme	General Notes	Photos
	Cladding	Fascia	Poor condition. Paint peeling on all sides	Repaint required. The good condition of the surrounding cladding draws attention to the poor repair of the fascias. Pay extra care to preparation work to ensure the new paint lasts	120m	\$5.80/m Total: \$696.00	1 year Repaint 5-10 year cycles in conjunction with claddings

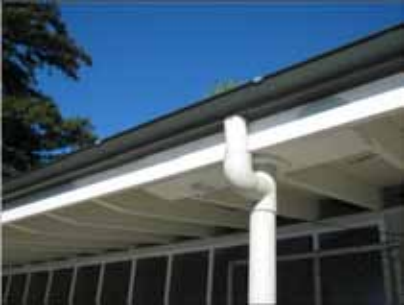
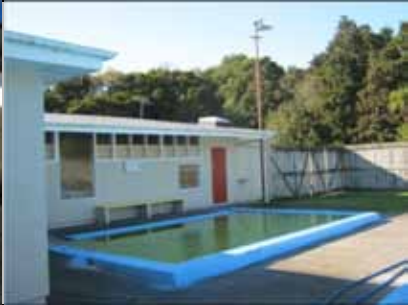
Roof	Roof and Spouting	Roof of entrance building appears in very good condition. Spouting is blocked and requires cleaning	Clear spouting of blockages. Wash down of spouting and fascia throughout facility to remove green algae growth.	100m ²	\$5.60/m ² \$560.00	1 year

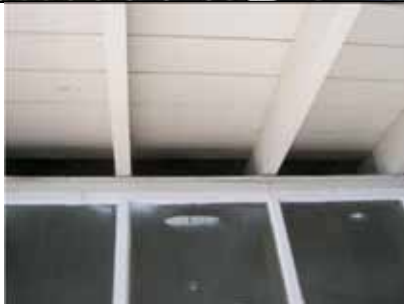
Windows and Doors	Timber Joinery	Timber joinery in fair condition. Paintwork peeling in places. High level steel bird mesh corroded and often broken		100m ²	\$38.00/m ² Total: \$3,800.00	2-5 years Repaint 5-10 year cycles in conjunction with claddings	Discretion may be used to evaluate repainting of windows with some windows worse than others. The figures provided here are a conservative estimate to cover repainting all at the same time.

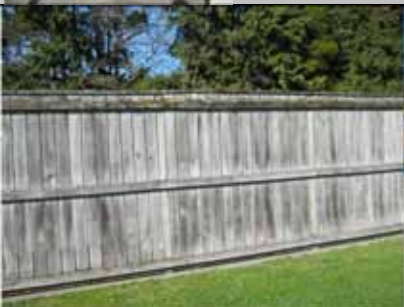
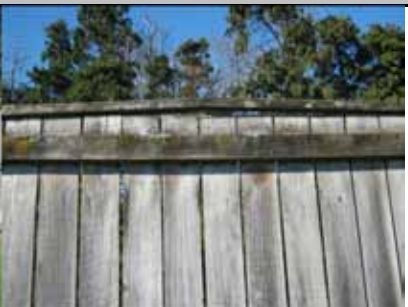
Fencing	Timber Paling	Generally good condition. Top plate de-nailing in places	Minor repairs as required. Yearly inspections to monitor overall condition

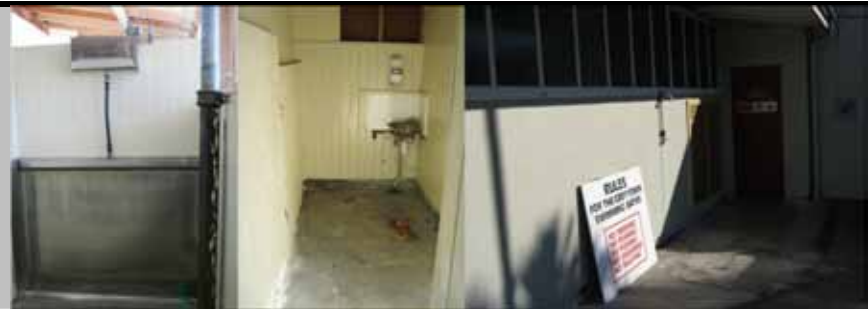
Component Group	Component Type	Component Name	Condition Evaluation	Recommendations	Estimated Quantities	Unit Rate	Maintenance Programme	General Notes	Photos
		Fixtures	3 x WC (1 male 2 female) and 1x Urinal. 1x Exterior shower. All in average condition but fit-for-purpose	Yearly inspections on condition and replace or repair as required.				Fixtures were not tested during inspection

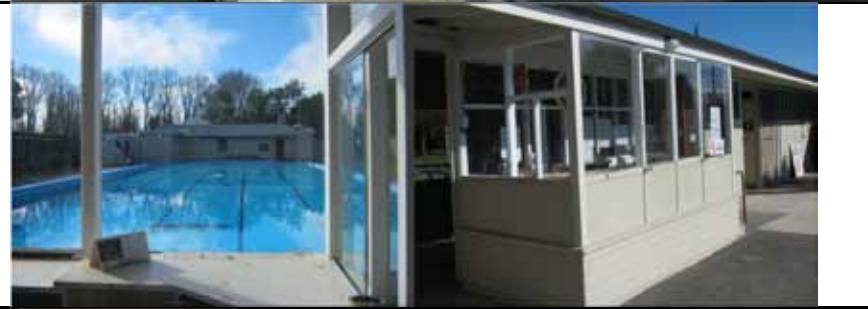
Site Office	Internal Linings/glazing	Adequate condition in keeping with the age of facility	Repaint window joinery as required.	Rates covered elsewhere		5-10 years

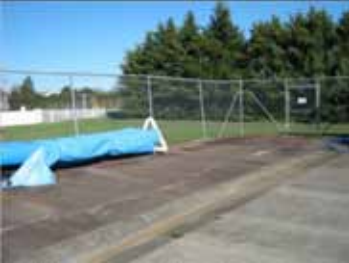
Fencing	Galvanised Steel chain link fencing	No evidence of concrete footings visible around posts. No mowing strip to the perimeter of the fence line. Galvanised steel posts with minor rust	Touch up areas of rust with Rust-Arrest and a galvanised primer paint. Repair posts with new footing and a continuous concrete mowing strip to perimeter	Concrete 4m ³	\$319.00/m ³ Total \$1,276.00	2-5 years Yearly inspection and touch-ups of any rust

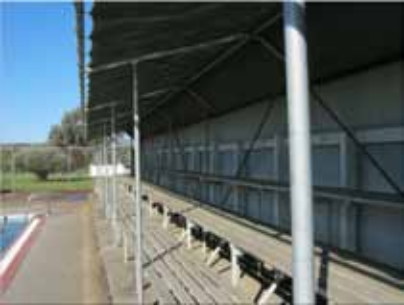
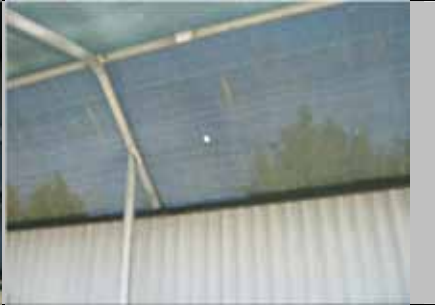
Planting	Trees	Deciduous trees dropping significant leaf litter	Negotiate to remove trees close to property boundary				There are a number of significant trees surrounding the pool creating maintenance issues with leaf litter.	
	Grandstand	Grandstand shade roof	Generally good condition. Evidence of recent repair to the galvanised steel roof structure. Minor hole in fabric at one location	Monitor condition and schedule a replacement within 10 years	60m ²	\$250/m ² Total \$15,000.00	10 years for replacement. Monitor condition each year for change	Could be increased in size to offer better sun protection (not included in rate estimate)

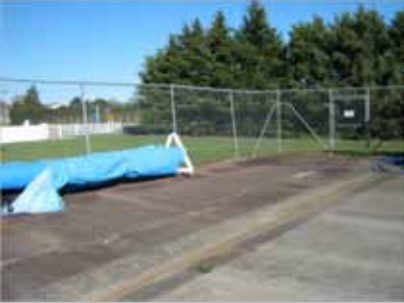
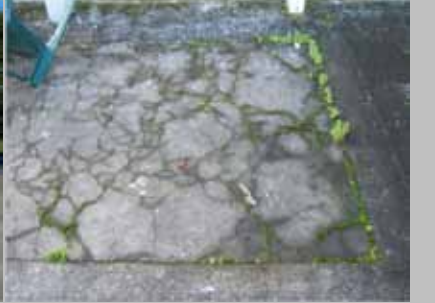
Grandstand	Timber seats	Generally good condition	Monitor condition each year				Seats/grandstand is east facing. Anecdotal evidence suggests the shade cloth roof provides little shade during the summer months.	
	Paving	Concrete paving	Significant cracking to some areas of older trowel finish concrete. The overall condition of the exposed aggregate concrete surrounding the main pool is fair. Differences in levels between sections of paving present possible tripping hazards and are creating spaces for weeds to establish.	Full replacement recommended	350m ²	\$74/m ² Total: \$25,900.00	10 years for replacement

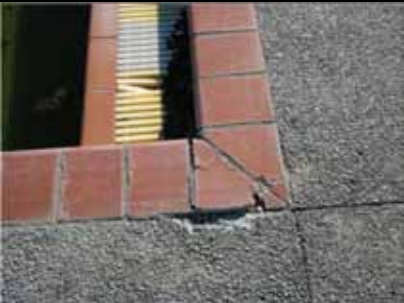
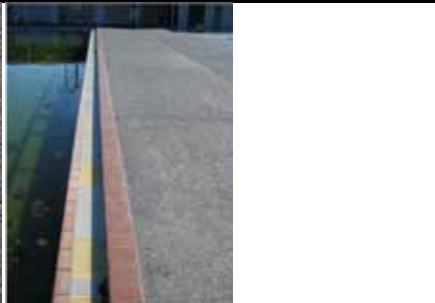
Pool Surround	Tiles	Appear generally sound condition. Minor localised damage in places.		24m ²	\$112.00 Total: \$2,688.00	10 years for replacement. Coordinate with paving

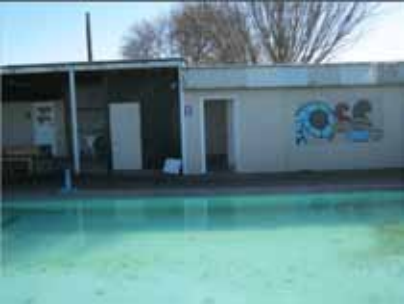
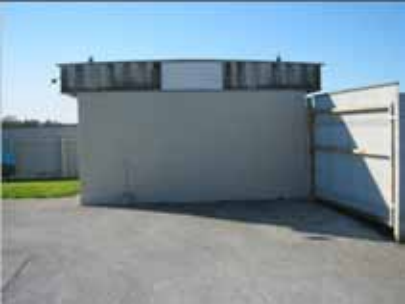
Changing Sheds	Cladding	Concrete Masonry – Generally good. Paint is in good condition Colorsteel – Mansard type cladding sections of door head height appear in fair condition Unknown profiled panel – appears either a fibre cement product or possibly an asbestos bearing material. Stained in places with moisture staining sheet edges	Repaint all as required on a 5-10 year cycle	200m ²	\$18.60/m ² Total: \$3,720.00	5-10 years

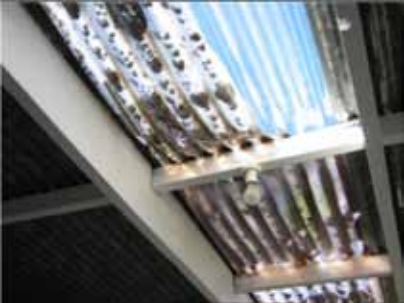
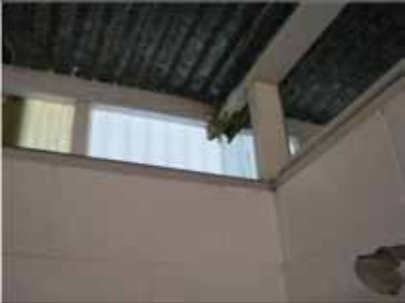
Roof	Clearlite skylights warped and failing in changing sheds. Some repair work has been carried out with replacement sheets provided in places.	Replace all Clearlite with new within 2 years	25m ²	\$58.00/m ² Total: \$1,450.00	2 years	NOTE: Evaluation was a visual inspection from ground level and internally only.

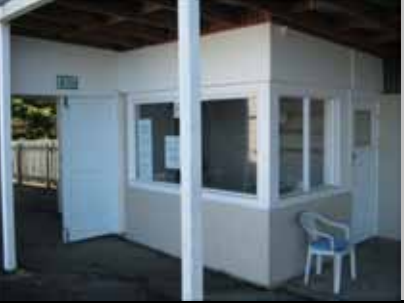
Office	Cladding	Concrete Masonry and fibre cement sheet – Generally good condition. Paint is in good condition	Repaint all as required on a 5-10 year cycle	30m ²	\$18.60/m ² Total: \$558.00	5-10 years

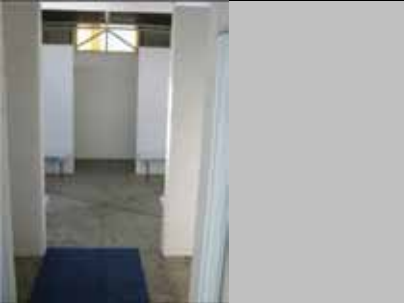
Internal									
	Female Changing	Walls/Floors	Adequate condition in keeping with the age of facility	Repaint walls as required	120m ²	\$17.80/m ² Total: \$2,136.00	5 years

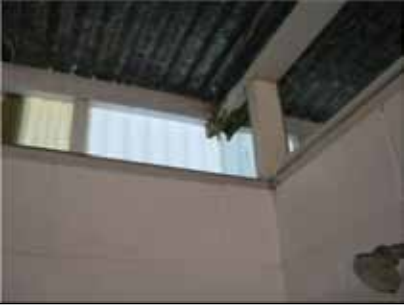
Ceilings	Rotting timber roof framing members, underside of damaged clearlite (as above),		30m	\$16.60/m Total: \$498.00	2 years	Costs do not include for removal/reinstatement or replacement of roofing to enable rafters to be replaced

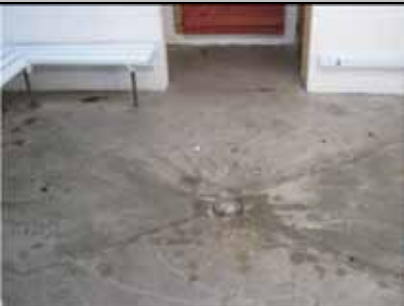
timber seating all in fair condition. Appear 'fit-for-purpose'						
	Male Changing	Walls/Floors	Adequate condition in keeping with the age of facility	Repaint walls as required	120m ²	\$17.80/m ² Total: \$2,136.00	5 years

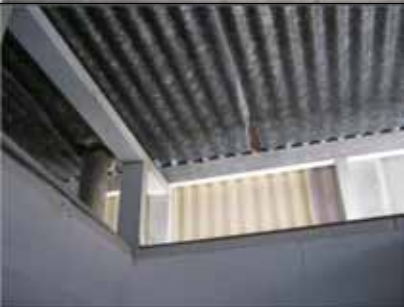
Ceilings	Clearlite and underside of galvanised steel roofing iron	As per external works section

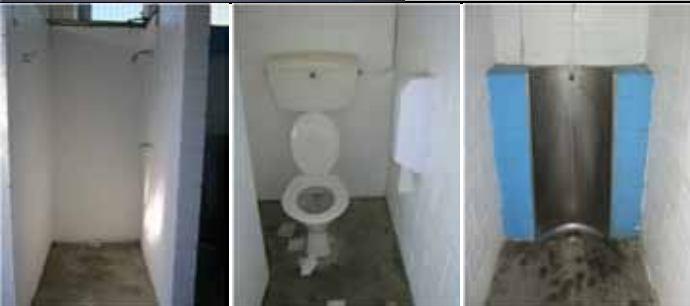
Fixtures	2x showers, 1 x WC and 1x Urinal. All in average condition but fit-for-purpose					Fixtures were not tested during inspection

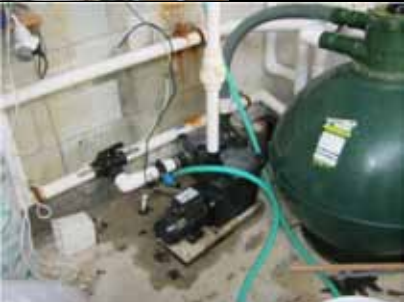
Fixtures	Steel bandit ties have been used to secure pipes – now corroding.	Replace galvanised steel bandits with stainless steel or plastic ties	Lump sum	\$200.00	1 year	Condition and compliance of the pumps, filters and processes are more fully detailed in the PRMP.

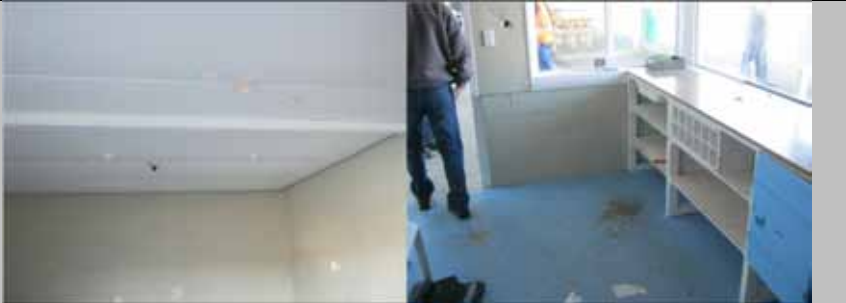
Site Office	Internal Linings	Painted concrete masonry walls in generally fair condition. Damage to plasterboard wall linings. Painted concrete floor showing wear.	Patch and repaint damage wall linings Repaint floor Repaint walls	2m ² 15m ² 30m ²	\$25.10/m ² Total: \$50.20 \$16.90/m ² Total: \$253.50 \$17.80/m ² Total: \$534.00	1 year 5 years 5 years

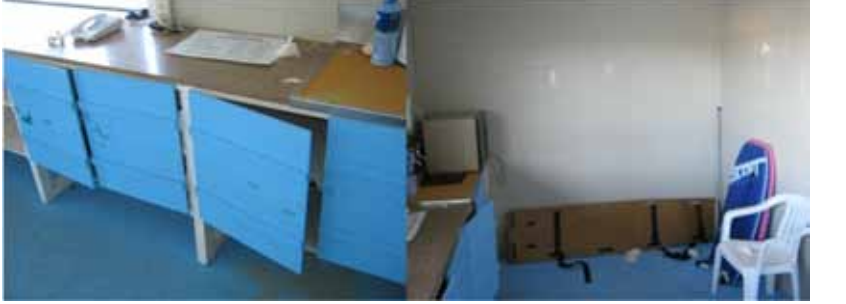
Fixtures	Evidence of a break-in. The joinery units are in average condition. Considered fit for current purpose however replacement for aesthetic reasons may be justified within a 10 year period.		5m Joinery unit	\$206.00/m Total: \$1,030.00	5-10 years
