Martinborough, Greytown, and Featherston Treated Wastewater Discharges: Low-flow Assessment of Ecological Effects

Prepared for South Wairarapa District Council

Adam Forbes (MSc)
Forbes Ecology
July 2013

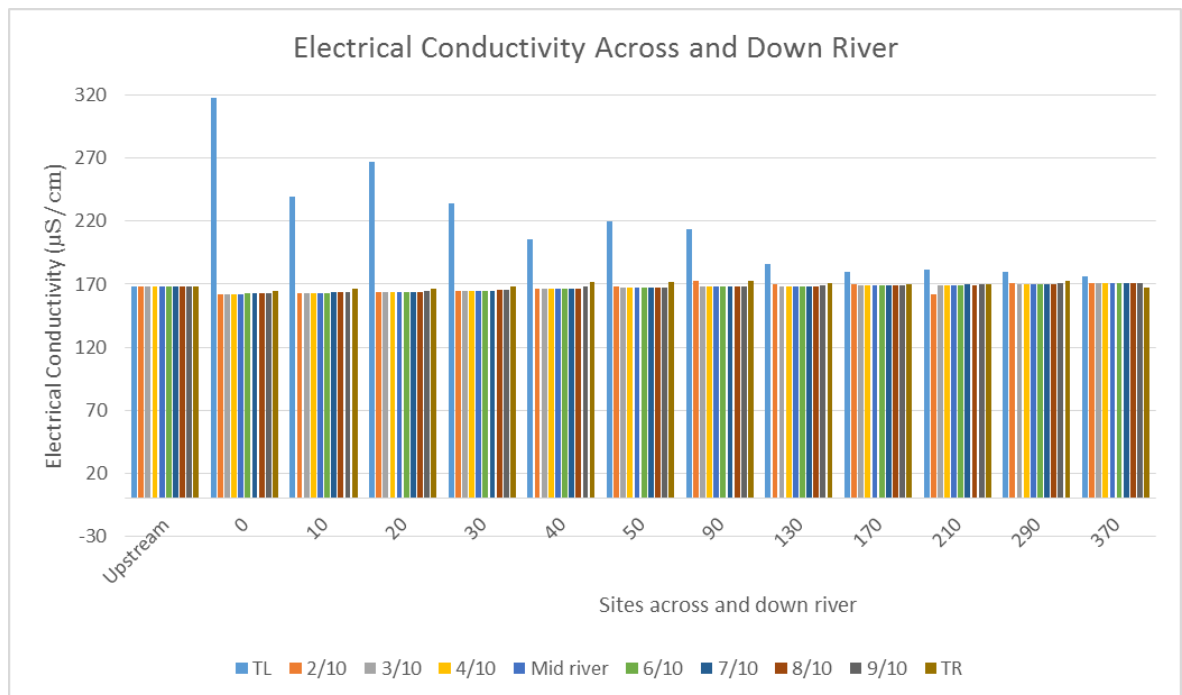
Figure 4: Analysis of treated wastewater mixing at Martinborough with regard to (A) EC across and downriver, (B) Comparison of EC from TL river edge and remainder of river's width (mean; error bars one SEM), (C) Comparison of DRP concentrations from TL river edge and remainder of river's width, (D) DRP concentrations across and downriver, (E) Periphyton cover across and downriver.

With regard to the concentrated plume, the DRP concentrations show the same spatial pattern as EC—the most concentrated plume being confined to the river's edge, in the zone 0–4.2 m laterally across river from the TL river bank. Within 10 m downstream of the outfall, DRP concentrations within the concentrated plume had reduced four-fold. A more gradual reduction in DRP concentration in the area adjacent to the TL river bank was found to continue for the length of the area surveyed (370 m downstream of the outfall). At the 370 m mark, DRP concentrations at the TL bank were still an order of magnitude higher than in directly adjacent areas of the river width. This shows that, although diminished in concentration, the most concentrated part of the plume is against the TL bank for a distance of 370 m downstream of the outfall. Outside of the area of the plume, DRP concentrations were very nearly identical to upstream concentrations.

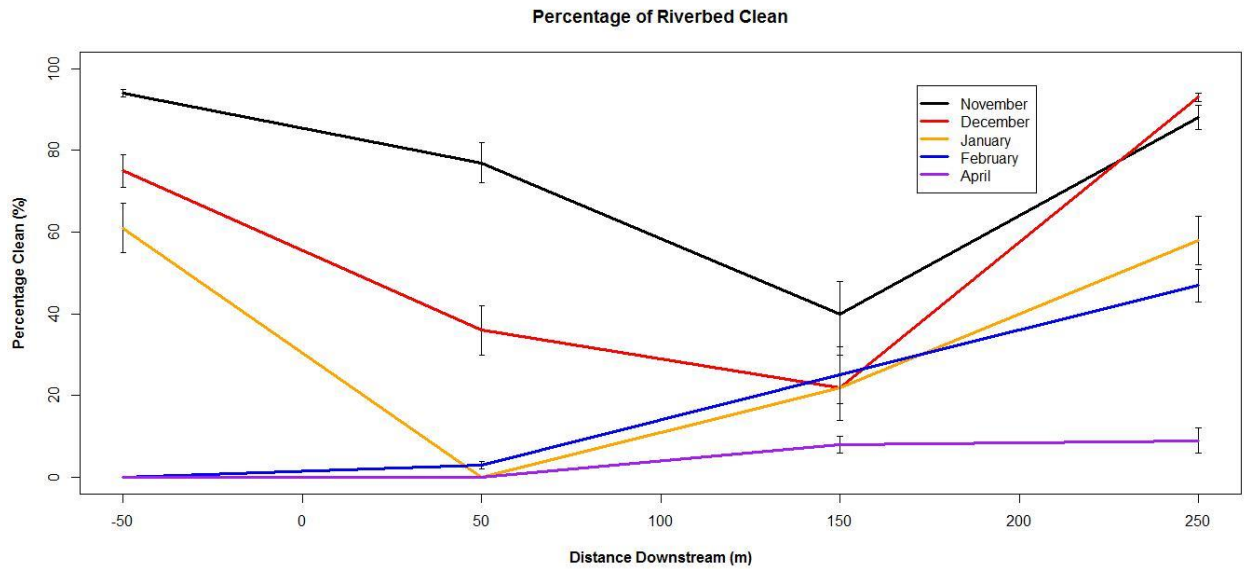
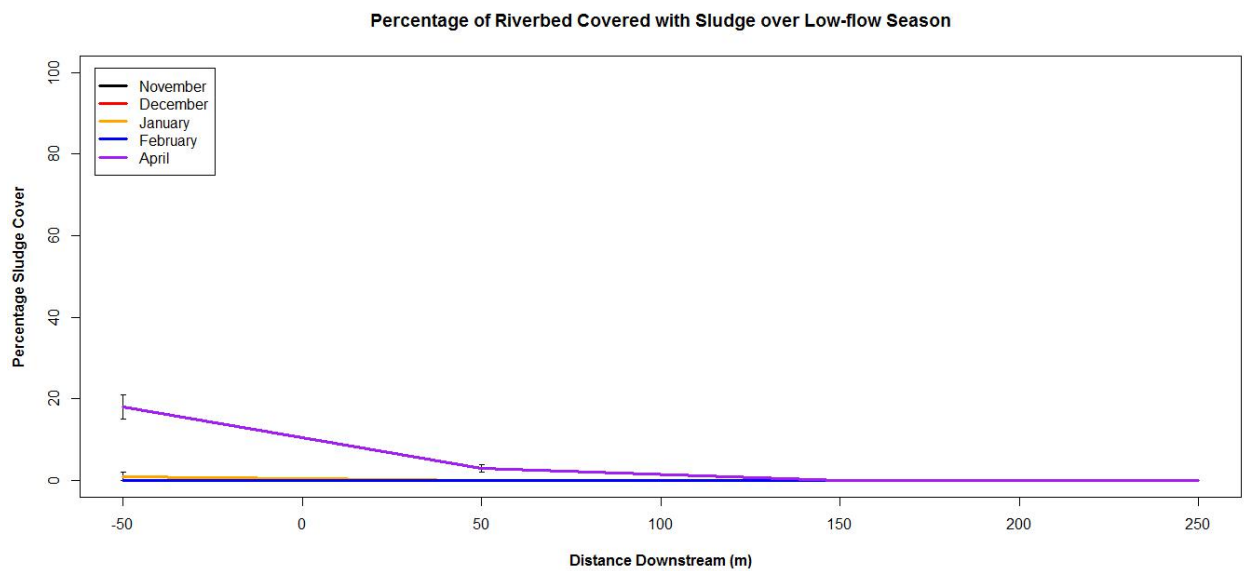
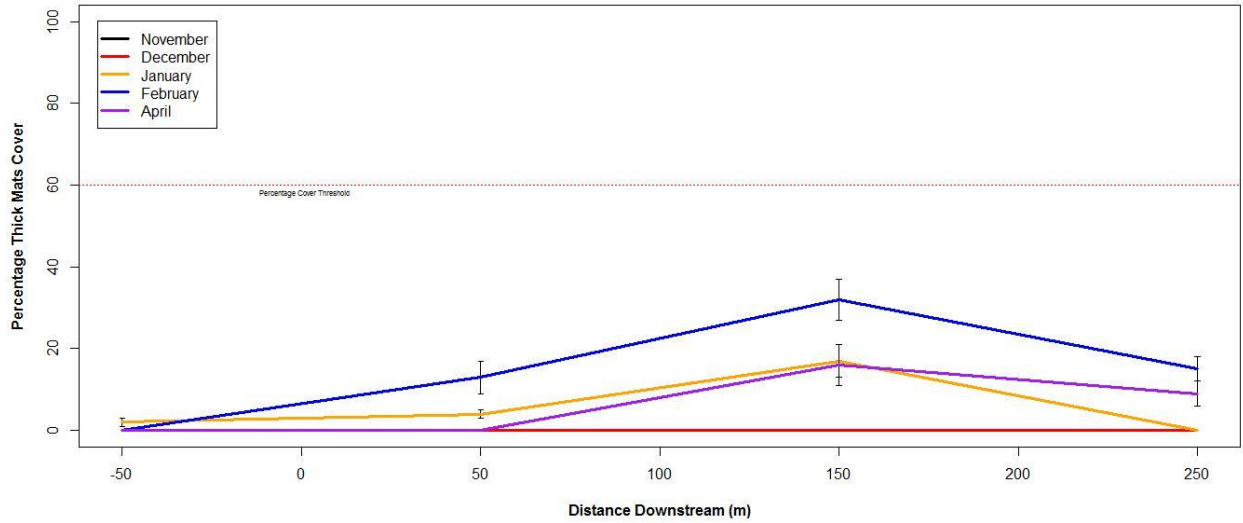
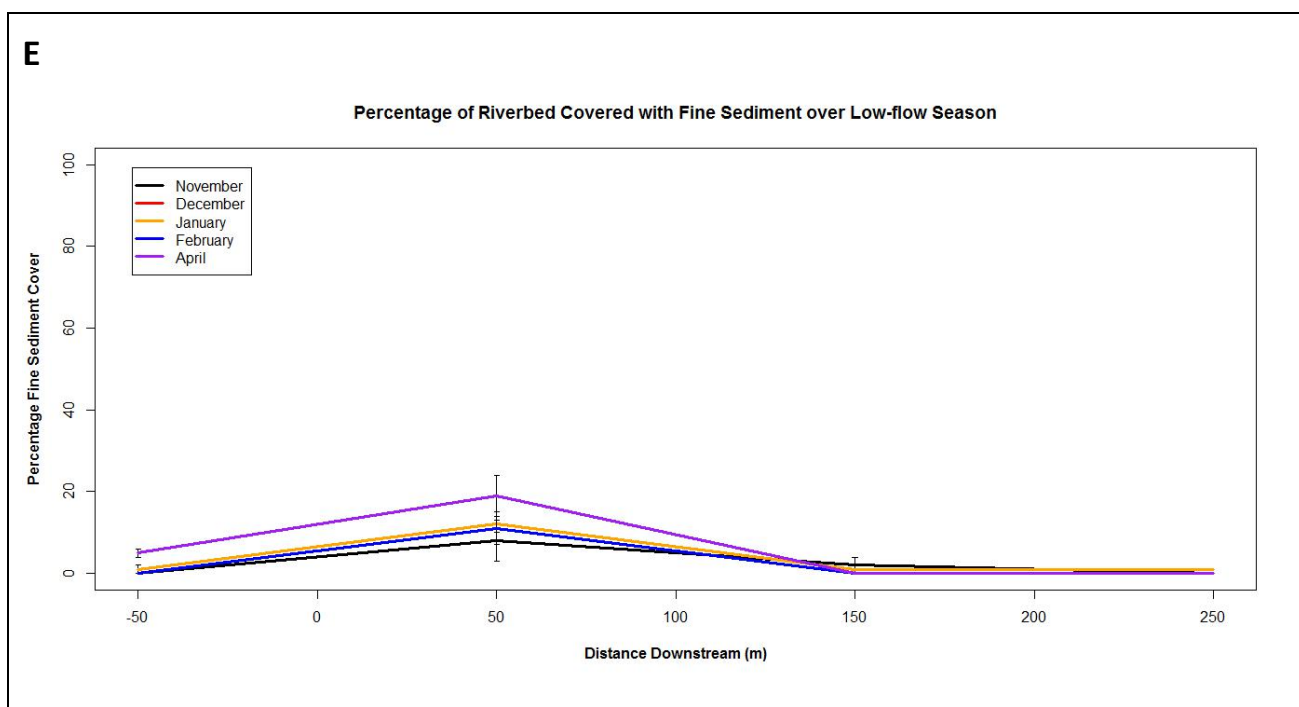
Figure 7: Results from visual assessment of (A) % riverbed clean (B) % cover by sludge (C) % cover by thick mats (D) % cover by coarse long filamentous algae (E) % cover by fine sediment. Error bars represent one standard error of the mean.

The percentage of the riverbed which was clean (i.e. free from periphyton and fine sediments) varied considerably at all sites surveyed (upstream and downstream of the outfall). During November the discharge caused a statistically very highly significant¹ reduction in the proportion of clean riverbed at the point 150–190 m downstream, but no significant² effect at 250–290 m downstream. In December the proportion of clean riverbed

within the plume, at 50–90 m³ and 150–190 m⁴, was statistically very highly significantly reduced. However, at the downstream most site the proportion of clean riverbed increased to be comparable with upstream conditions occurring at the time. In January, the proportion of the riverbed clean at 50–90 m downstream of the outfall was 0%. Yet more than 60% upstream was clean. By 250–290 m downstream there was no significant⁵ difference in the proportion of clean riverbed, compared to upstream conditions at the time. During February and April no clean riverbed occurred upstream, but in both months clean areas were present at 250–290 m downstream. This makes assessment of the contribution of the discharge on the percent of the riverbed clean not possible for those months.

Fine sediment deposition at the point 50–90 m downstream of the outfall increased progressively over the monitoring period. This site was comparatively more depositional (deeper and slower flowing) than the other downstream monitoring sites, which could be a factor leading to this result. Nevertheless, sediment deposition at the point 50–90 m downstream of the outfall was observed to be considerable and the source of sediments would have been the treated wastewater discharge. Proportional cover by sediment consistently reduced by the 150–190 m downstream point, to levels comparable to upstream conditions, and no increases further downstream were detected.

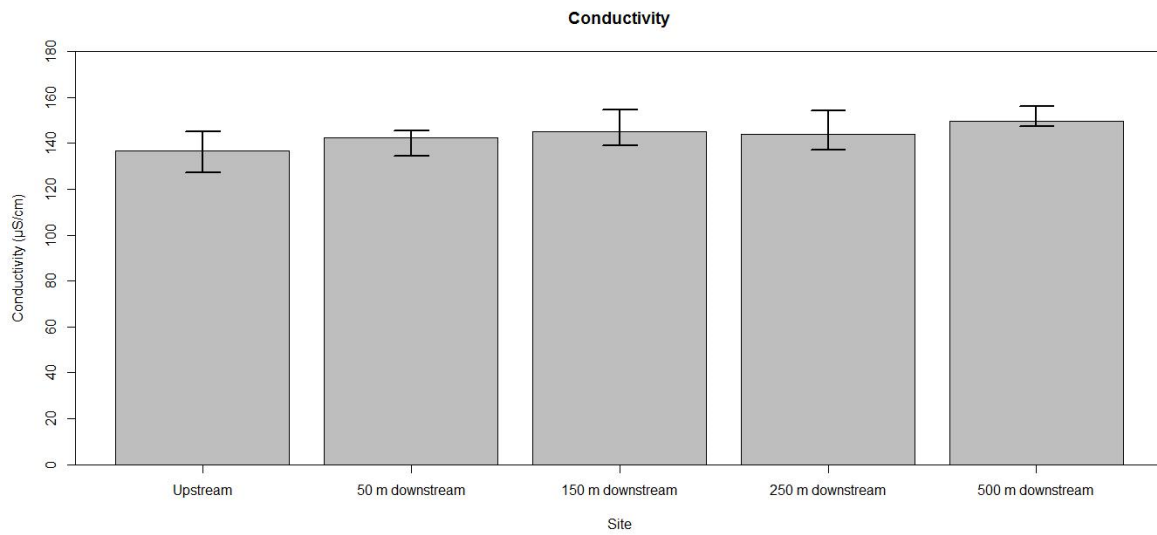
Figure 9: Results from water quality monitoring for (A) electrical conductivity (B) pH (C) suspended solids (D) turbidity (E) black disk. Median values are plotted and error bars represent the interquartile range.

Despite the sediment deposition noted at the area 50–90 m downstream of the outfall, mean suspended sediment concentrations at any downstream monitoring site was not significantly different to the mean upstream concentration¹³.
