# Hinekura Road Realignment

*Project Brief (5-C4072.01)*

*27 March 2023*

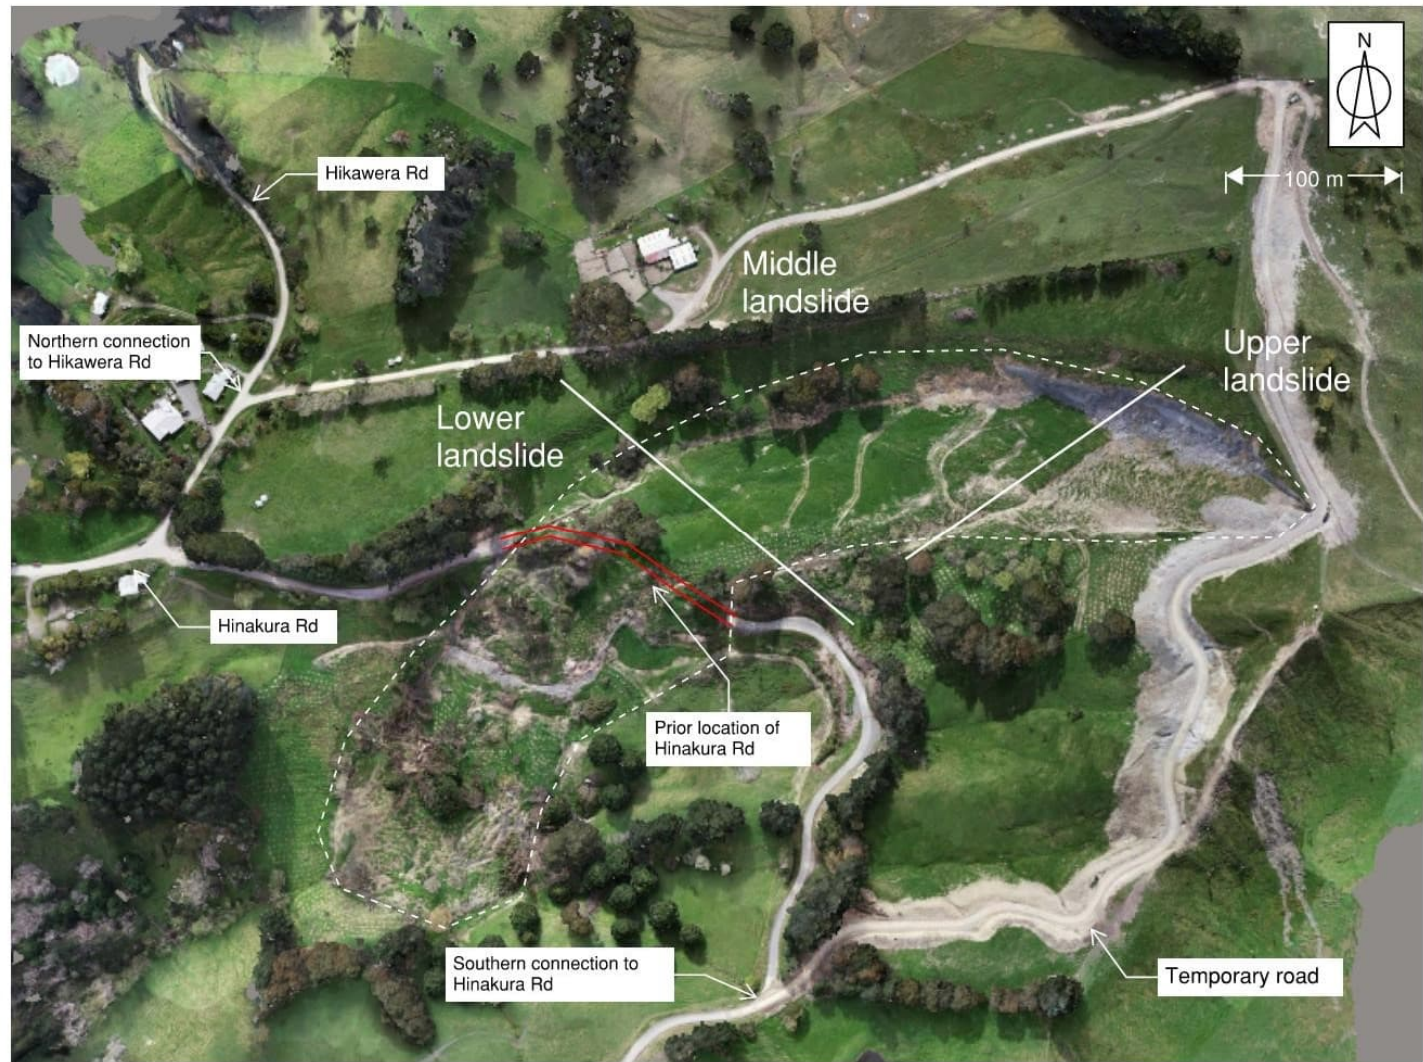
*Location plan at Landslide site*

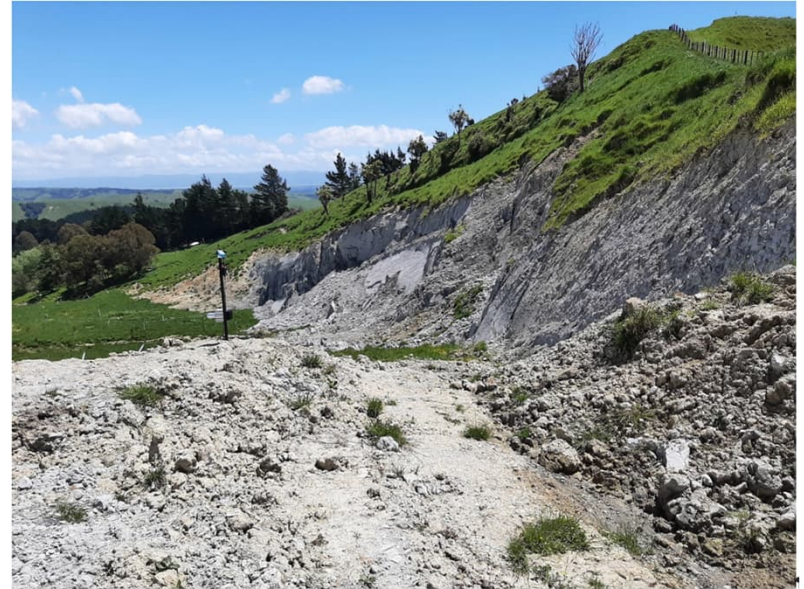
Photo-6: Upper-landslide-with-top-of-Extensometer-1-visible-1

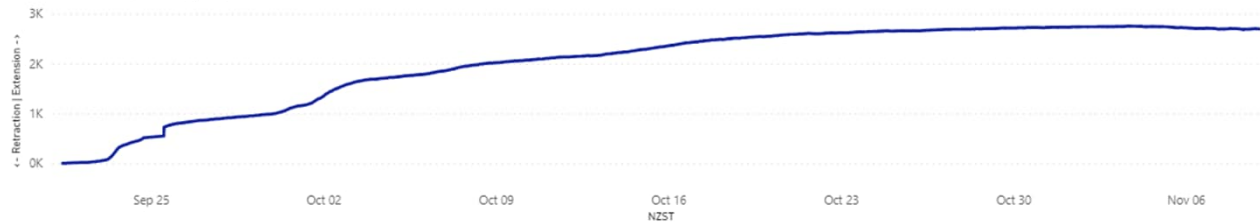
Extensometer 1 (mm) vs NZST

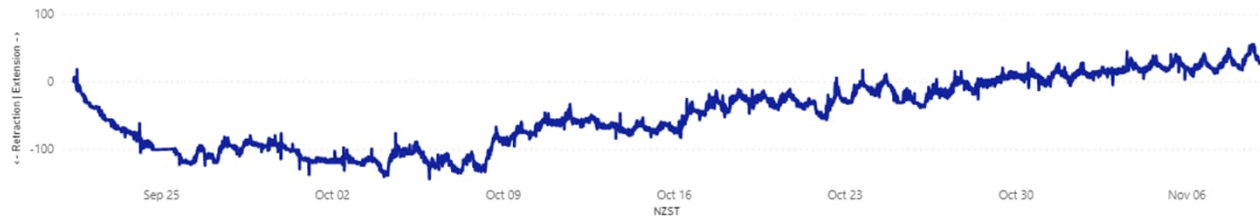
Extensometer 2 (mm) vs NZST

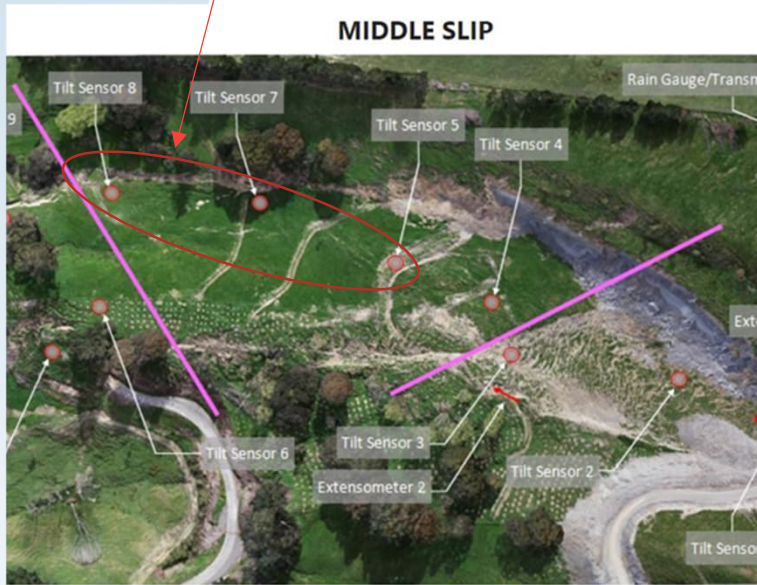
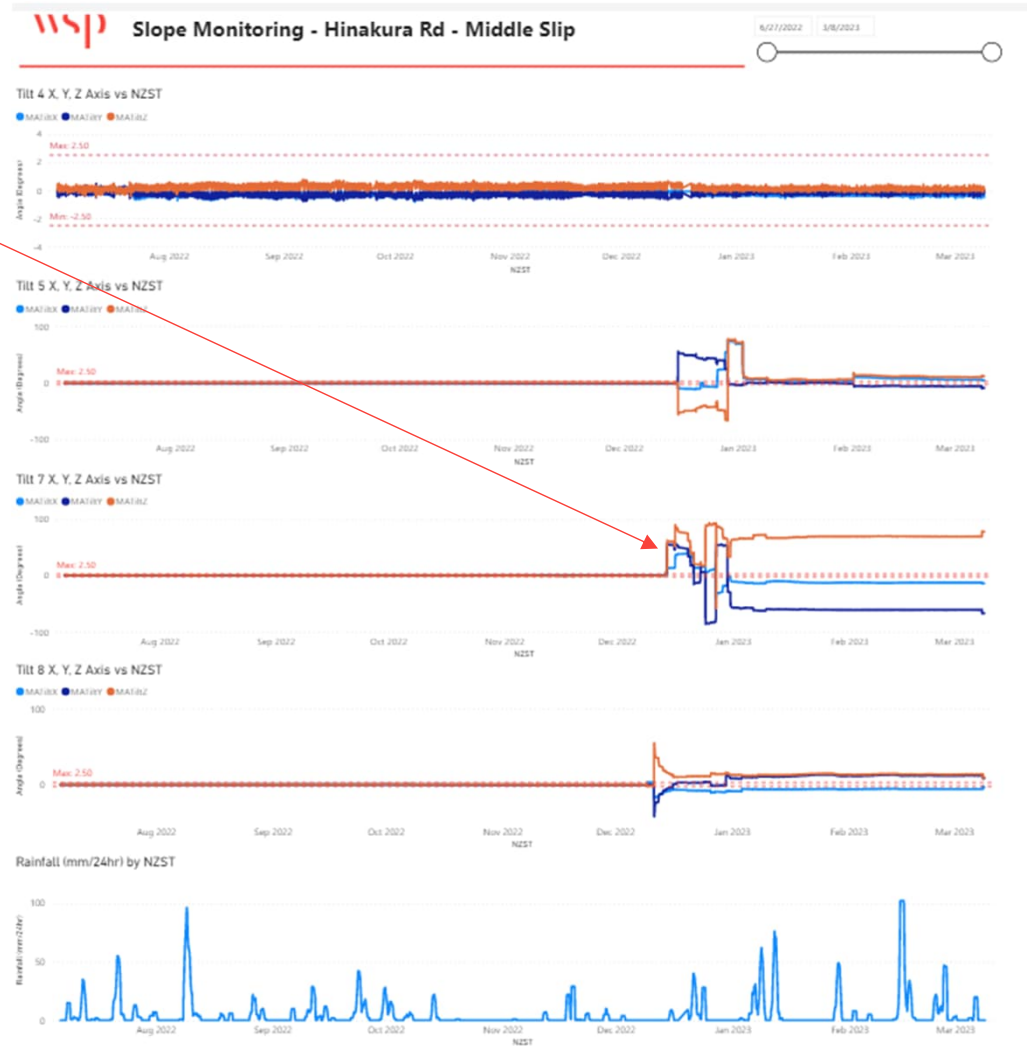
# Middle Section

Stable til Dec 2022

Tilting from December 2022 (restocked paddock)?

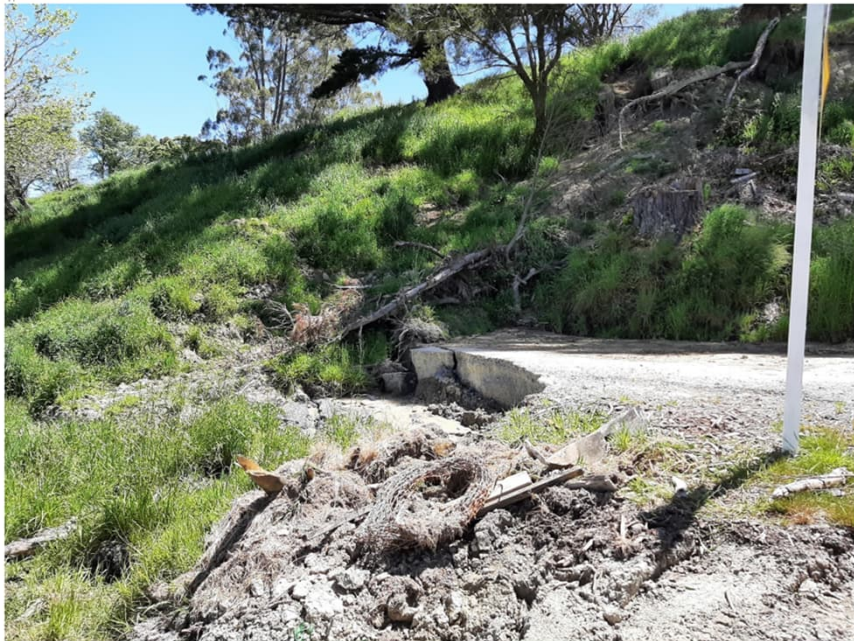
# Edge of landslide at old Road level

Photo 1: East end of landslide

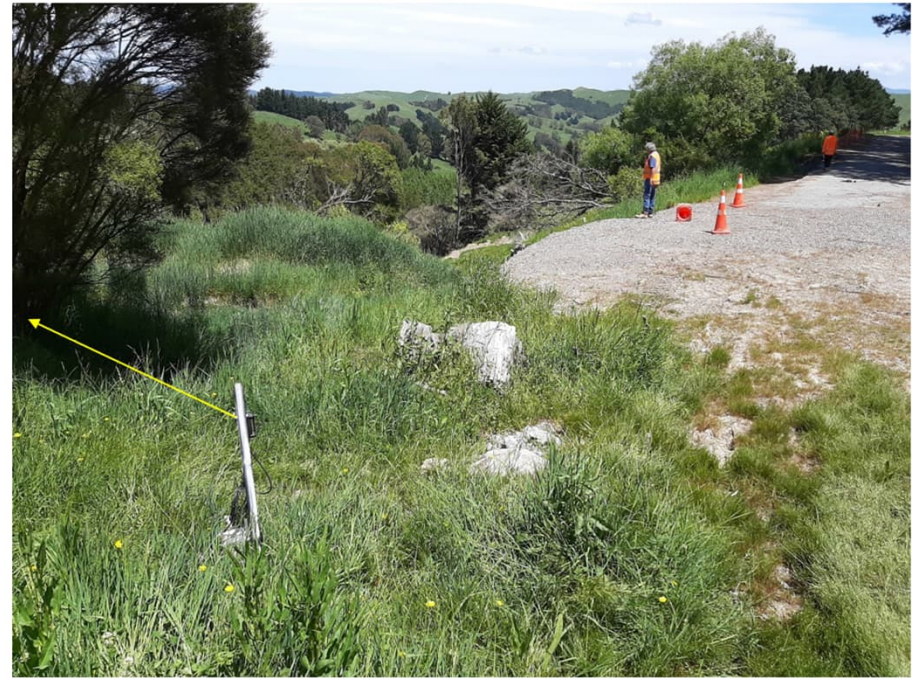
Extensometer 3 location

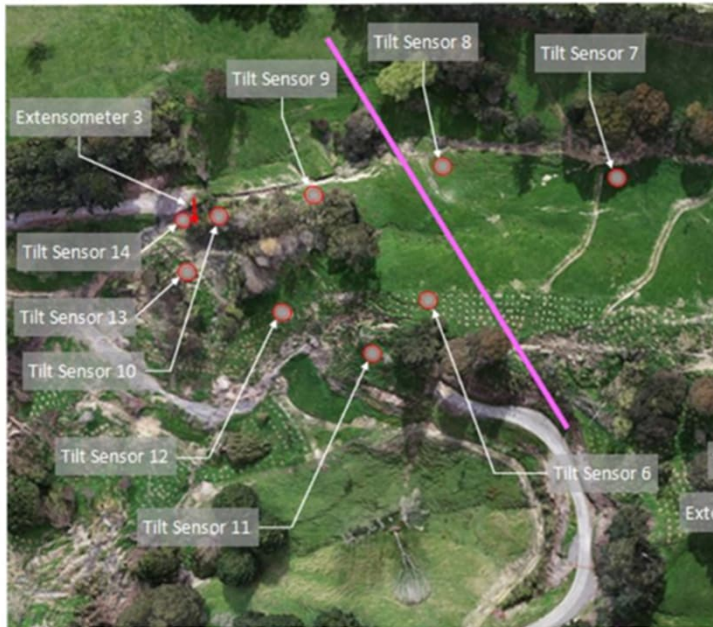
# Lower area data past 2 months

## LOWER SLIP

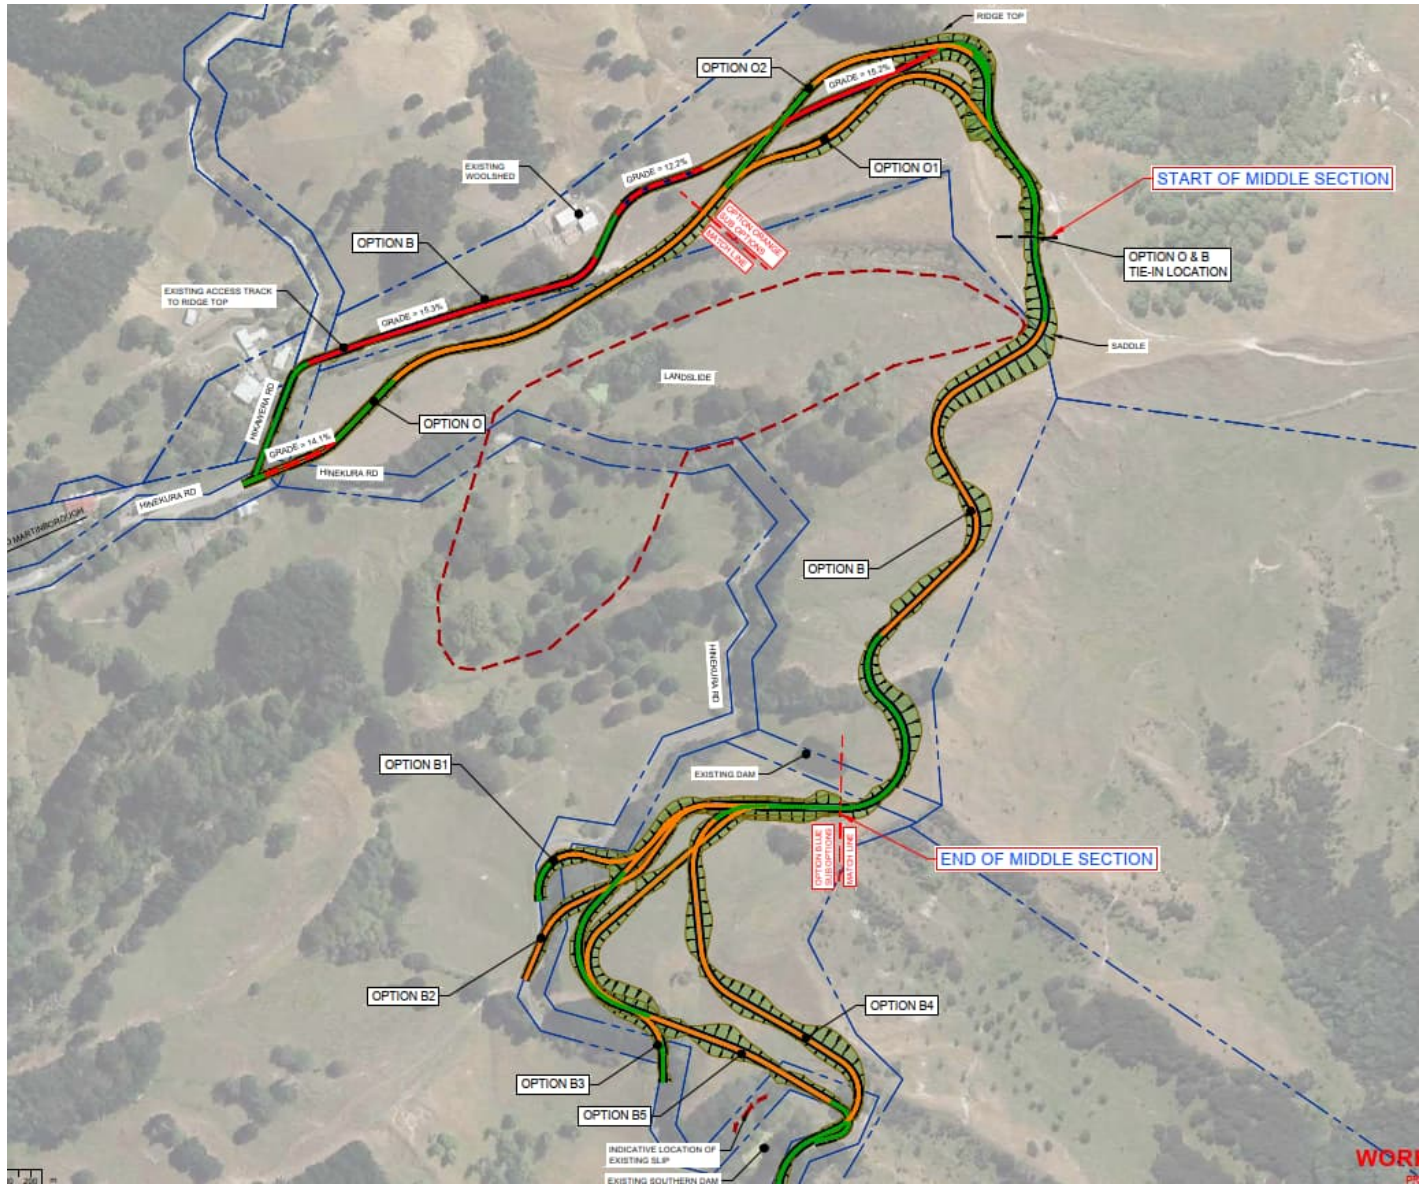
# Realignment Options (Sep / Oct 2022)

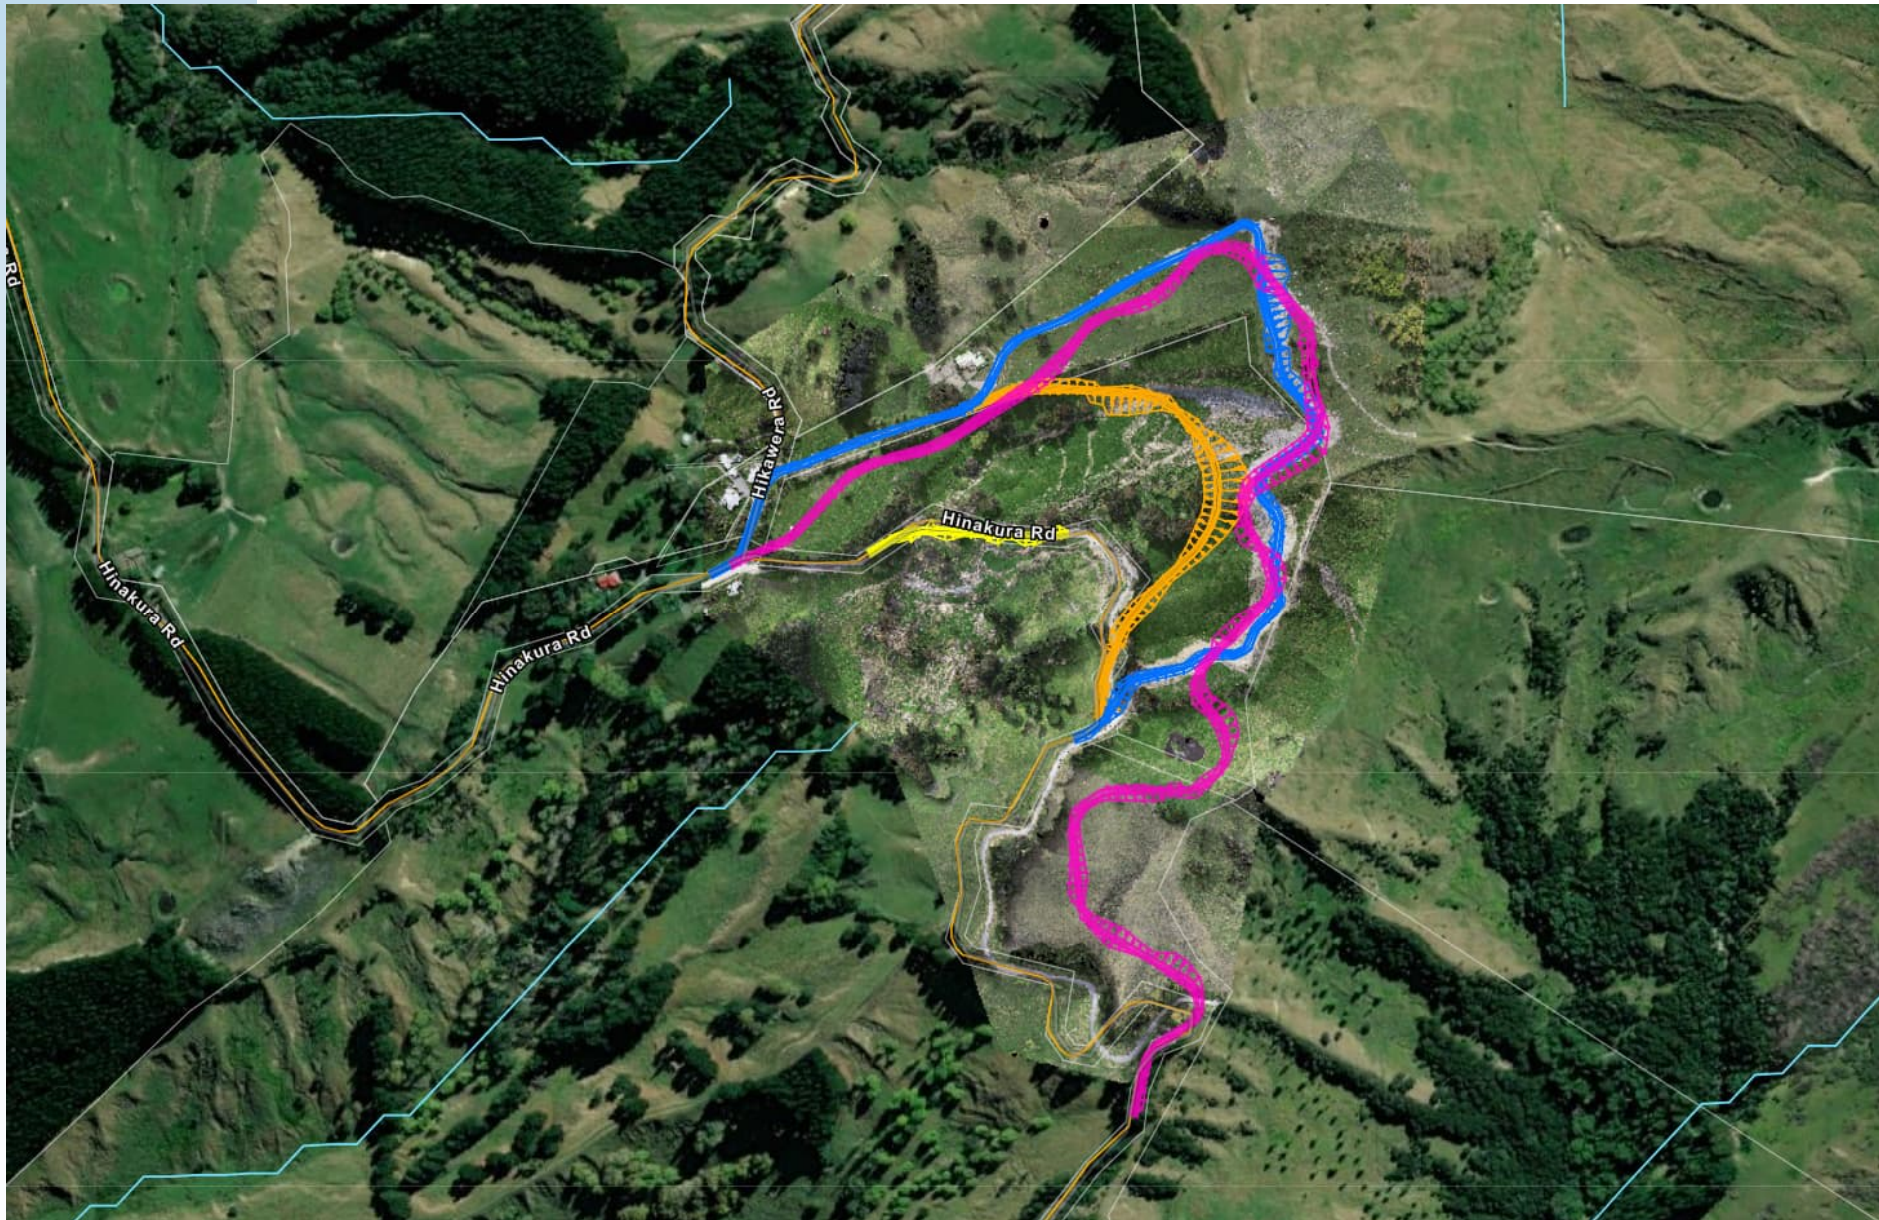
# Realignment Options - Shortlisted (Jan / Feb 2023)

Aspect		Option 1	Option 2	Option 3	Option 4	Option 5
Length		2.03 km	1.53 km	0.23 km	0.65 km	57 km
Horizontal Alignment	No. curves	19	28	2	4	Approximately 74 OCCC on the alternate route. Investigations required to identify if treatments are required and if so treatment type.
	% Of OCC	0%	25%	0%	0%	
	Min curve radius	32 m	15 m	100 m	80 m	
Vertical Alignment	No. of vertical curves	15	11	5	3	it was noticed that the vertical alignment was comfortable with only gradual inclines and declines
	% Of vertical grades $\geq 12\%$	33.3%	54.5%	20%	33.3%	
	Maximum Grade	14.15%	19.12%	12.0%	12.0%	
Earthworks	Predicted amount	Large amount	Earthworks may be required to bring the road to standard	Medium amount	Medium amount	Undefined amount
Slips/ Resilience		By passes the slip zone. Investigation and stabilisation work likely required	By passes the slip zone. Investigation and stabilisation work likely required	Traverses through current slip zone Stabilisation work will be required Underlips and over slips forming at the start of Hinekura Road so will require work there to stabilise	Traverses through the upper slip, if the landslide can be dug out to achieve stable ground	Various over slips and under slips and developing slips were identified during the site visit, however it was noted that these slips are not yet affecting the carriageway.
