SOUTH WAIRARAPA DISTRICT COUNCIL

7 JULY 2021

AGENDA ITEM C8**HINEKURA ROAD UPDATE****Purpose of Report**

To update the Committee on the current situation, progress made and plans to remedy the road drop at Hinekura Road.

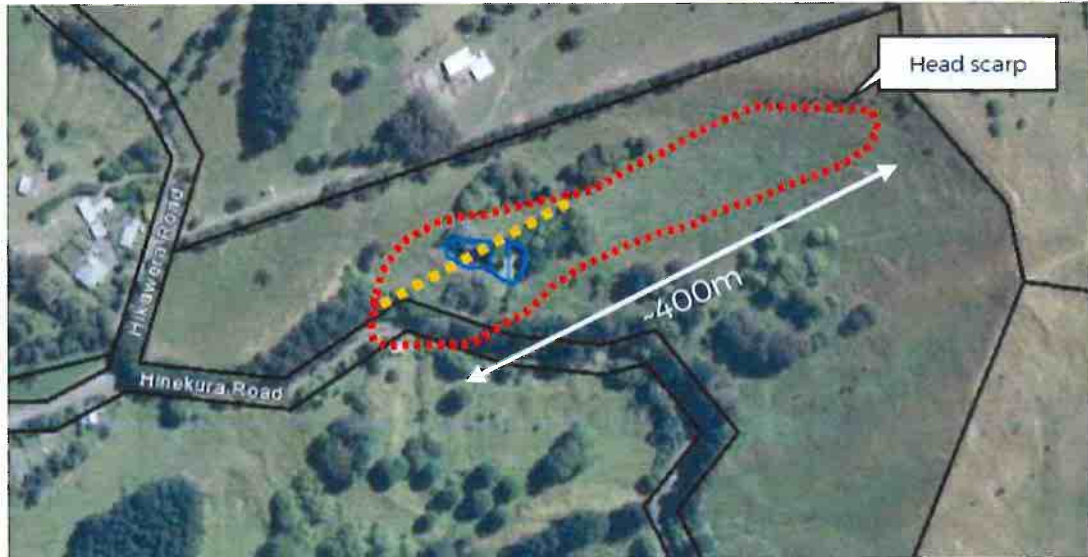
The area of the landslip is substantial (approx. 450m x 150m, shown in red, below) and includes the water supply for the property at 1673 Hinekura Road (shown in blue). The area requiring recent tree felling extends beyond this indicative red line.

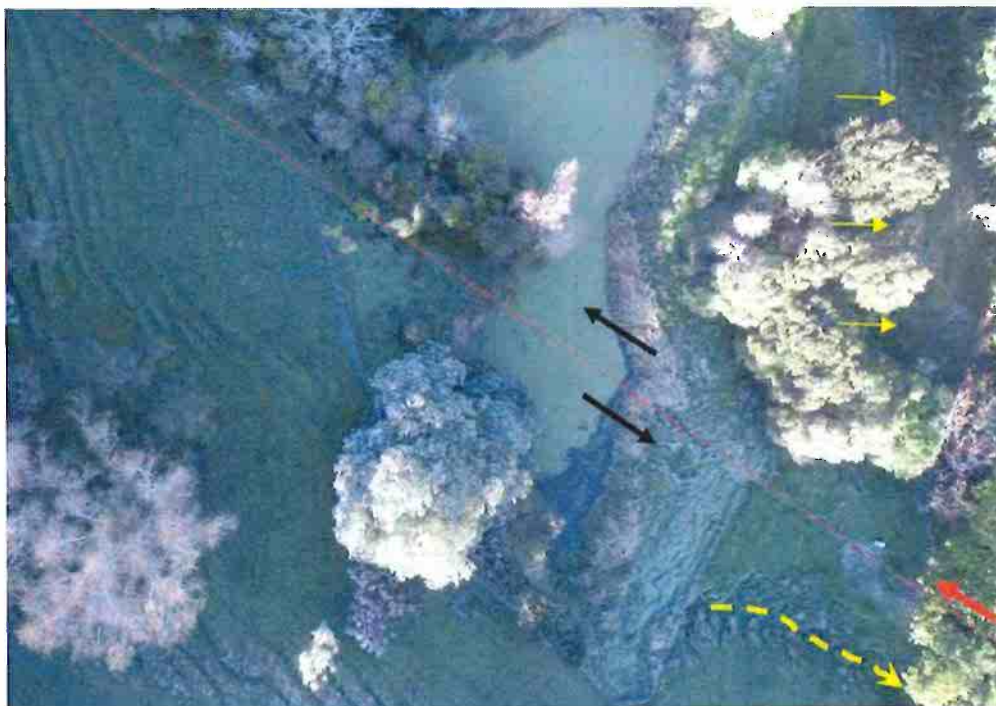
While some overflow from the dammed water supply is present (as identified by the yellow arrows), it is likely that water from above is also of concern, as shown by the tension cracking above the dam in the image, below. (The red and black lines identify a possible line of tension that may require further investigation.)

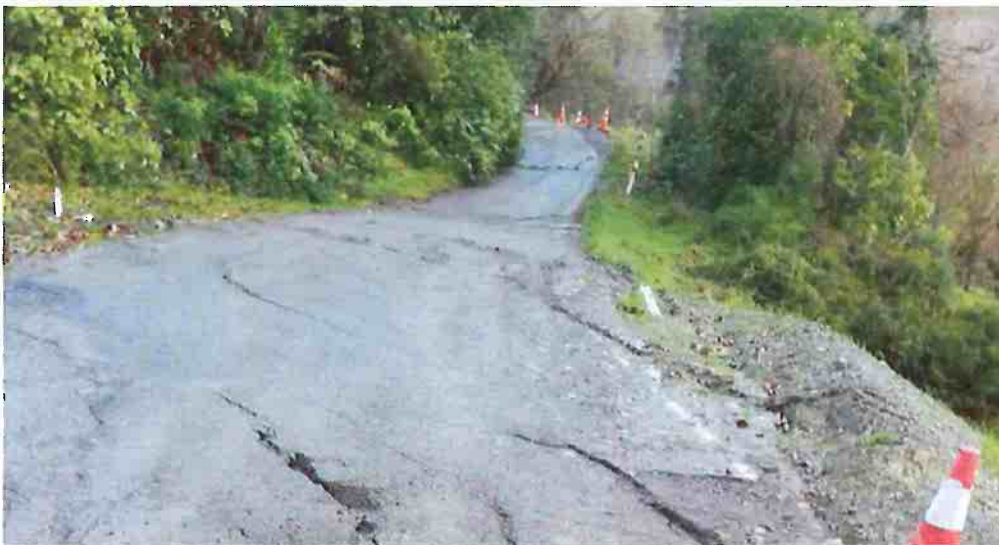
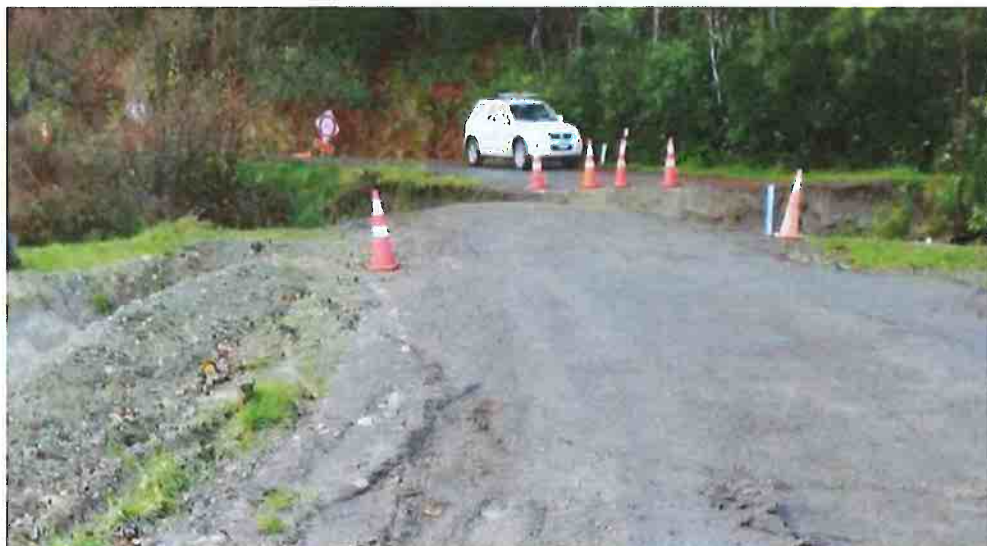
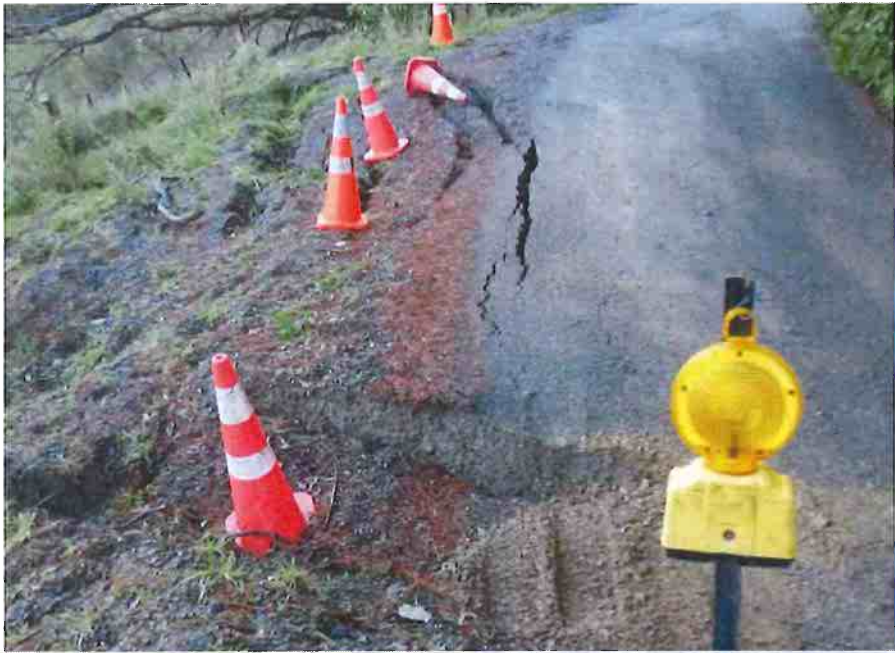
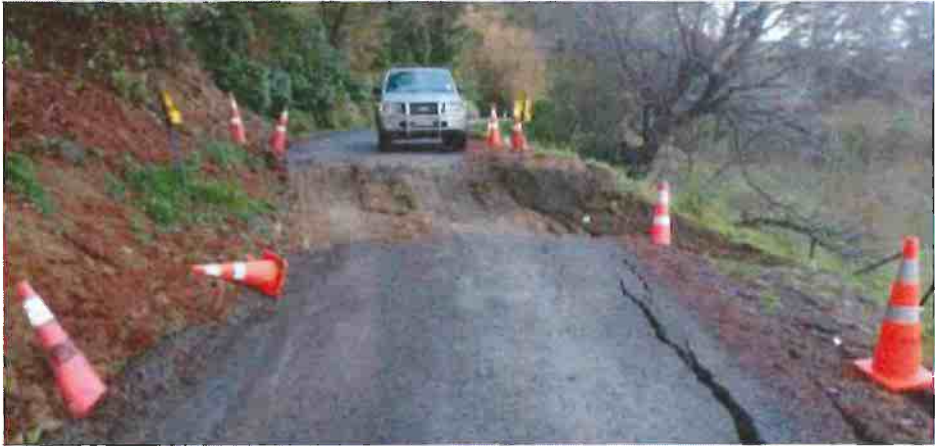
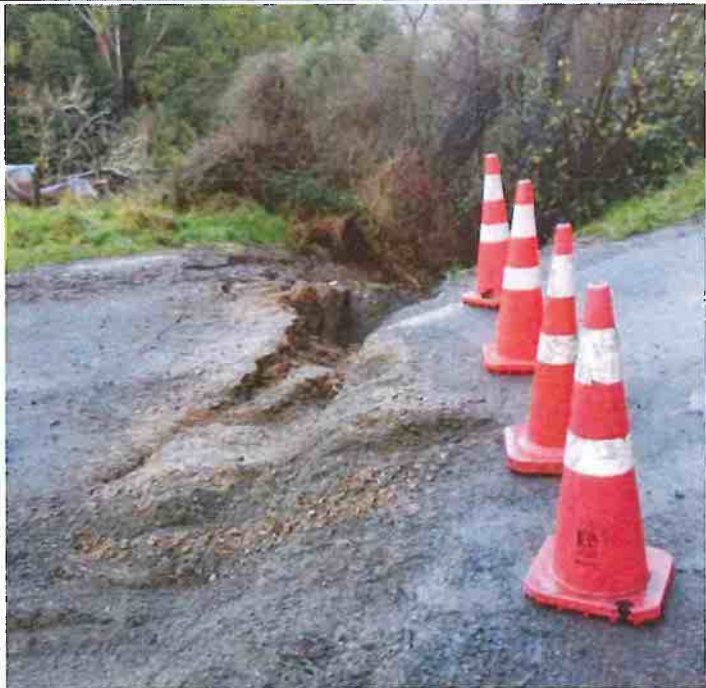
The survey marks were monitored and no movement was detected in the area. However, through the 21st to the 23rd of June 2021, the area experienced significant rainfall (160mm+) that resulted in the road area shifting by approximately a metre. The following images (23rd June) show that shift and cracking in the road surface:

With this shift, the road was closed to vehicle traffic due to the significant risk for further movement and alternative routes shared (noting these add significantly to user travel time). Since then we have been able to restore light vehicle access through the area by:

- Felling dangerous trees in the area (many leaning over or near the road) that presented additional risk (noting further trees have been removed this week),
- Continuing to clear drainage in the area (noting it can often refill after rain), and
- Metalling and cutting back the entry and exit points of the slip to allow for vehicle access and reduce loading on the slip itself.
