## **ASSETS AND SERVICES COMMITTEE**

### **Agenda**

- B1.** Draft Roding Activity Management Plan

| <b>C2.</b> | Cape Palliser Road Coastal Erosion Report | Pages 153-252 |

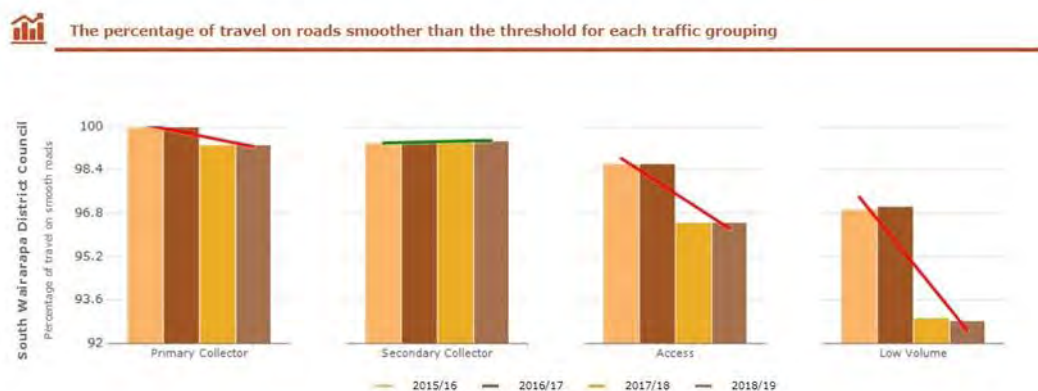
Table 8.1 Percentage of travel on roads smoother than the threshold for each road category

The decline in condition is occurring in the Low Volume and Access Roads at present. However, in time, this will occur in the Primary and Secondary Collector class of roads and at this point the deteriorating condition of the Road Network will become more visible to the Community.

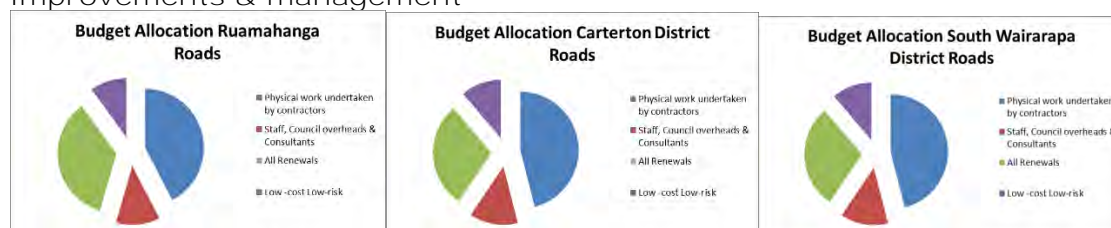
Figure 8.1 Allocation of maintenance budgets – Carterton & South Wairarapa networks

The following pie charts show the current split between activities for providing the roading network in the first three charts. The last two charts show the breakdown of the maintenance budget into work categories. Note the major part of the renewal funding is spent on replacing the road surfacing.

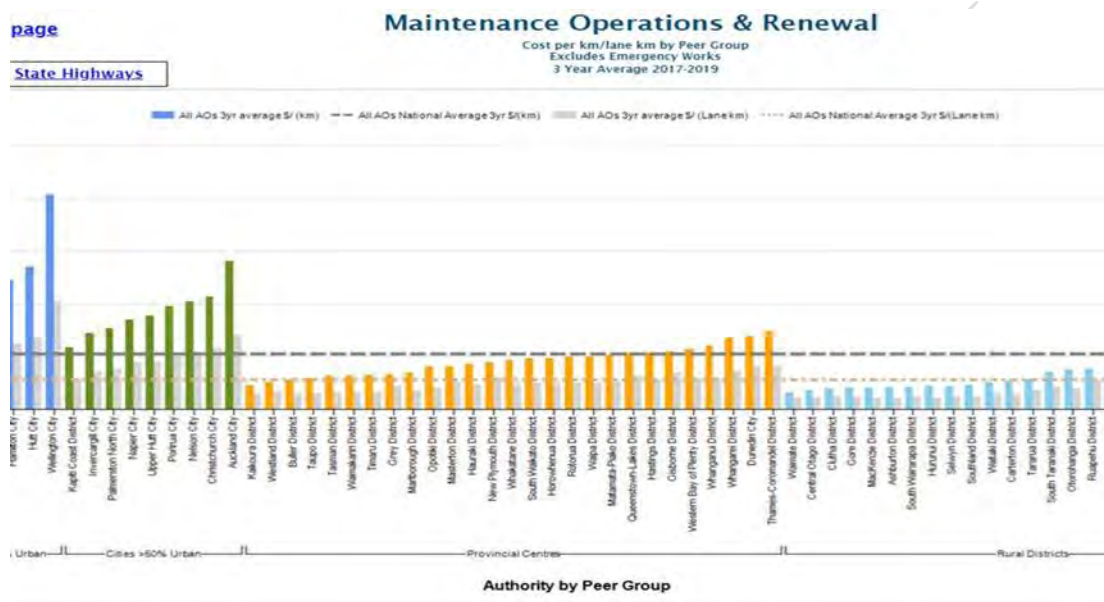
Figure 11.1 National Comparison of Maintenance & Renewal

The rates of asset renewal are above the mean in comparison with other councils. The Low Volume seal surfaces are required to last 12 years at the historic levels of renewal funding.

The historic level of funding for the Carterton & South Wairarapa Roding Network's maintenance and renewal has been very low compared to their peer group, see Figures 11.1 and 11.3. This means that the current strategy for maintenance and renewals is providing an efficient cost outcome. However, the condition surveys are showing a marked decrease in levels of service on low volume roads. The reduced amount of work that can be done because of increased contract rates means the decline in levels of service will increase unless action is taken to address the trend.

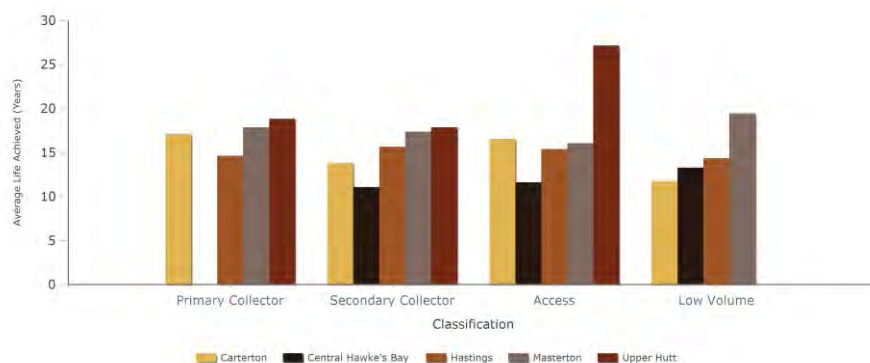
Figure 11.2 Carterton Chipseal resurfacing average life achieved, four-year average to 2018/19

The road condition, measured through the Smooth Travel Exposure (STE), is the highest amongst the Wairarapa Councils. This is particularly so for the Access and Low volume ONRC category roads.

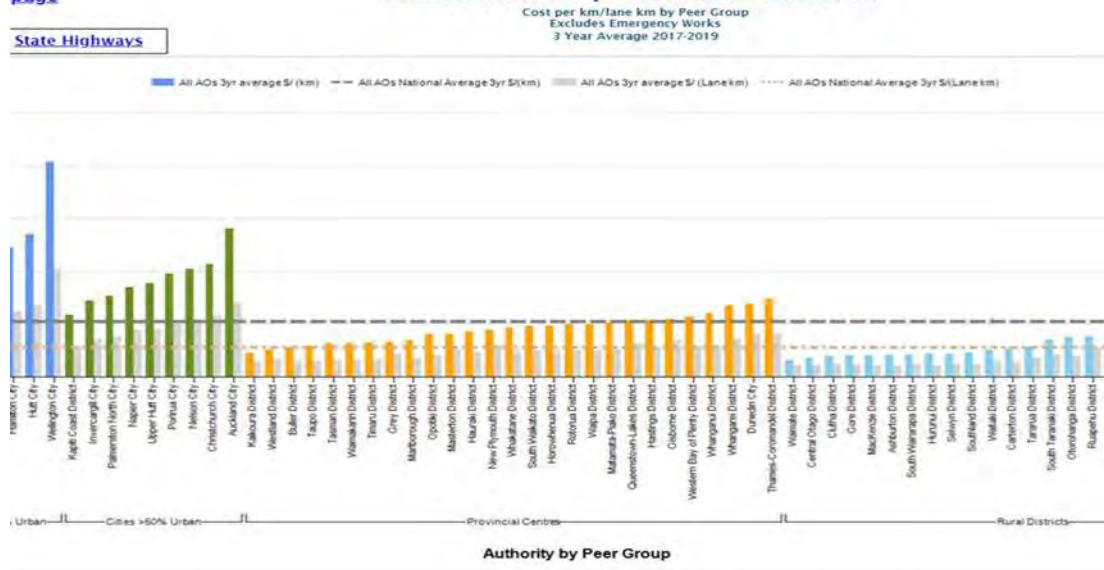
Figure 11.3 National Comparison of Maintenance & Renewal

The rates of asset renewal are also low in comparison with other councils. The Access and Low Volume seal surfaces are required to last 27 years at the historic levels of renewal funding, which is considered to be an unrealistic intervention level

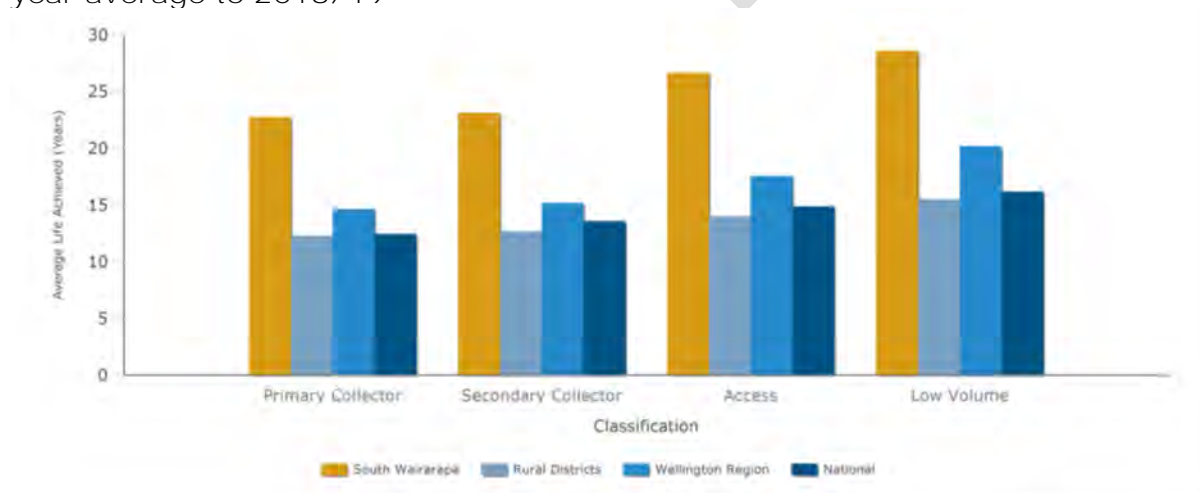
Figure 11.4 South Wairarapa Chipseal resurfacing average life achieved, four-year average to 2018/19

Previously the road condition, measured through the Smooth Travel Exposure (STE), equalled and exceeded the peer group average and was a significantly better result than the national average. However, over the last four years this measure shows the road network's condition is declining. This is particularly apparent for the Low Volume and Access road categories.

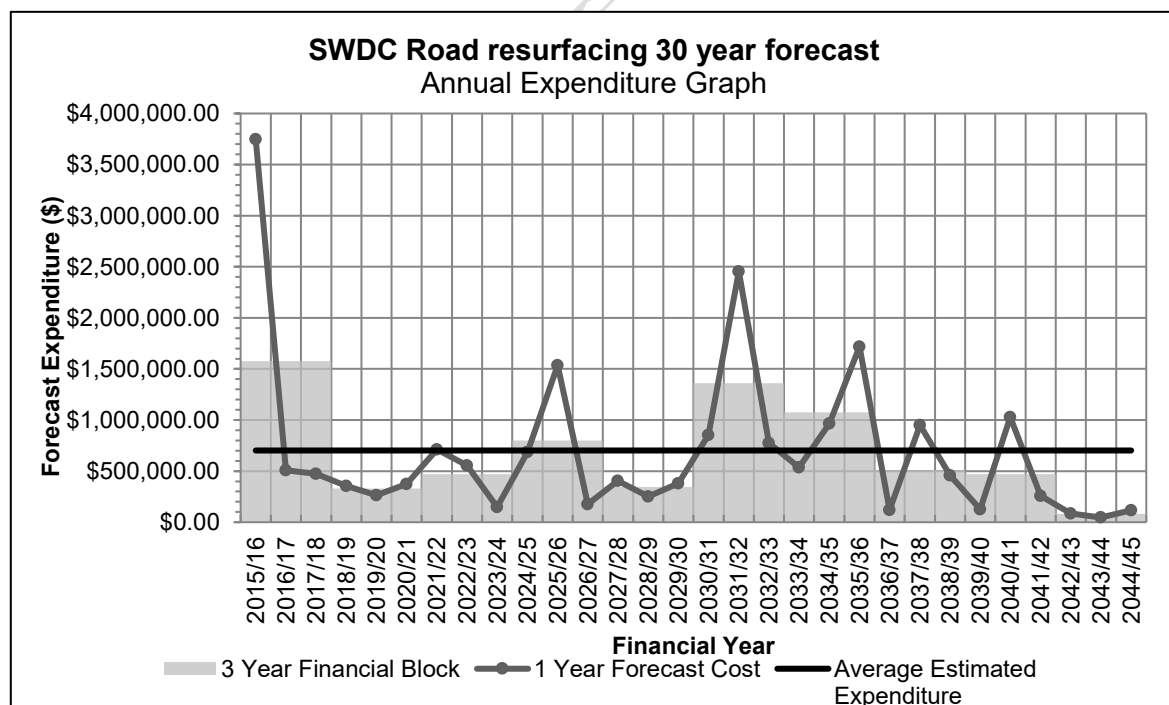
Figure 15.5 Road Resurfacing Forecast - SWDC

A constant level of expenditure equal to the average estimated expenditure will theoretically 'smooth' the renewal requirement over successive years. Also a constant level of expenditure enables simpler financial management of the renewal funding requirement.

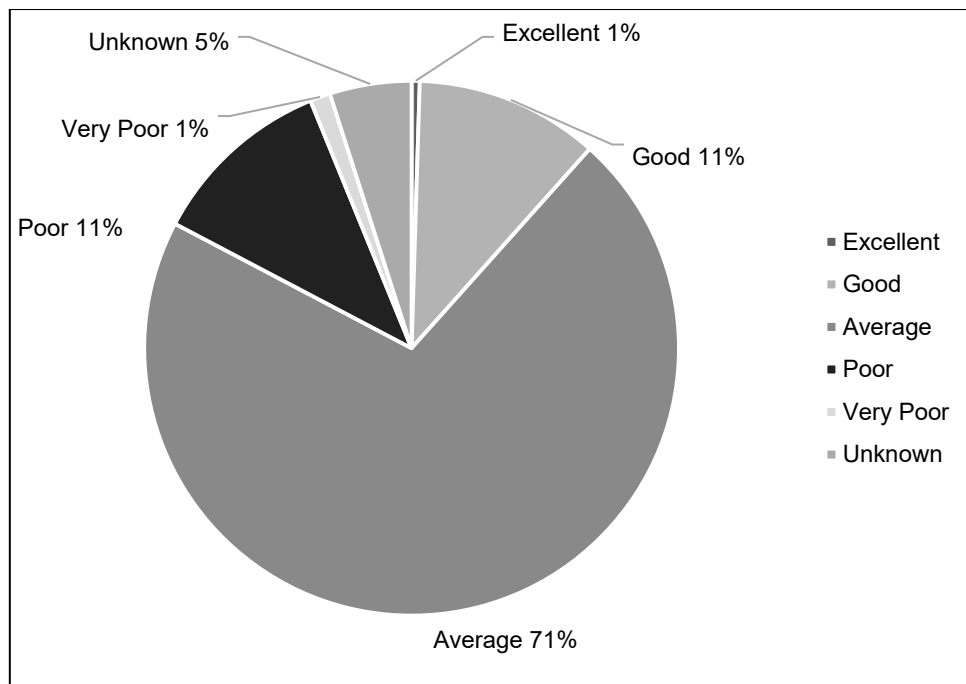
Figure 15.6 Condition - Small Culverts SWDC

The second Figure below shows the recorded condition of the small culverts on the South Wairarapa section of the network.

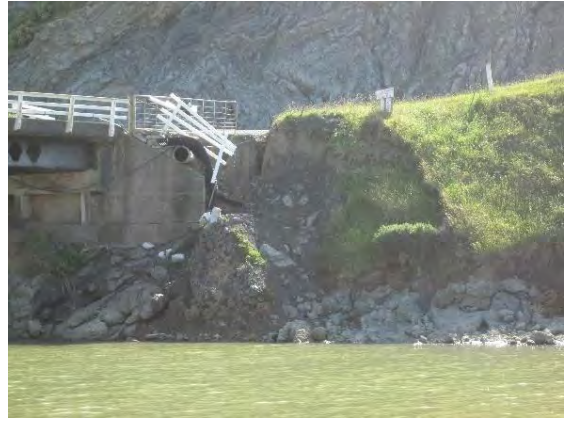
Te Awaiti Bridge abutment washout

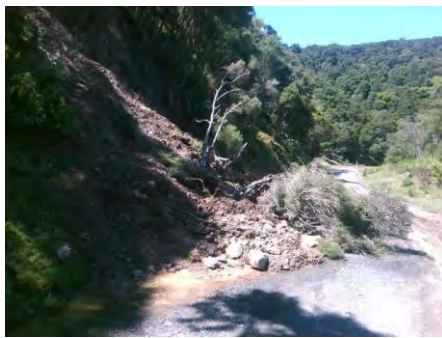
White Rock Rd slips

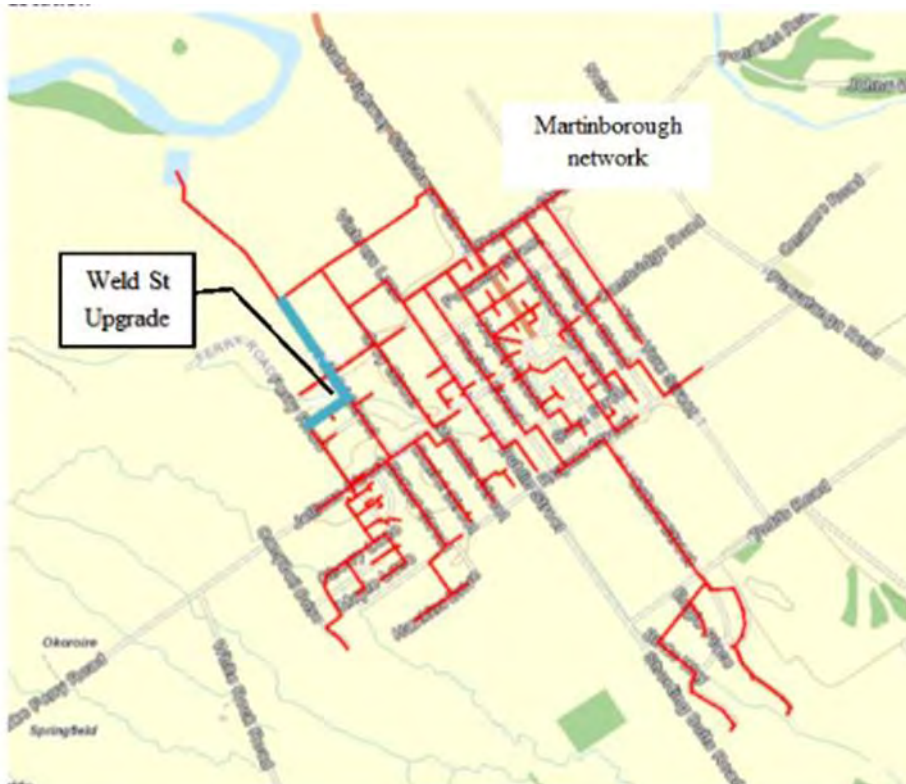
Replacing 0.7km of 150mm asbestos cement wastewater main with a 250mm polyethylene (PE) main in Weld Street, Martinborough.

The existing wastewater main in Weld Street carries wastewater from approximately the southern third of Martinborough. It is under-sized for the load, resulting in frequent blockages and occasional overflows from manholes during wet weather conditions.

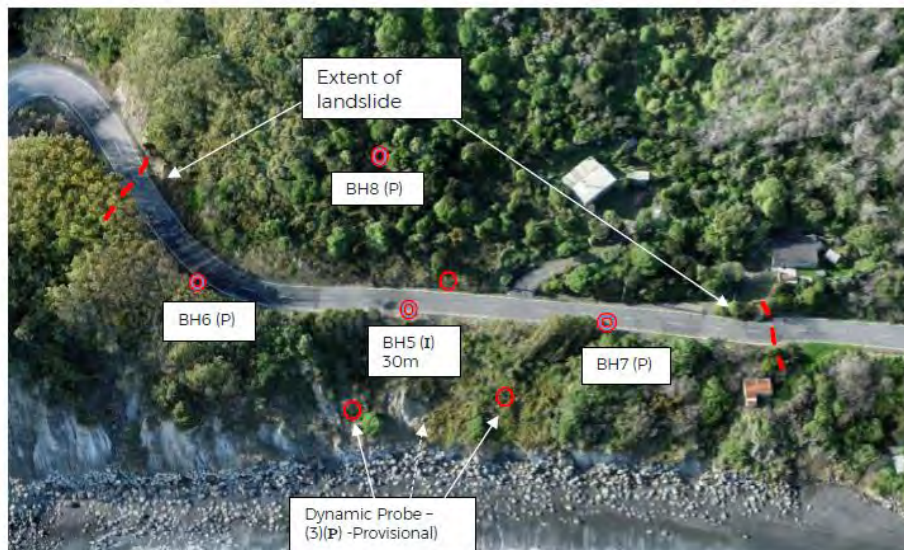
Figure 3: Active section of Te Kopi North landslide, with provisional location of boreholes (15-30m deep each), with inclinometers (I) proposed in one and standpipe piezometers (P) in three boreholes and probe holes.

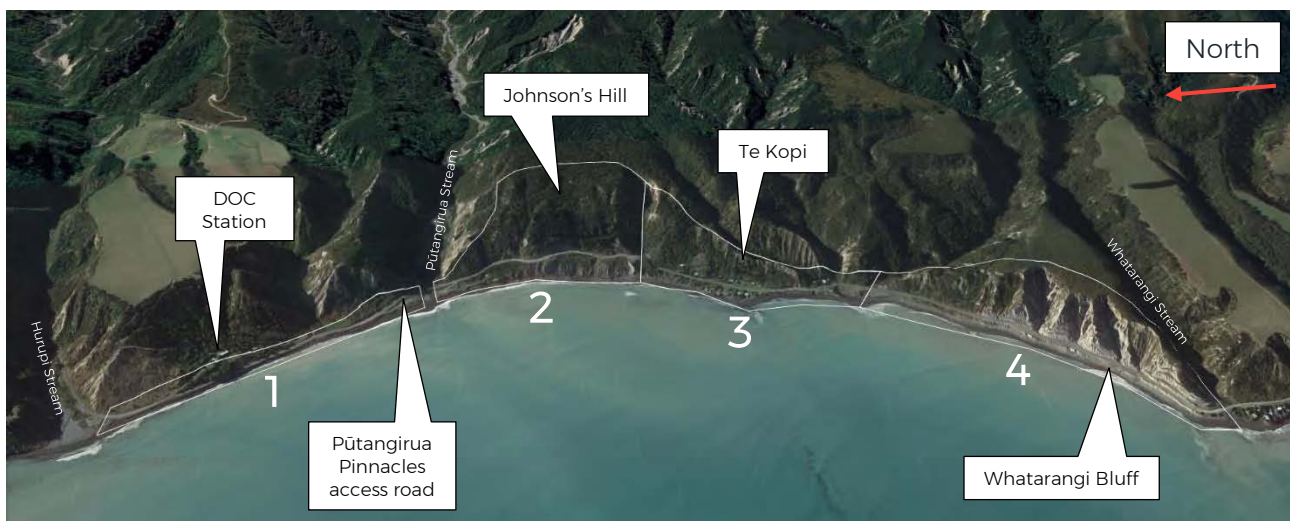
Figure 1: Site overview, showing the individual sections and the main geographical features referred to in this study (Google Earth, 2020)

We have divided the study area into four sections (Figure 1). Each of these is characterised by a different set of issues impacting the road.

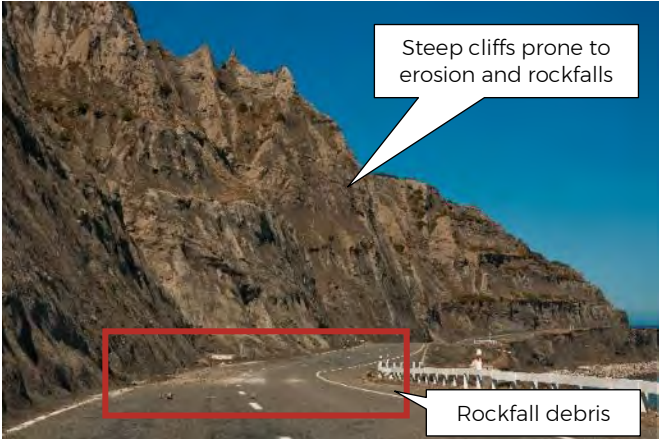
Whatarangi Bluff, March 1999 (Capper, 2011)	Slippage or small debris flows from erodible mudstone cut faces or rockfalls from harder bands, particularly in steep cut sections.  Sections impacted: Johnson's Hill (Section 2) Whatarangi Bluff (Section 4)	Generally acceptable as failures are generally relatively small to date and quick to clear, or easy to dodge debris due to low traffic volumes.
Wave overtopping, localised erosion and storm debris

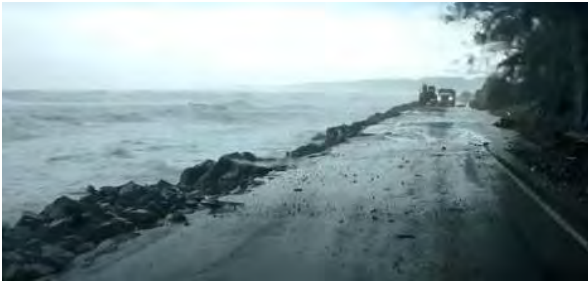
DOC Station, June 2013 (Actual Vision Ltd, 2013)	Wave overtopping the cliff, causing road damage and carrying debris from the beach onto the road during storm events.  Sections impacted: DOC Station (Section 1) Te Kopi (Section 3)	Both wave and debris overtopping affect the level of service of the road and can put people and vehicles at risk. Risk from debris is presently generally acceptable to SWDC as debris volumes are relatively small and can be removed quickly. The risk level is expected to remain acceptable over the coming ~5-10 years, but a potential increase in debris volumes may become less acceptable in the medium to long term if sea level rises and storm event frequency increases.

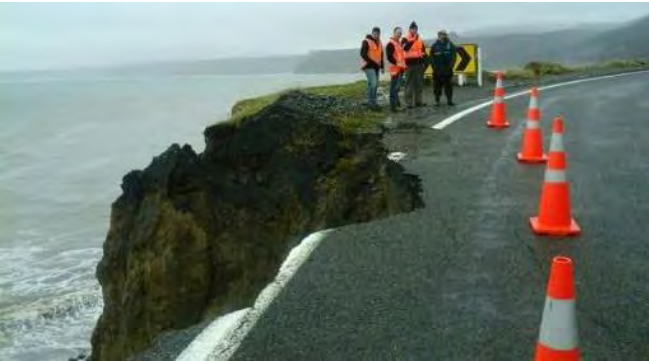
Whatarangi Bluff, September 2015 (Stuff, 2015)	Destabilisation and slumping of slopes below the road eating into the carriageway, related to coastal erosion at the base of the sea cliff and to groundwater seepages daylighting on the cliff face  Sections impacted: DOC Station (Section 1) Te Kopi (Section 3) Whatarangi Bluff (Section 4)	Consequences of localised erosion may lead to significant road width eroded away, which can pose at risk people and vehicle safety if, for instance, a vehicle drives into a non-existent (eroded) section of road.  Due to the low likelihood of significant road widths being removed at once, risk tolerances will vary depending on the extent of road affected.  Underslips impacting the shoulder or one lane may be broadly tolerable with some traffic management controls.  Whole road closure for multiple days is not likely to be acceptable as there are no alternative access routes.

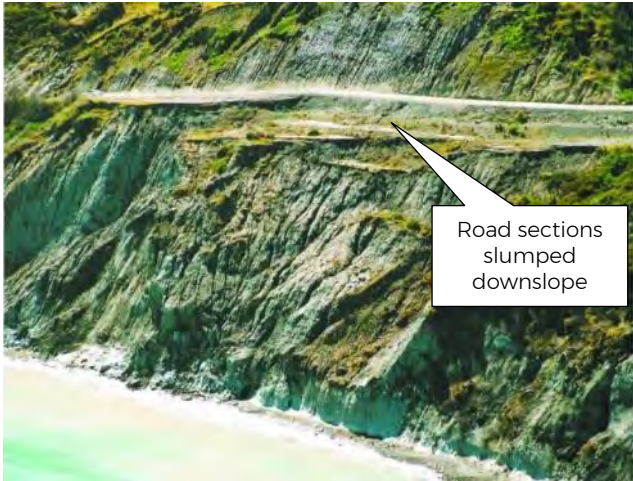
Johnson's Hill Landslide, ongoing (WELA, 2003)	Larger-scale movement of unstable slopes that the road is located on.  Sections impacted: Johnson's Hill (Section 2.3) Te Kopi (Section 3.2)	Varies depending on the extent of road affected and the amount of dropping of the road. Significant earthquakes (e.g. Kaikōura 2016) and saturation following significant rainfall (e.g. winter 1995) increase movement and risk.  Landslide movement at Johnson's Hill and the north end of Te Kopi typically causes grade changes within the road, which can result in rough ride, loss of control, damage vehicle undercarriages or in the worst case make the road impassable.  In the worst case, mass evacuation of the landslide and road may result in longer-term road closure or fatalities.  Johnson's Hill landslide has been the most problematic while at the north end of Te Kopi (Section 3.2) settlement of the pavement seems to be gradual and is currently resulting in reduced level of service only.

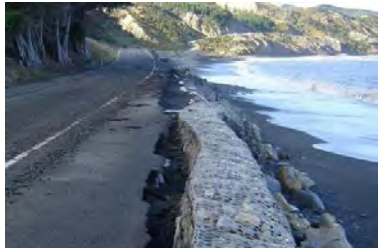
Gabions

(NZ Herald, 2013)	Wire mesh baskets filled with rocks, placed in front of slopes to absorb wave energy.	DOC Station – currently present	Not a good long-term solution, as they become undermined and outflanked as per photo. The current state of most of the gabions along Cape Palliser Road can be considered failed structures.
Groynes

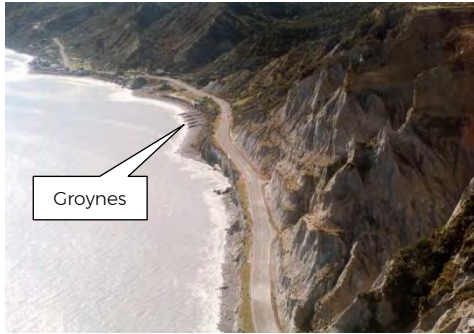
(Wairarapa Times-Age, 1995)	Elongate structures placed perpendicular or oblique to the shoreline, to induce beach accretion by retaining part of the along-shore sediment transport.	Whatarangi Bluff – groynes were in place prior to 1995 but are no longer present	The groyne structures may have contributed to either beach accretion or erosion in the past. With the information available, it is not possible to make comments on the performance of these coastal structures.
Boulder beach / rip rap

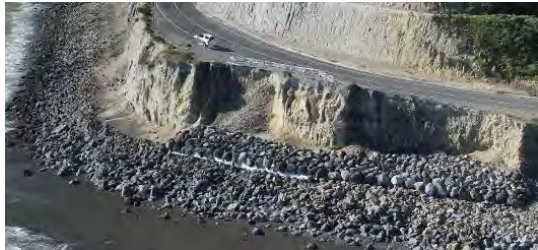
(WSP UAV imagery, 2020)	Engineered, interlocking rock armour which helps with wave energy dissipation and protects from coastal erosion.	Section: 1. 100% of length 2. Historically used, no recent rip rap 3. Some rip rap was installed in 1999 at Te Kopi 4. Multiple layers used since 2009 - buried at base of cliff (as per SWDC drawings)	The current rock rip-rap design, together with the lack of maintenance, lead to a current structural failure and poor performance of the structure. Cape Palliser Road has numerous compromised sections – particularly in Section 1, but also in Section 4

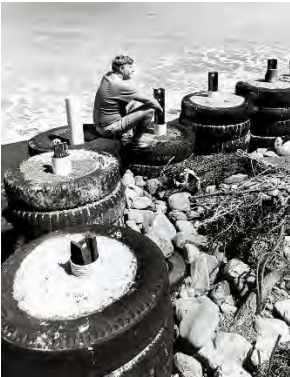
(Duggan, 1994)	Other structures installed to absorb and deflect wave energy, including tyres and non-engineered rock armour.	Near private residences – tyre barriers were installed in the early 1990s at Te Kopi	Due to the lack of information, it is not possible to comment on the performance of such measure.
Drainage measures

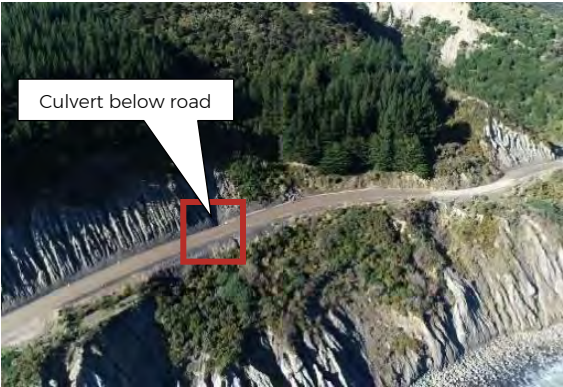
(WSP UAV imagery, 2020)	<p>To intercept and redirect groundwater and / or surface water from slopes to improve slope stability.</p> <p>Existing and previous measures:</p> <ol style="list-style-type: none"><li>1. Drilled sub-horizontal drains</li><li>2. Swales and surface cut-off drains</li><li>3. Subsoil cut-off drains</li><li>4. Culverts with long outlet pipes to discharge on more stable ground</li><li>5. Planting to remove moisture from soil</li></ol> <p>Other Options:</p> <ol style="list-style-type: none"><li>6. Pumpwells</li></ol>	Johnson's Hill – measures 1 to 5 are currently present in various states/condition, with a new subsoil drain installed in May 2020.	<p>Measures need to be located strategically to target groundwater and/or surface sources that are affecting stability.</p> <p>Measures require maintenance; drainage may be destroyed or blocked, while outlet pipes may not remain in optimum locations.</p>

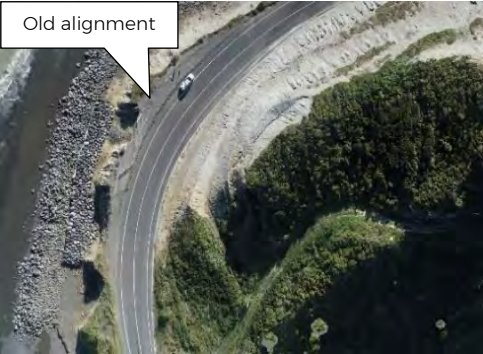
(WSP UAV imagery, 2020)	Repositioning of the road further back from the cliff edge, to reduce the risk of road sections collapsing due to erosion.	Multiple sections – recent realignment at Whatarangi Bluff after a drop out in 2015	Creating a larger buffer zone between cliff edge and road reduces the risk of road erosion and overtopping.

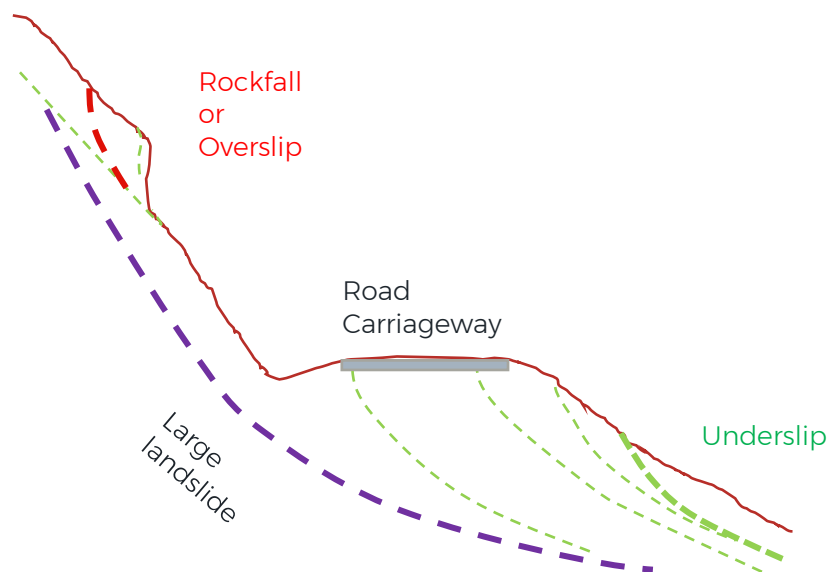
Figure 2: Different categories of instability, with respect to the road carriageway

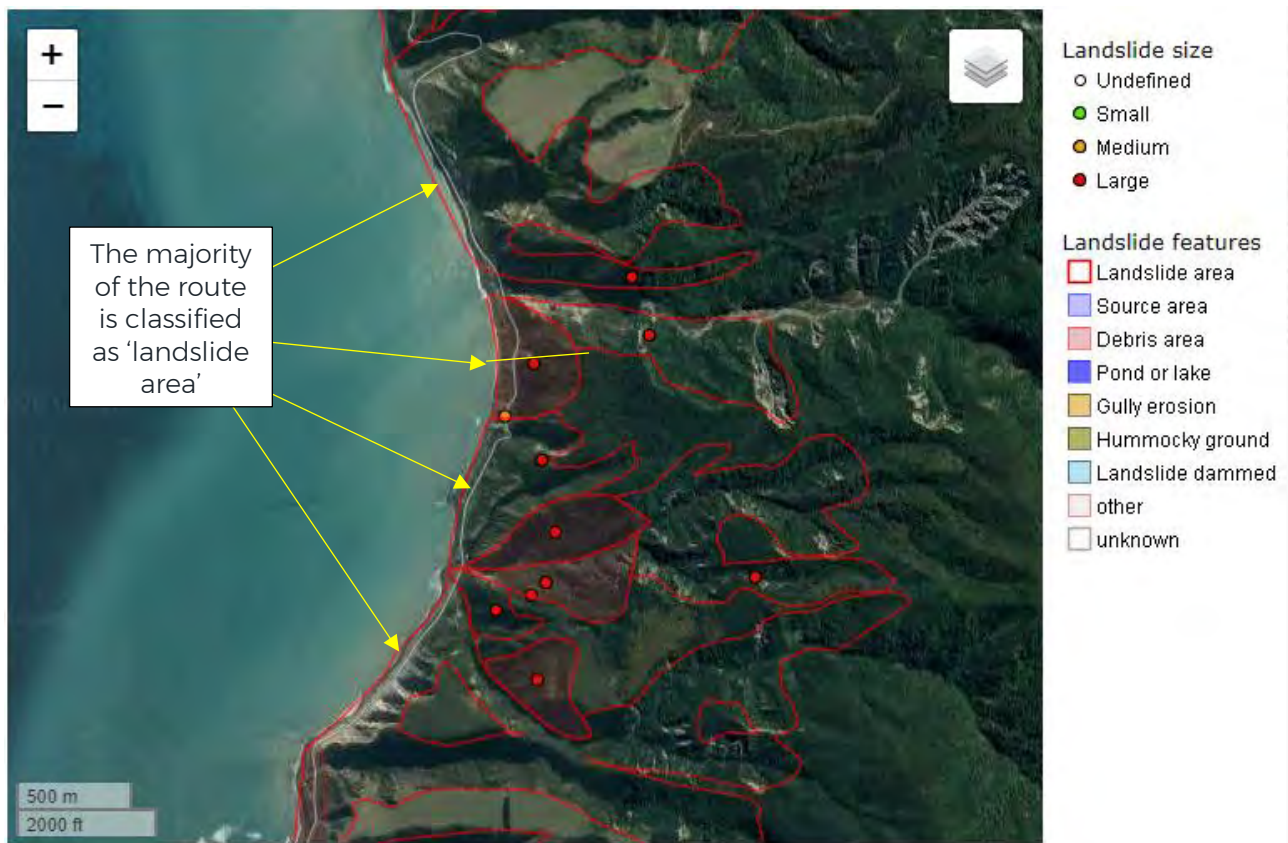
Figure 3: The study area as seen in the GNS landslide database.

GNS Science have a National Landslide Database (GNS, 2019) which shows landscapes that GNS have assessed as being caused by landsliding. The majority of the current Cape Palliser Road study area is shown by GNS as 'landslide area' (Figure 3). Our understanding is that these refer to sites where land sliding has long ceased as well as sites which may still be active. The level of activity is not shown on GNS's map.

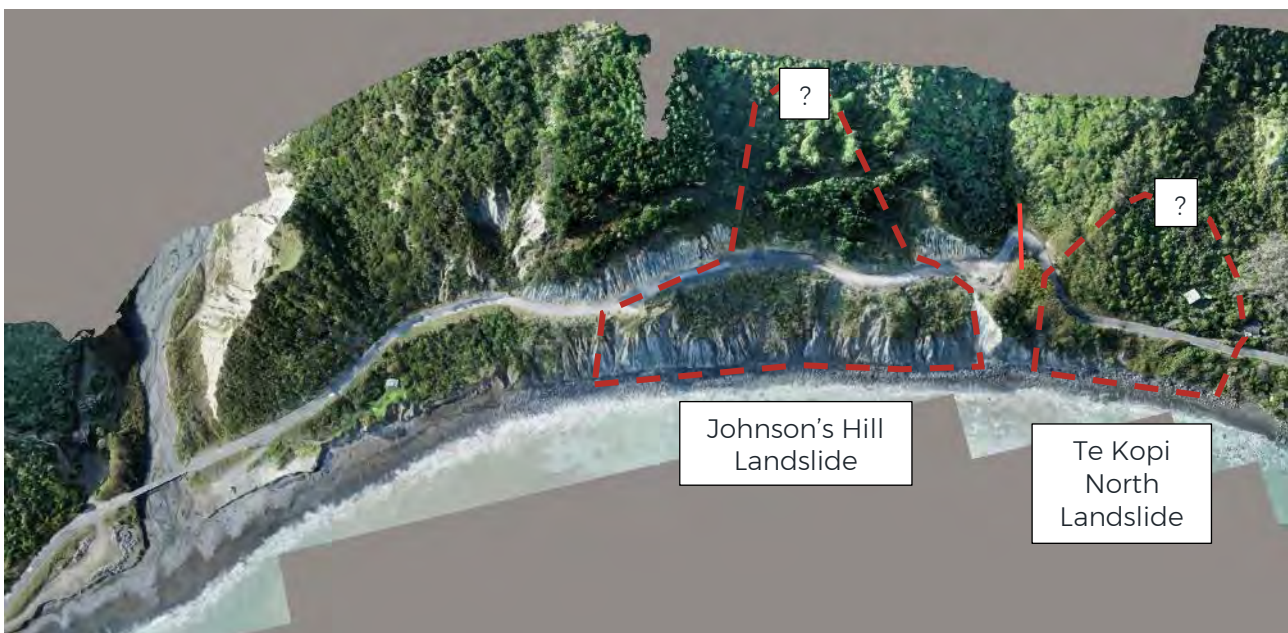
Figure 4: The indicative extent of the two large active landslides on Johnson's Hill and the northern end of Te Kopi. Lateral extent is well defined from observed side scarps within the road (abrupt changes in gradient). Upslope extent is not well defined.

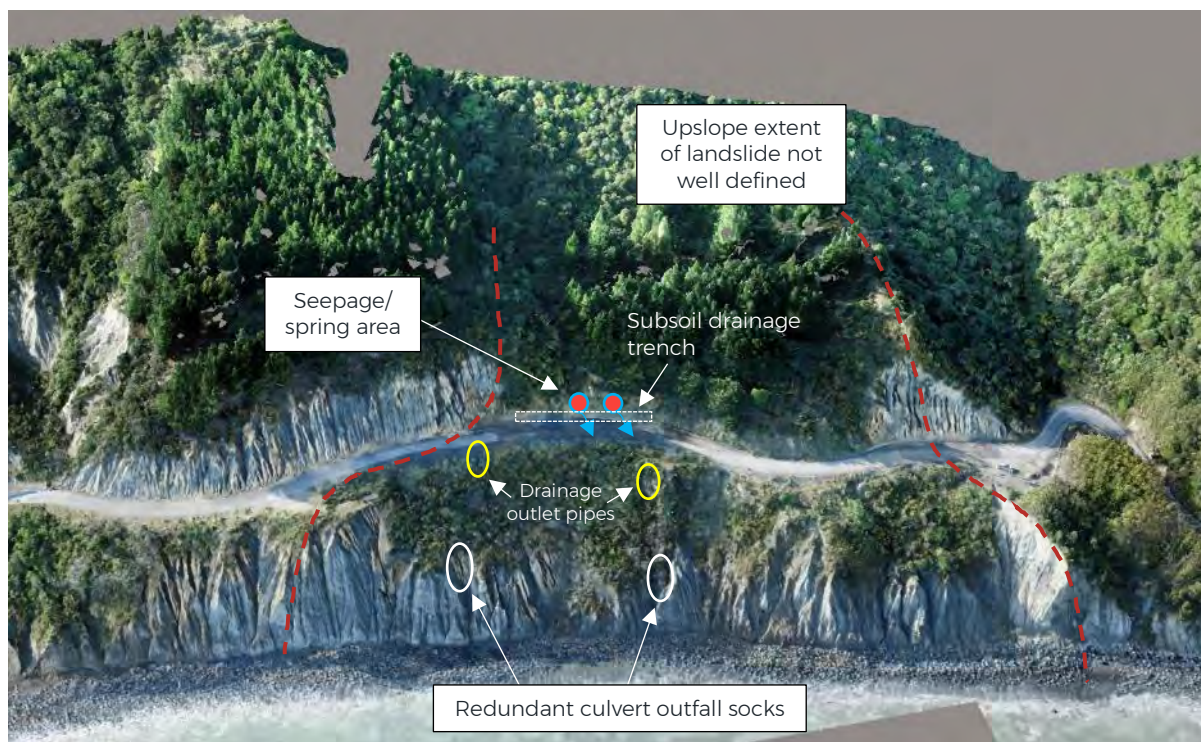
Figure 5: Active section of Johnson's Hill landslide, with various drainage features shown.

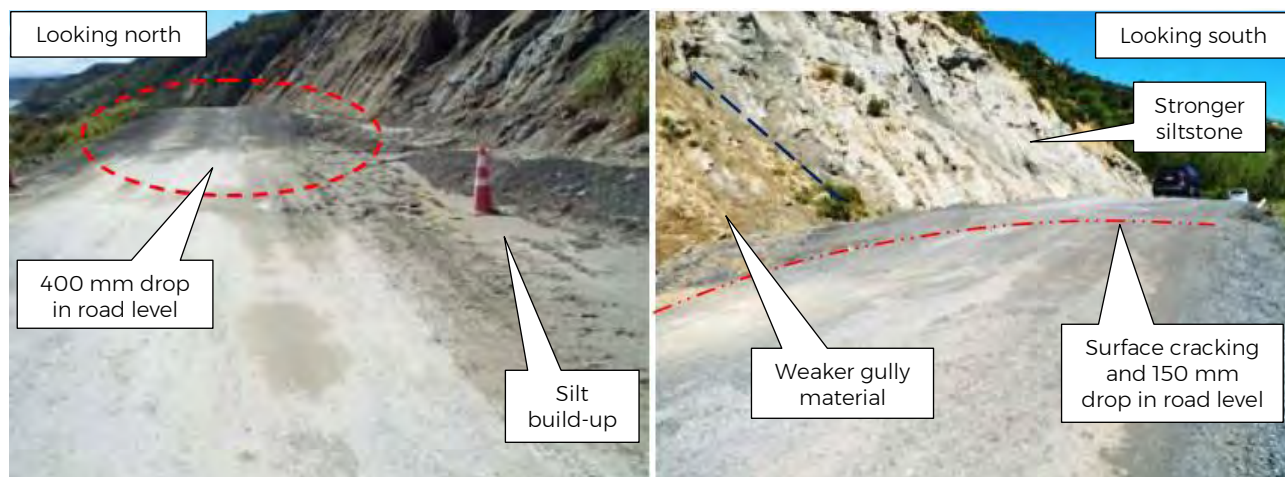
Figure 6: Views north and south along Cape Palliser Road at the Johnson's Hill landslide (Samcon, 2018).

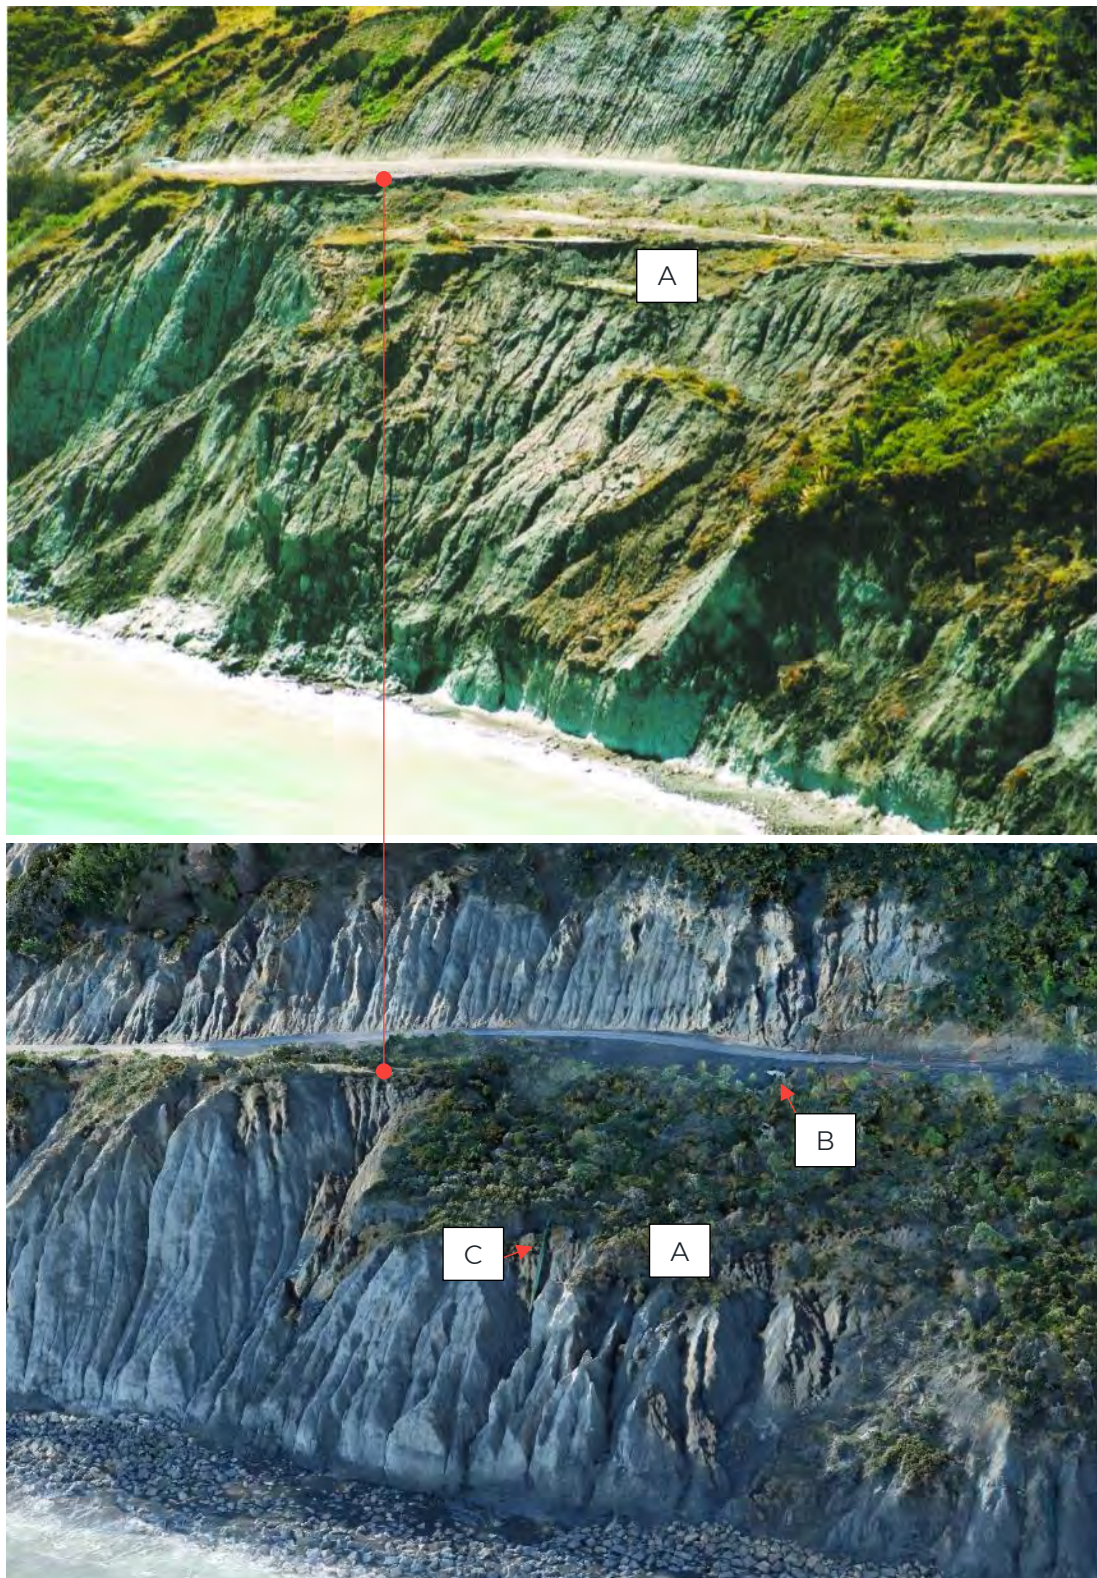
Figure 7: Images from 2003 and 2020 showing the development of the Johnson's Hill landslide. Note that slumped old road benches in 2003 at A have all but disappeared - down the slope as at 2020. Note the extent of rill erosion in 2020. B is culvert outlet. C is the redundant outlet sock.

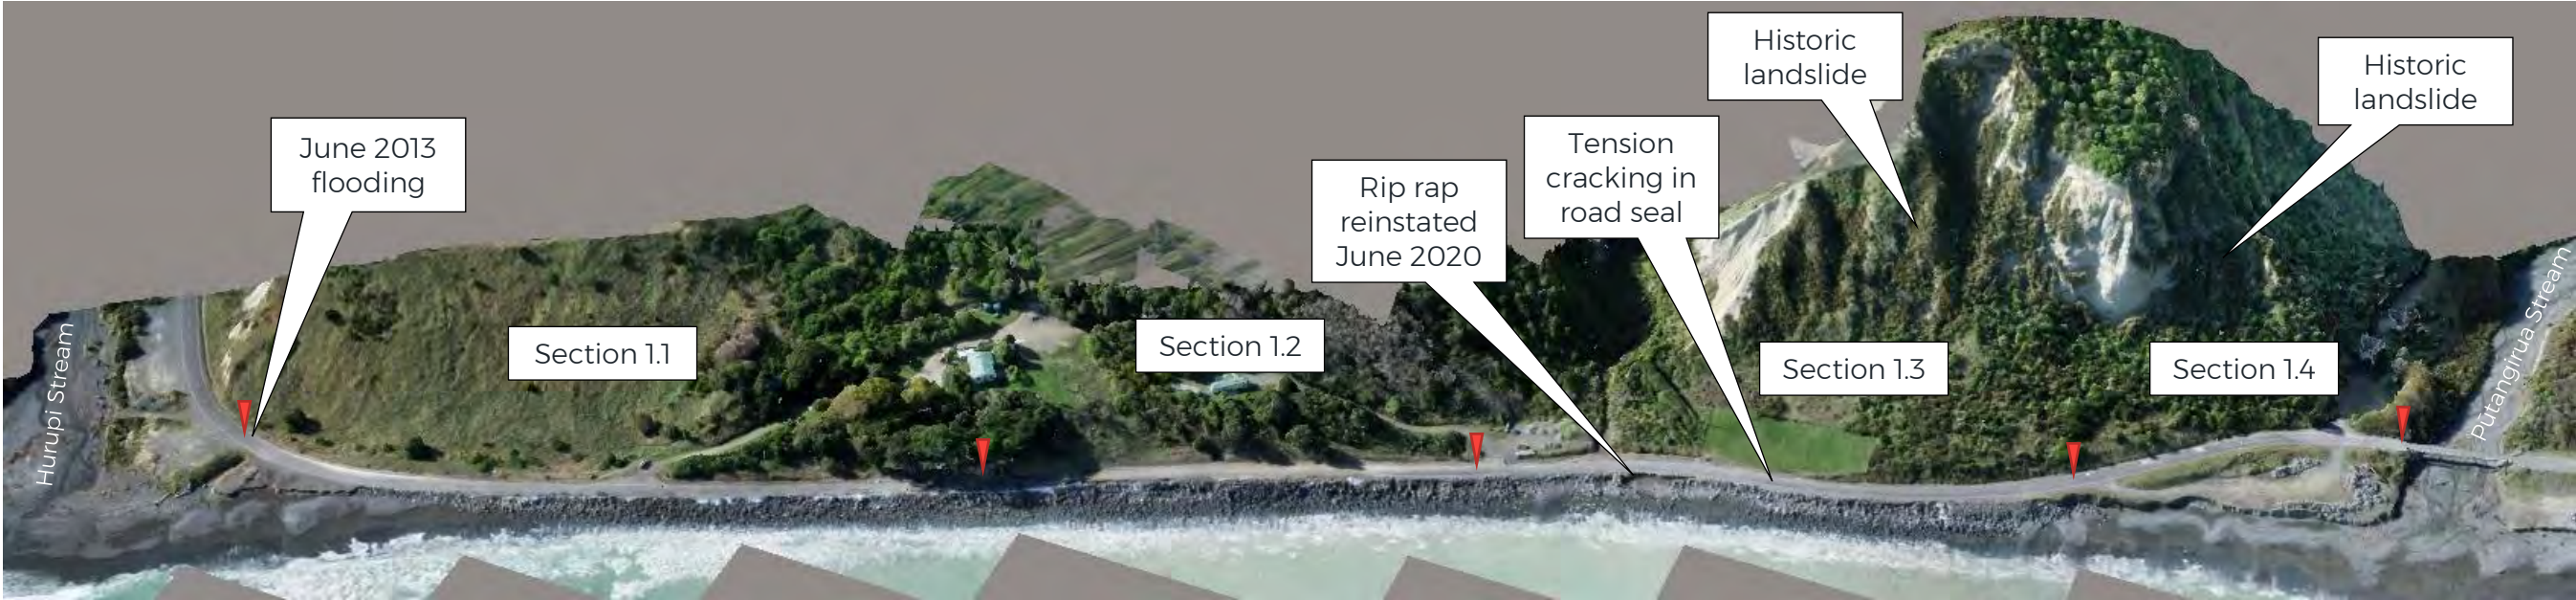
Section 1.1	Section 1.2	Section 1.3	Section 1.4
RP Extents		12.56 to 12.86	12.86 to 13.04	13.04 to 13.30	13.30 to 13.44
Road Elevation (NZGD/NZTM2000)		4.2 m to 5.0 m	4.6 m to 7.0 m	4.6 m to 6.9 m	6.9 m to 8.6 m
Structures below the road		Rip rap – poor condition Gabions – occasional, very poor condition	Rip rap – poor to moderate condition Gabions – occasional, poor condition	Rip rap – poor to moderate condition Gabions – occasional, very poor condition	None
Risk to the road relating to:	Slopes above the road	Low risk – shallow slope. Wide shoulder.	Low to moderate risk – shallow to moderate slope. Narrow shoulder.	Low to moderate risk – shallow to moderate slope. Wide shoulder. Historic landslide on upper slope above southern end.	Low to moderate risk – shallow to moderate slope. Wide shoulder. Historic landslide on upper slope.
	Slopes below the road	Moderate risk – low but steep slope, overhanging in places. Very narrow shoulder. Rip rap and gabions undermined. Wave overtopping may damage the road during storm events.	Moderate risk – low but steep slope, overhanging in places. Very narrow shoulder. Rip rap and gabions undermined.	Moderate to high risk – low but steep slope, overhanging in places. Very narrow shoulder. Rip rap and gabions undermined. Wave overtopping may damage the road during storm events. Tension cracks and settling across ~1/4 of seal width.	Low risk – low, shallow slope. Wide shoulder, buffer zone to erode before road coastal erosion happens.

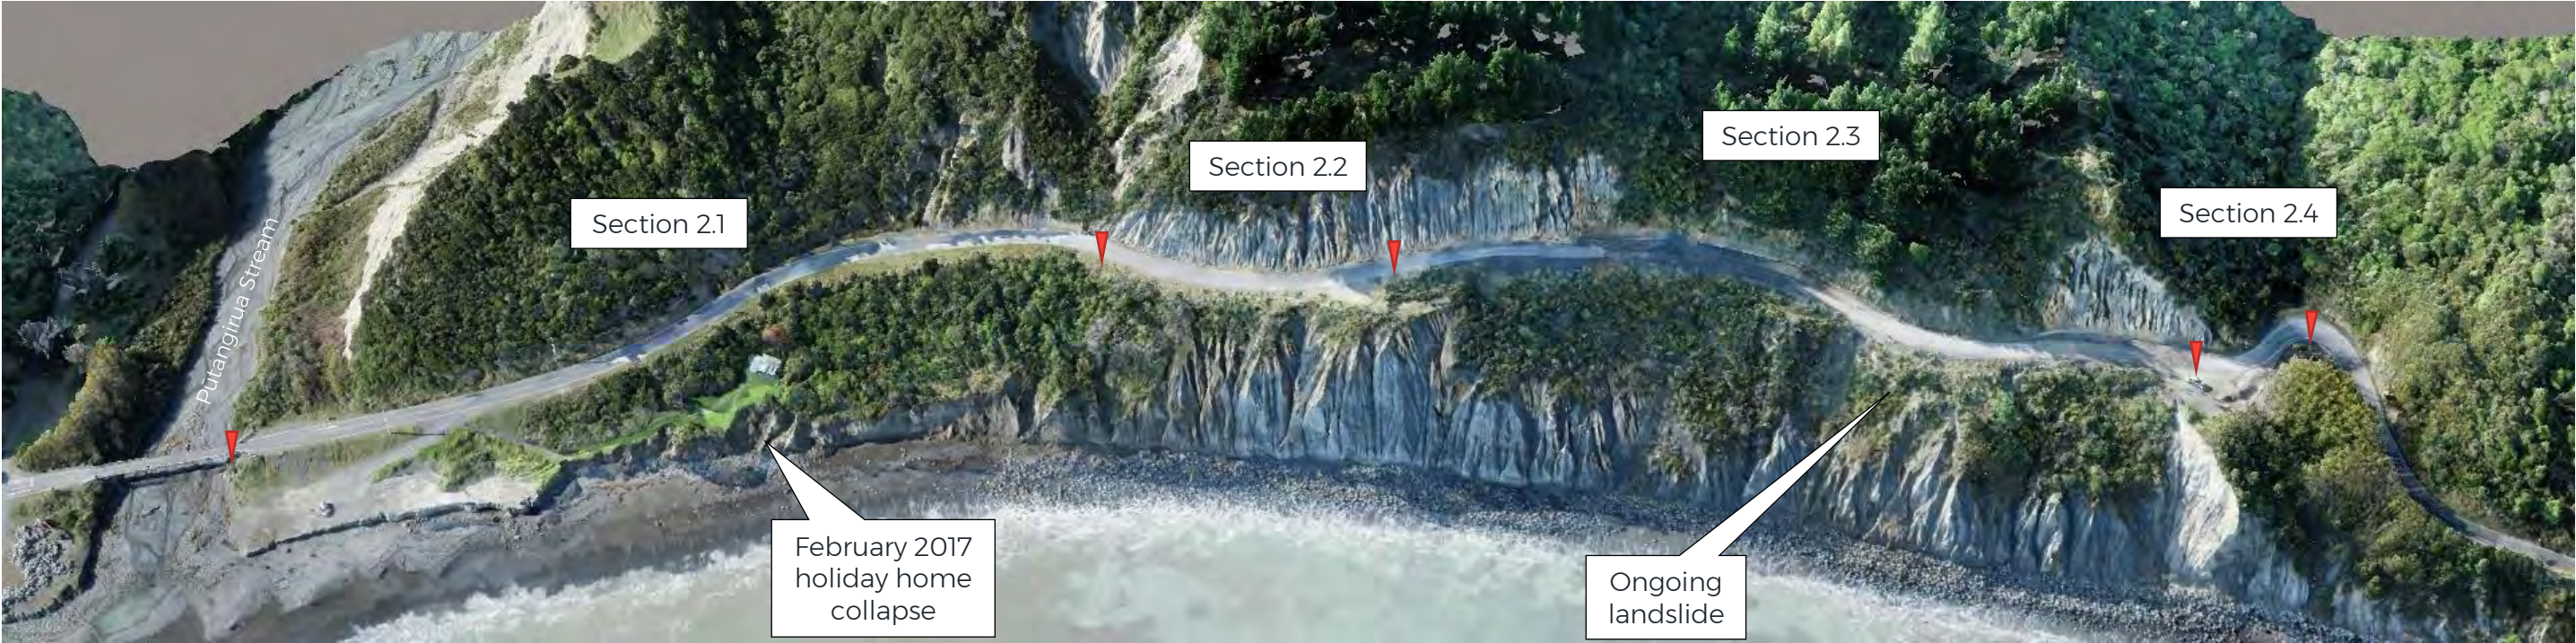
Section 2.1	Section 2.2	Section 2.3 (Johnson’s Hill Active landslide)	Section 2.4
RP Extents		13.48 to 13.76	13.76 to 13.84	13.84 to 14.10	14.10 to 14.14
Road Elevation (NZGD/NZTM2000)		8.4 m to 30.0 m	30.0 m to 37.5 m	34.6 m to 38.7 m	30.4 m to 34.6 m
Structures below the road		Cliff toe rip rap – occasional, very poor condition	Cliff toe rip rap – very poor condition	Cliff toe rip rap – very poor condition	Cliff toe rip rap – very poor condition
Risk to the road relating to:	Slopes above the road	Low to moderate risk – moderately steep slope. Narrow shoulder. Small overslips and rockfalls at southern end.	Moderate risk – moderately steep cut slope. Narrow shoulder. Small overslips and rockfalls. Gully erosion of cut slopes.	High risk – large-scale active landslide. Areas with moderately steep cut slopes and narrow shoulder. Gully erosion of cut slopes.	Low risk – moderately steep slope in stream gully. Wide shoulder. Outside area of active landslide.

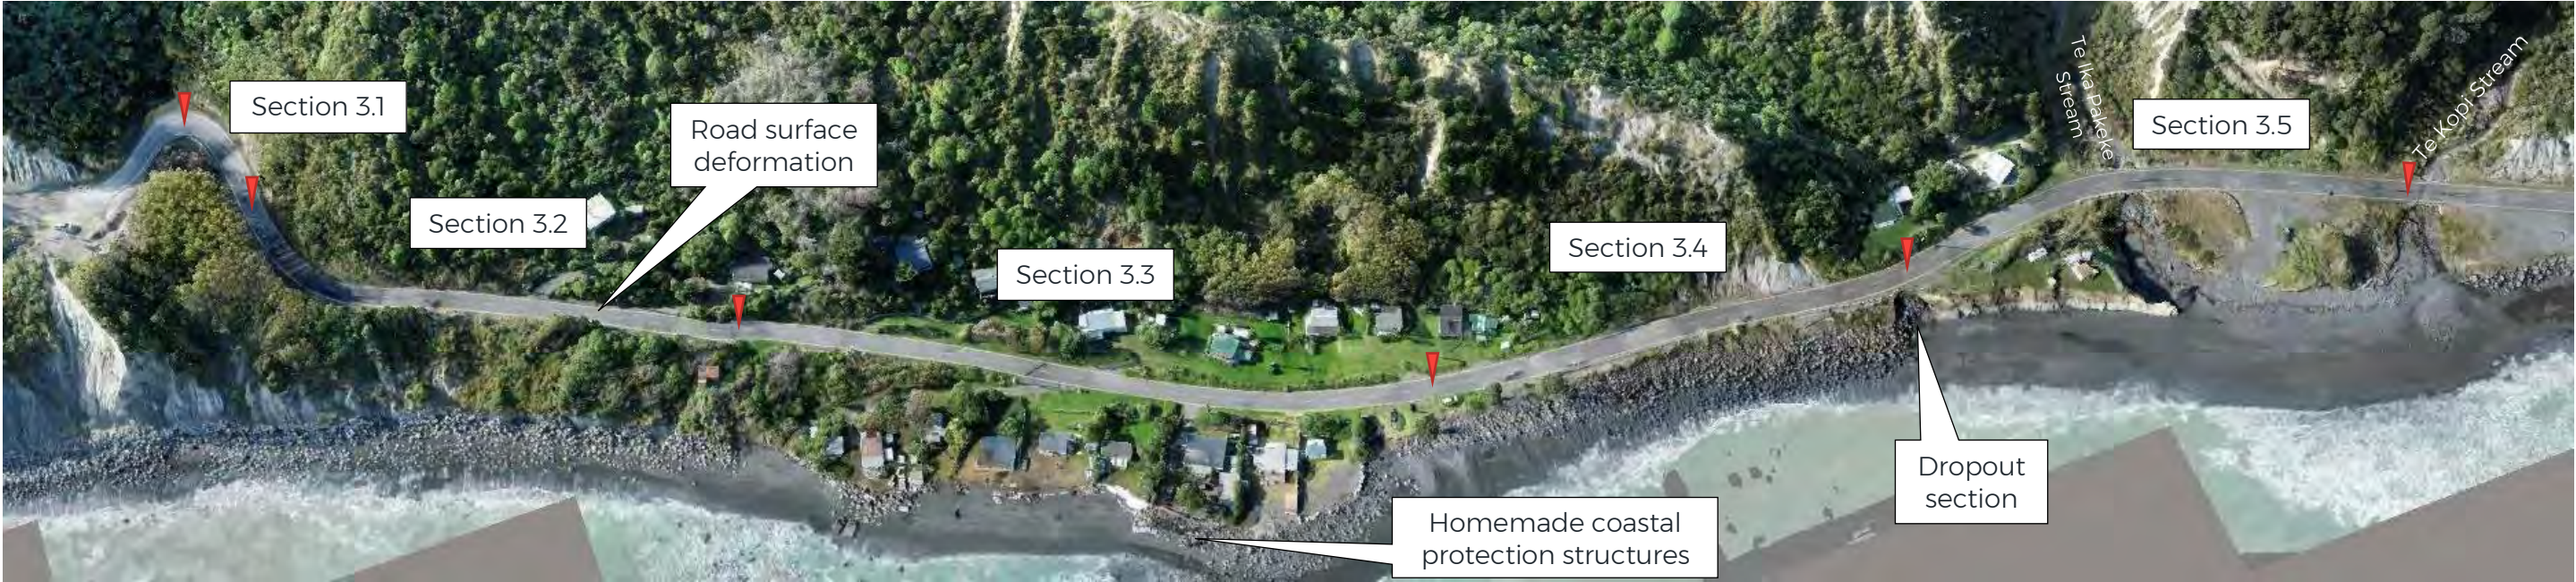
Section 3.1	Section 3.2	Section 3.3	Section 3.4	Section 3.5
RP Extents		14.14 to 14.18	14.18 to 14.34	14.34 to 14.56	14.56 to 14.72	14.72 to 14.86
Road Elevation (NZGD/NZTM2000)		26.8 m to 30.4 m	12.4 m to 26.8 m	4.1 m to 12.4 m	4.8 m to 8.7 m	5.8 m to 8.7 m
Structures below the road		Rip rap – very poor condition	Rip rap – very poor condition	Rip rap – occasional, very poor condition Homemade protective structures – occasional, v. poor condition	Rip rap – poor condition	None
Risk to the road relating to:	Slopes above the road	Low risk – moderately steep slope in stream gully. Wide shoulder. Outside area of active landslide.	Moderate to high risk – active slope movement. Shallow slope. Narrow shoulder.	Moderate risk – shallow to moderate slope, wide shoulder. Dormant but possibly creeping landslide.	Low to moderate risk – moderately steep slope. Narrow shoulder. Small overslips and rockfalls at southern end.	Low risk – shallow slope. Wide shoulder.
