ASSETS AND SERVICES COMMITTEE

Agenda 2 February 2022

B1. Tauherenikau River Crossing Water Pipeline Repair

Tauherenikau River Pipe Crossing failure

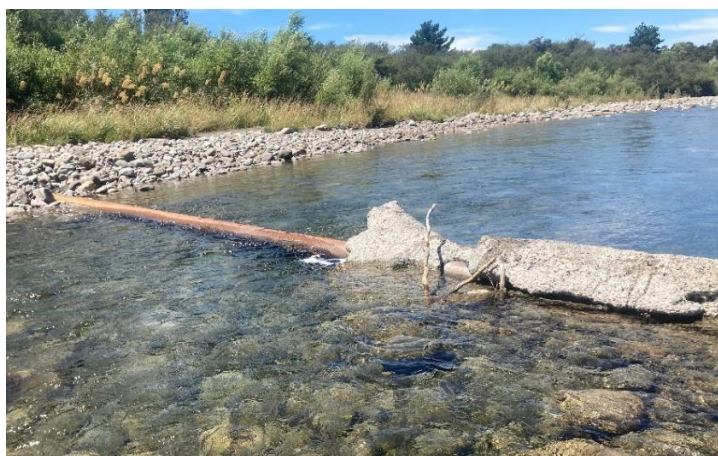
On 3 December 2021, WWL staff identified a water leak on the exposed pipeline that crosses the Tauherenikau river. Historic information revealed that this pipeline was originally buried beneath the riverbed and over a relatively short period of time, riverbed degradation has exposed the pipeline. A rock dam constructed about 200m upstream from this pipeline for supplying a local water race is likely to have exacerbated the degradation of the river in this reach resulting. This issue needs to be considered in any long-term solution.

Figure 1 - Pipeline crossing the Tauherenikau river

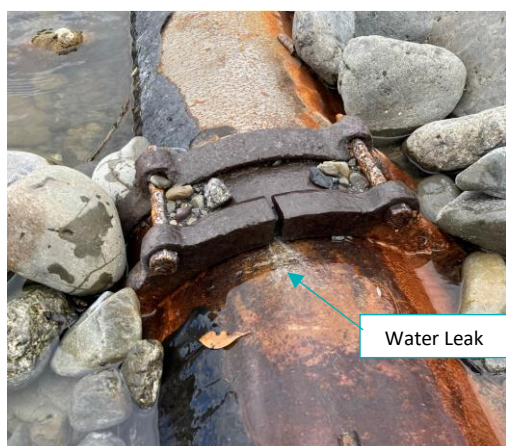
The leak is located on a pipe joint that is exposed at low river flow. It is vulnerable to ongoing damage from the river which is an active waterbody. This natural river activity could potentially cause a pipe burst at that location. Further inspection has also identified at the exposed steel pipeline is also currently undermined and as such is vulnerable to failure in a flood event.

Figure 2 - Leak on the pipe

- This option recommends repairing the water leak using the fitting as described in Option 2.
- The scope of works in this option is expanded further to provide additional protection to the existing pipeline from damage.

- Includes encasing the exposed pipe with concrete and placing large rocks along the pipeline.
- The concrete will provide additional protection to the pipe from rocks and debris that are transported by the river while the large boulders will slow down the forces of water that caused a void under the pipe in the first place.

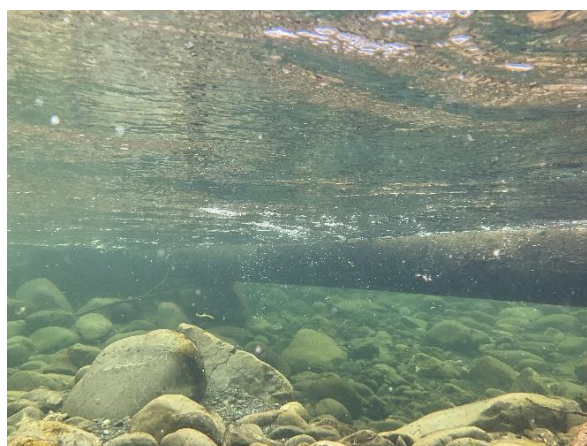
Figure 3 - Washout of rocks that supported the pipe

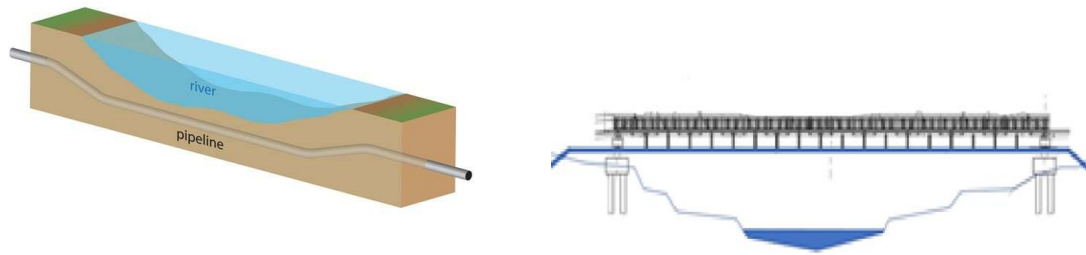
Figure 4 - Options to cross Tauherenikau river with a new pipeline

- To go under the river, the new pipeline will need to be constructed at some depth below the current riverbed levels. The rock dam (for the water race intake) about 200m upstream of the pipe crossing is expected to continue to degrade the riverbed which means the new pipeline will likely become exposed again in the future and depth of installation needs to consider this.

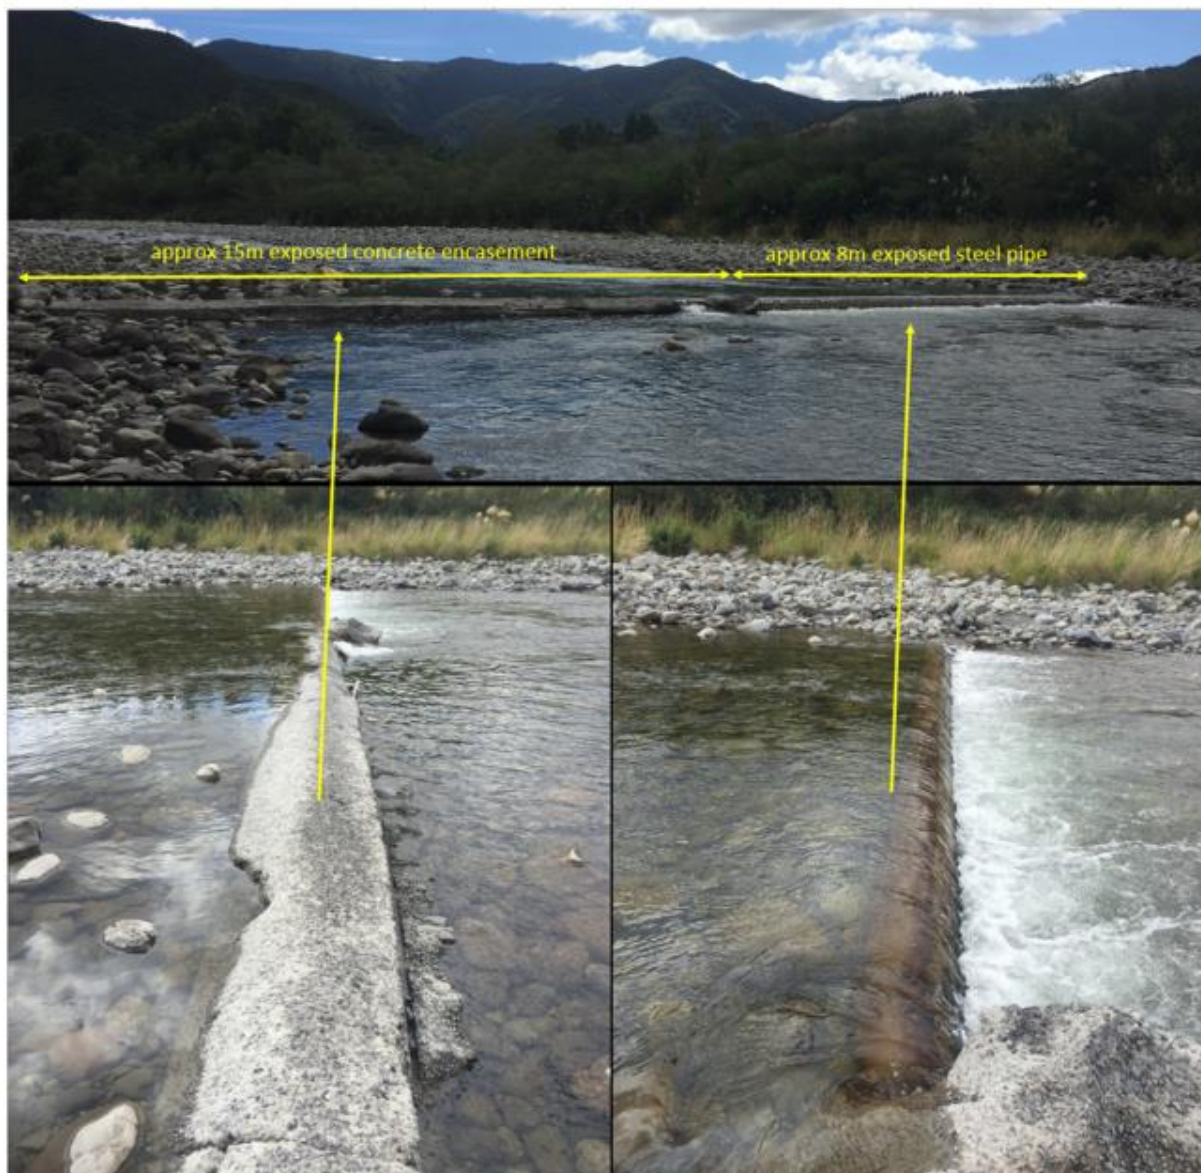
From what can be observed, the steel pipe appears to be in good condition, with some outer protection that has been damaged, exposed steel is bright and not showing signs of metal corrosion or rust. It appears that the steel pipe is a spirally welded pipe with no visible joints. The pipe alignment still looks true, with no bows or sags apparent.

The anticipated time and mode of failure is likely to be following a significant rain event and due to impact from debris in the river. It is noted that observations of this catchment have shown fast response times with water levels dropping rapidly following a flood event. While the risk of pipeline failure has been deemed minimal (Stantec – Initial findings memo) an emergency response and contingency plan is required to ensure risks associated with water supply disruption are managed. This contingency plan is only for the interim period ahead of a long-term upgrade solution.

Figure 1: Current situation Tauherenikau River pipe crossing (image taken from the Initial Findings Tauherenikau River Crossing Memo prepared by Stantec, dated 24/03/2021)

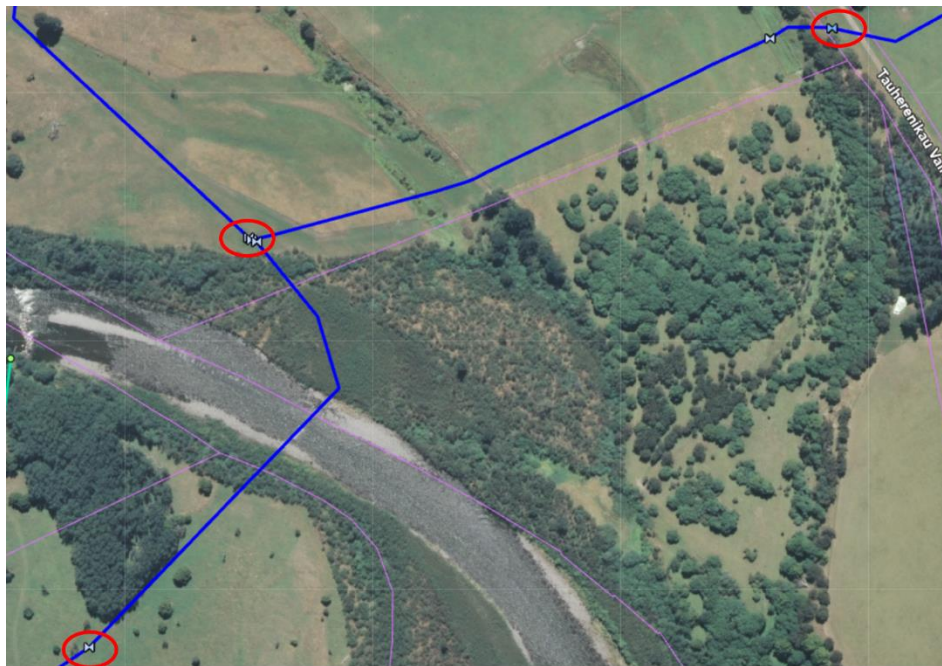
1. Isolate pipeline at both the Greytown and Featherston side by shutting off the valves, as per locations below. This may need to be opened at some point after the alarm to identify location of failure.

Figure 2: Isolation valves for river crossing pipeline (Wellington Water GIS 23/11/2021) Refer to Appendix 2 for location with respect to the Featherston town.

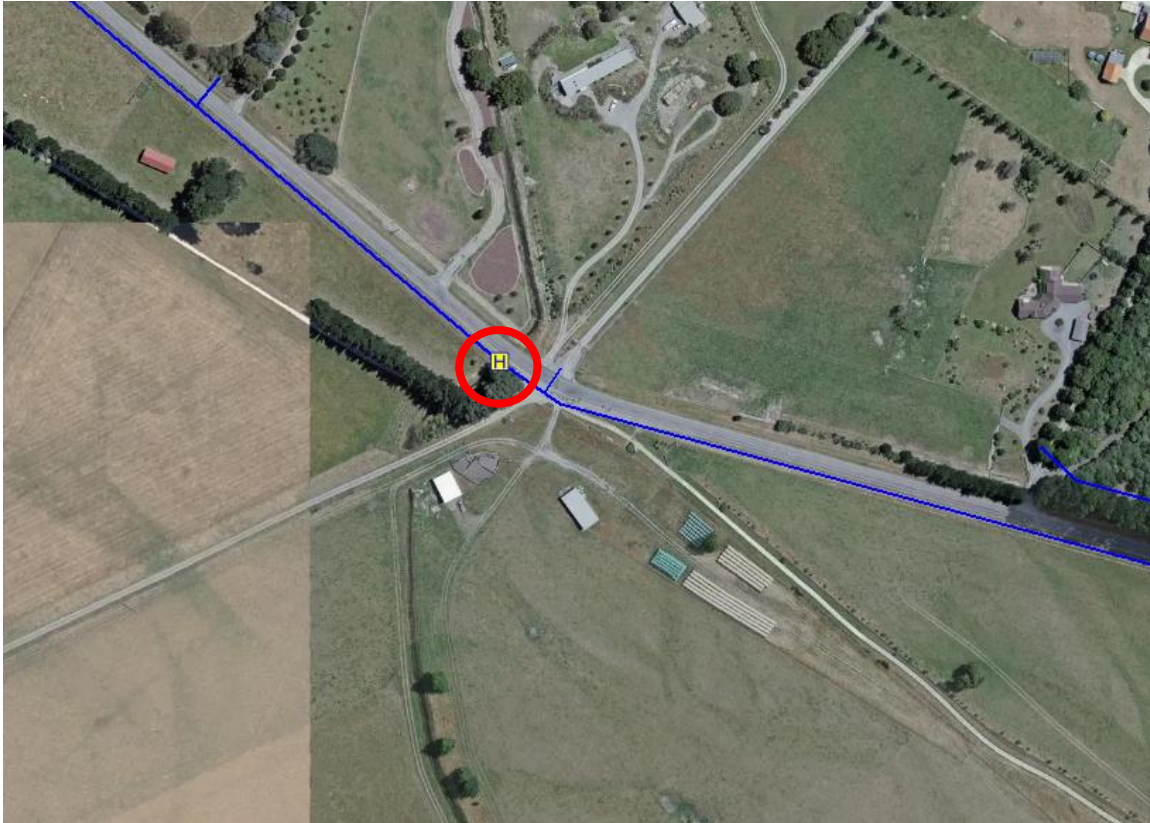
Figure 3: Recommended fill location for water tankers circled in red (151 Woodside Road). (Asset data from Wellington Water Open Data Portal (23/11/21). Aerial from LINZ - South-wairarapa urban 2021 0.075m & others 2020-2021)

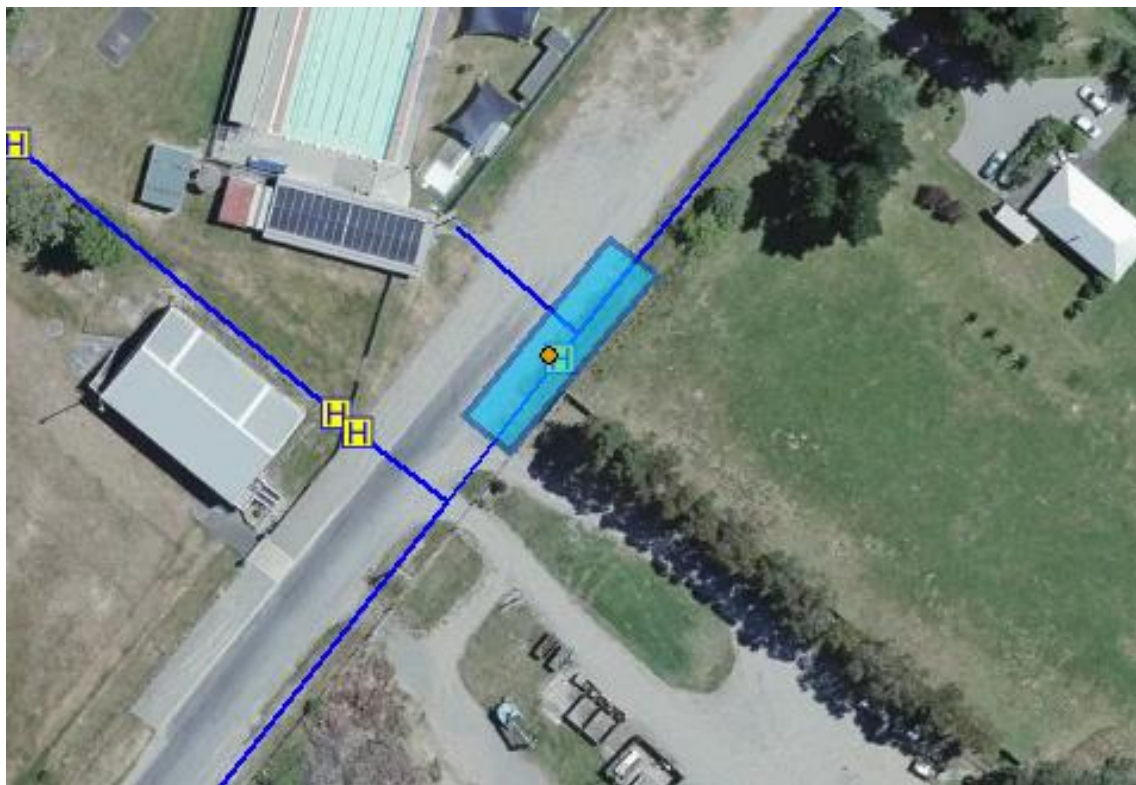
7. Of the four locations, the hydrant outside 62 Johnston Street appears to be the most suitable location for the pump boosters (Figure 4). There is space for the pump set up in the berm of the road at the hydrant. Although some of the pump set up will encroach onto the road, there is ample space on the other side of the road for vehicles to pass through. Traffic management will be required for the duration the pumps are set up there. The water trucks could be able to use the Featherston Recycling Station south of the recommended pump location (60 Johnston Street) for turning.

Figure 4: Recommended drop off location for water tankers in blue (berm outside 62 Johnston Street). Approximate hydrant location in orange. Recycling yard south of the recommended site to

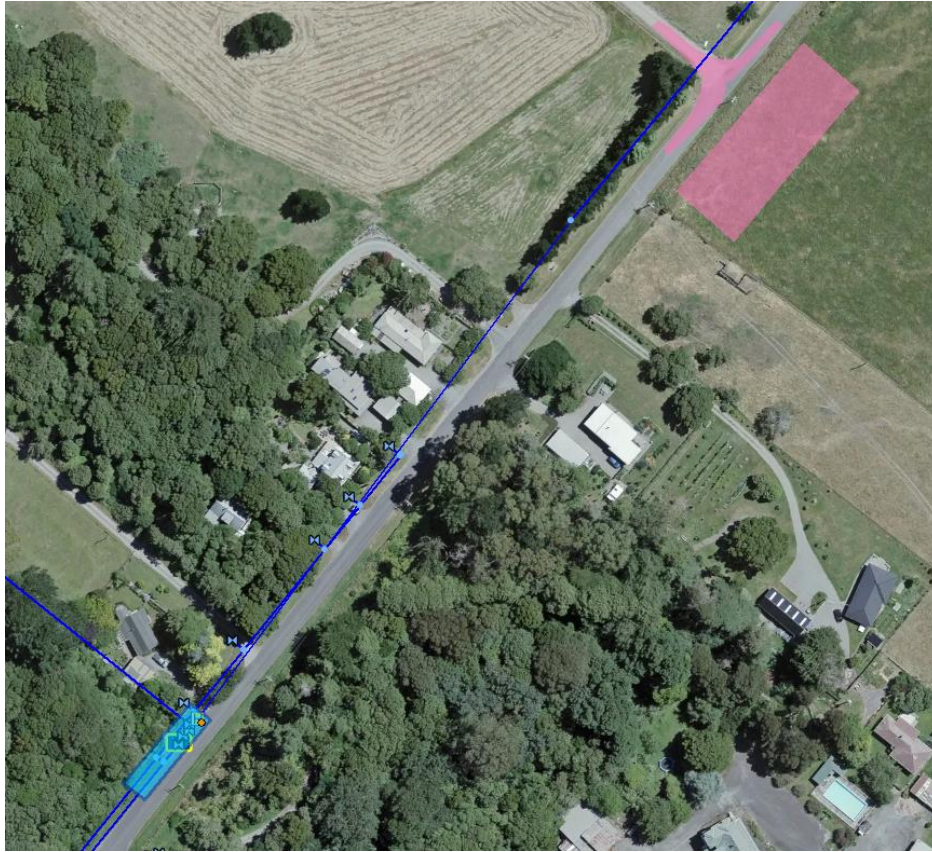
8. Other potential sites for the pump set up for emergency water supply include the berms outside: 81 Underhill Road (Figure 7), and the reserve south of 10 Harrison St West (Figure 8). For the two alternative options, private driveways can be utilised to turn for the return trip to refill.

Figure 7: Possible water pump setup location at 81 Underhill Road in blue and subsequent proposed turning bay area in the reserve (1320m², 22m x 60m). Approximate hydrant location in orange. (Asset data from Wellington Water Open Data Portal (23/11/2021). Aerial from LINZ – South-wairarapa urban 2021 0.075m & others 2020-2021)

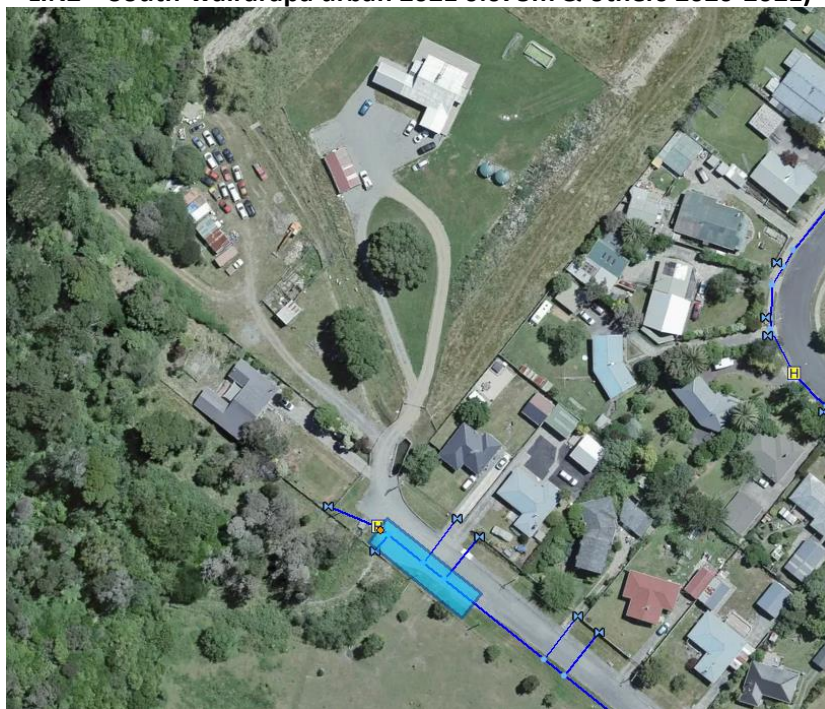
Figure 8: Possible water pump setup location outside the reserve south of 10 Harrison Street West in blue with approximate hydrant location in orange. It is proposed to use the private driveway north of the site for the water truck to return to refill. (Asset data from Wellington Water Open

Data Portal (23/11/2021). Aerial from LINZ – South-wairarapa urban 2021 0.075m & others 2020-2021)

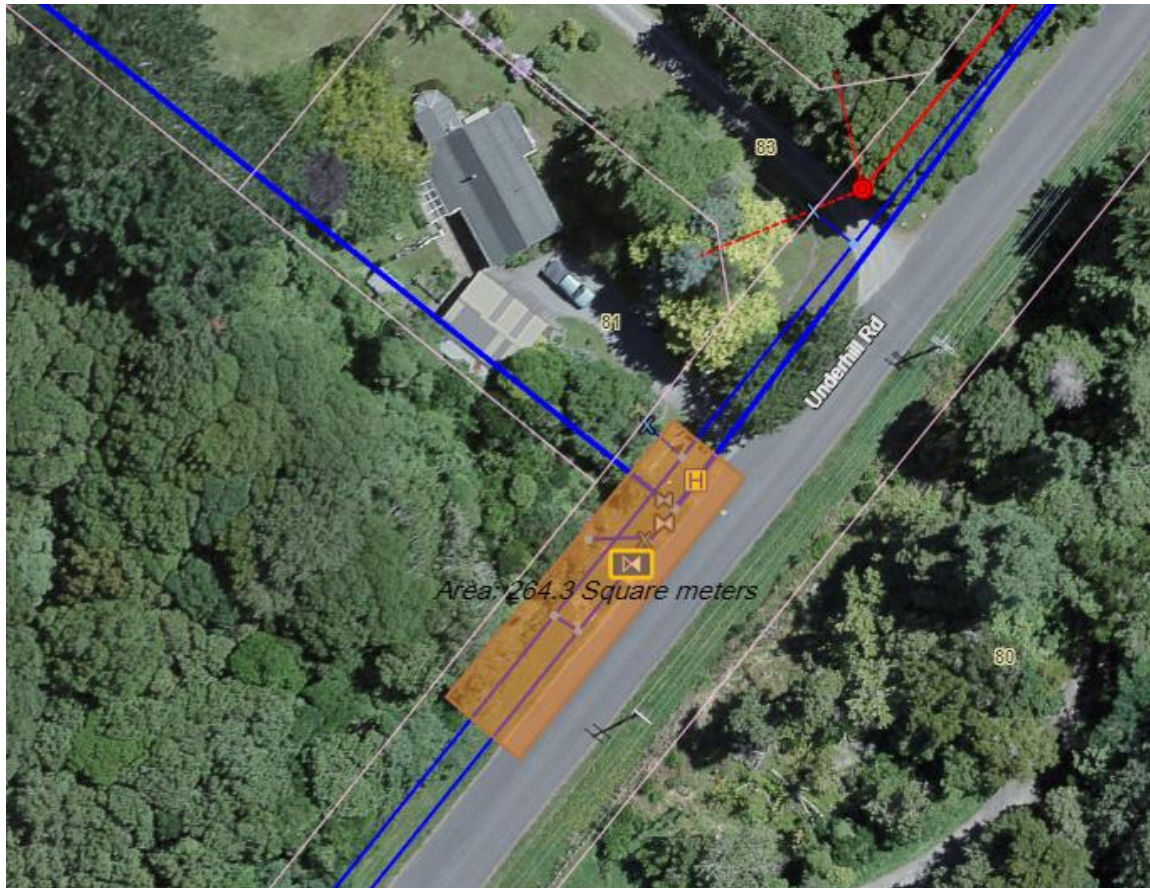
This response plan incorporates Wellington Water's desire to utilise the two standby pump sets in an emergency. However, there is a risk of system failure when pumping up to the reservoir in series. If one pump fails, then the entire system is compromised as the head required to reach the reservoir at the design flowrate would not be provided. Although using the two standby pump sets is possible, it is recommended that the two pump sets remain at the proposed immediate emergency pumping site outside 62 Johnston Street. While these pumps are providing immediate water supply to the town as per the response plan, Wellington Water can enquire with local suppliers if there is a suitable potable water pump which can supply the required flow and head to recharge the reservoir. This option minimises the time where the town will be relying solely on the bladders or have no water supply when the pump system is relocating to the site outside 81 Underhill Road. The pumps can then be used at 62 Johnston Street if the reservoir system is to fail.

Figure 9: Proposed location for network reticulation distribution arrangement via pumping to reservoir, and approximate extent of pump setup in orange. (Asset data and aerial from Wellington Water Regional Water Stormwater Wastewater App (23/11/2021))

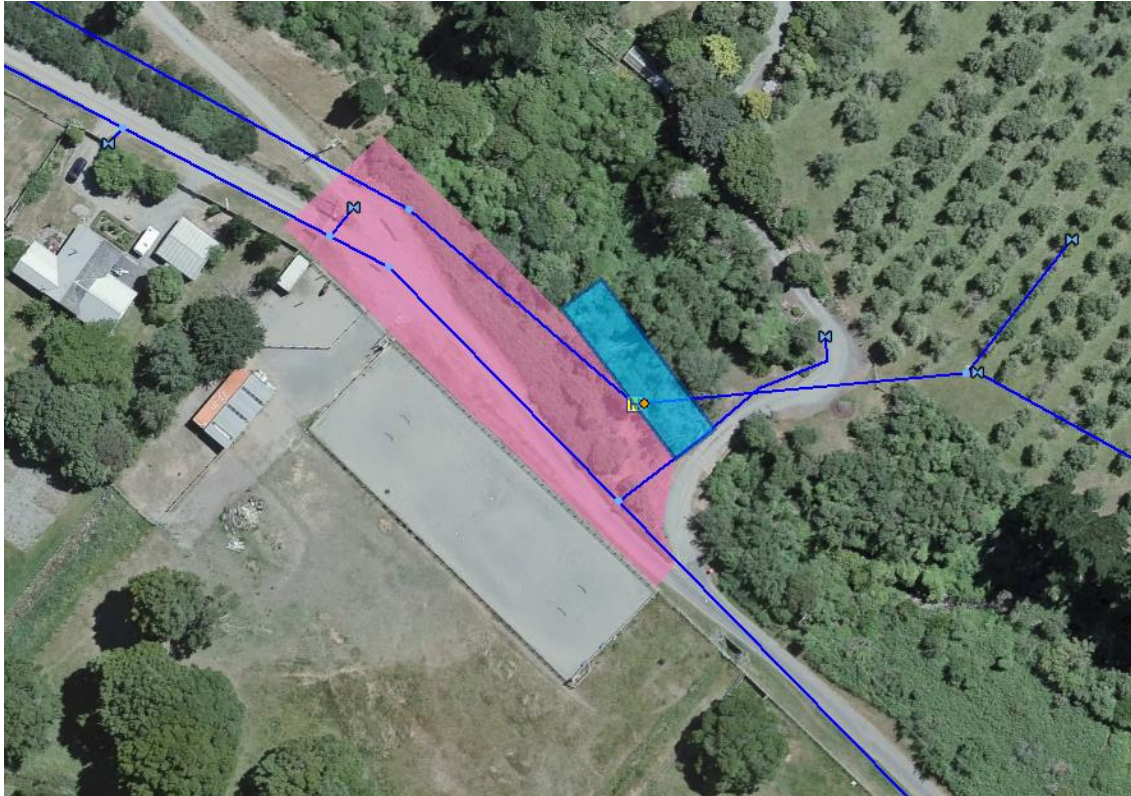
Another alternative location for pumping up to the reservoir is at the hydrant outside 14 Boar Bush Gully Road, illustrated in Figure 10. The hydrant is located within a vegetated area, which will require clearing to be able to have the pump arrangement in this location. Construction of a turning bay is also necessary to allow for the truck to make the return trip to refill. For this option, it is proposed to utilise the existing road, widening the hardstand to allow enough space for the water trucks to do a 180-degree turn. The proposed turning bay location and pump setup is illustrated on Figure 10. This option requires clearing of the vegetation and engineered design for the construction of the turning bay and platform for the pumping arrangement as there are steep falls at the hydrant location.

Figure 10: Alternative location of pumping set up to pump to Boar Bush Gully Reservoir outside 14 Boar Bush Gully Road. Pump arrangement highlighted in blue, and turning bay highlighted in pink. (Asset data from Wellington Water Open Data Portal (23/11/2021). Aerial from LINZ – South-wairarapa urban 2021 0.075m & others 2020-2021)

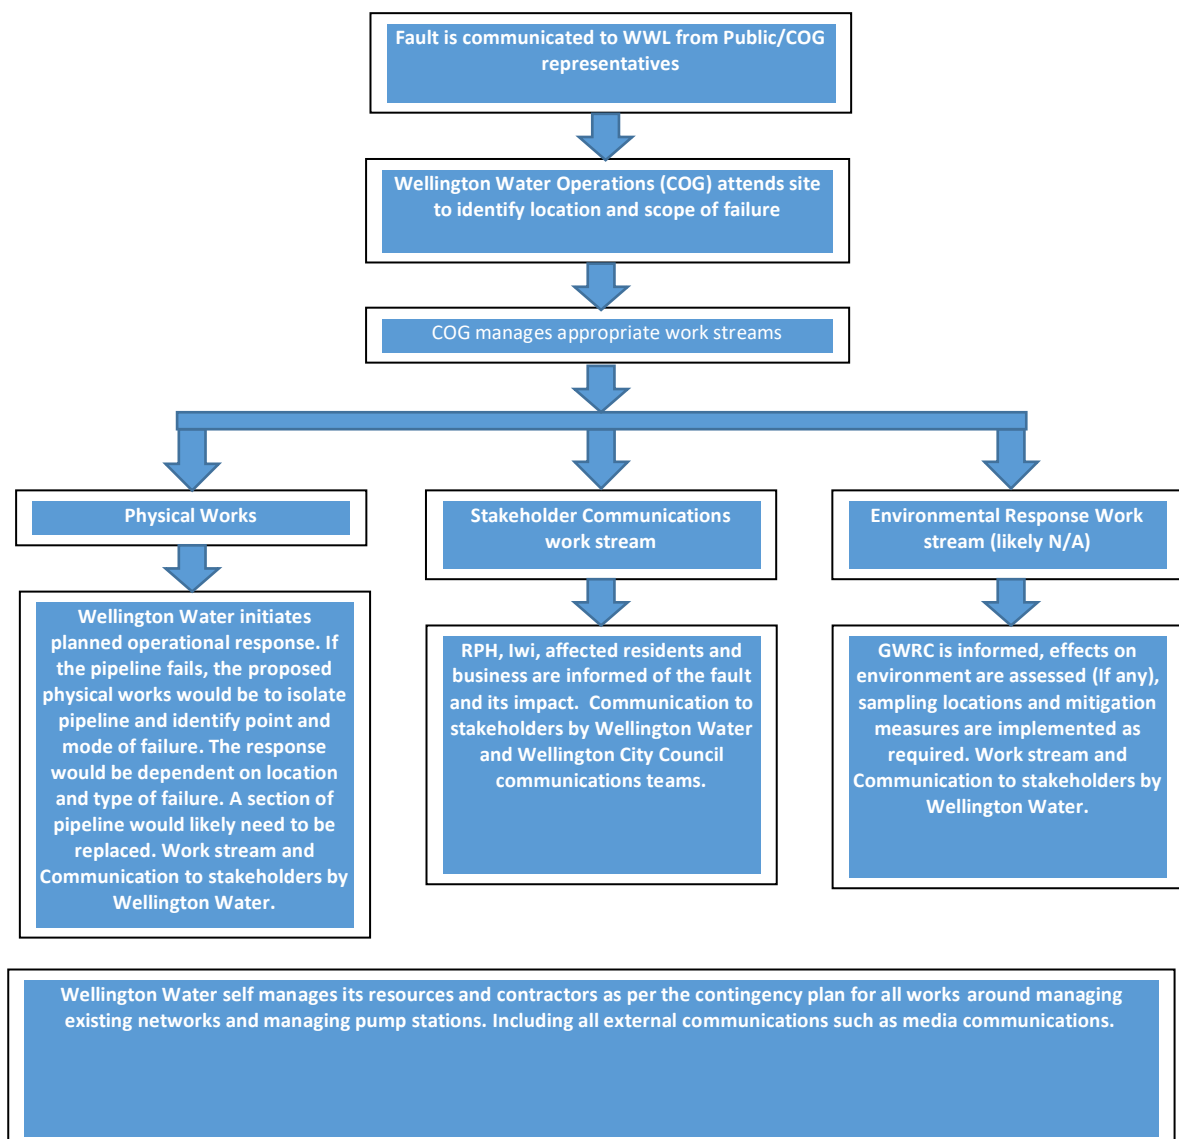
Incident Work stream Flowchart

The initial pre-planned operational response to a major failure or flooding event is outlined in the Incident work stream flow chart below.

Below is a step-by-step guide of the flow chart above.

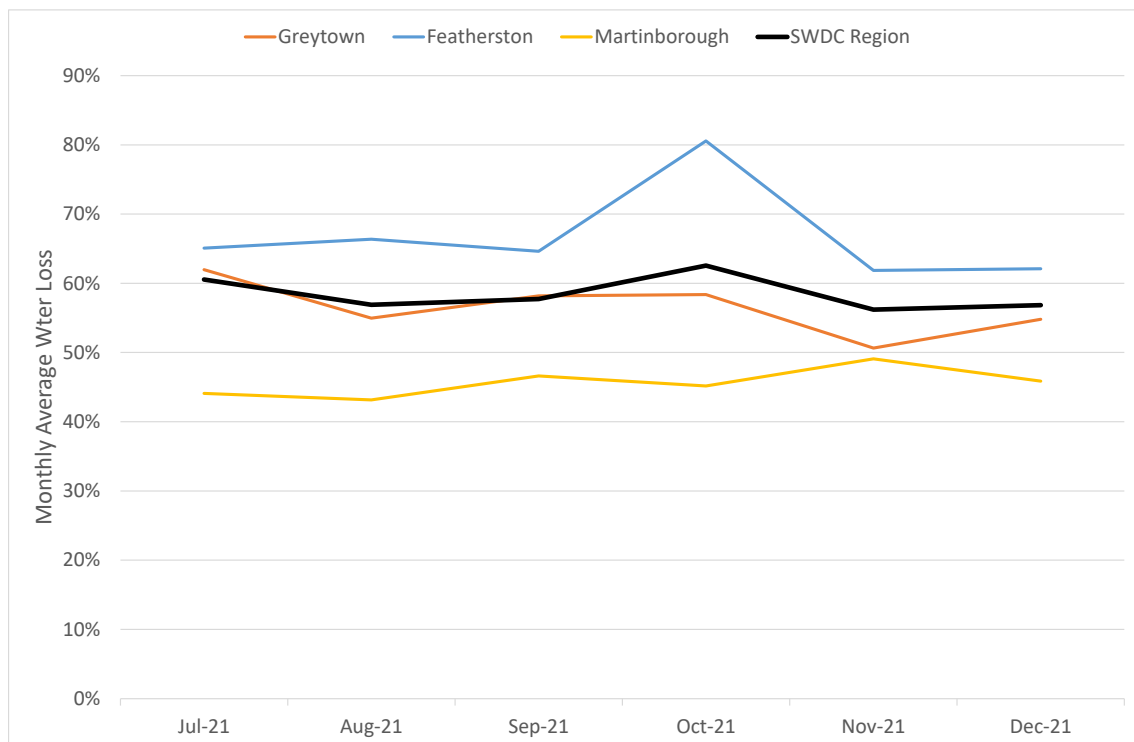
Losses over the past six months for each town and the region are presented in Figure 2.

Figure 2 Monthly average water losses by town and across the region.

The level of water loss is higher than would be expected and suggests that there may be some night time usage that we are not accounting for in the calculation, potentially from high use non-residential customers, or from unmetered or even unauthorised

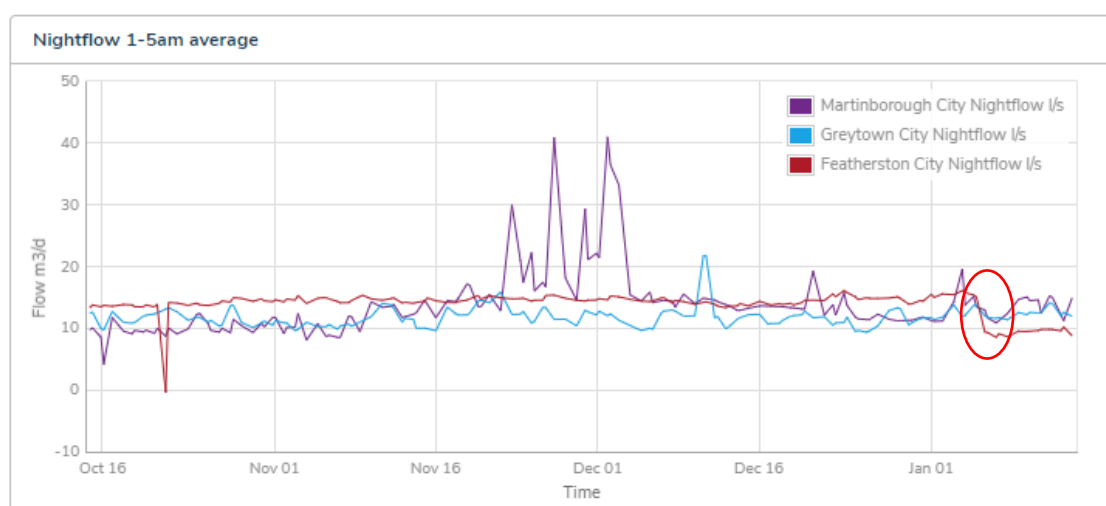
Whilst water loss expressed in percentage terms seem high, the impact of leaks can have on night flows and water losses is demonstrated by recent leak repairs made in Featherston. Figure 3 shows the trend of night flows for each of the three towns. There is a significant drop in Featherston night flow around 6 January, which coincides with the repairs of a leak on a 100-mm main Birdwood Street and a leaking connection on Boundary Street. These two leaks appear to have been contributing some 6 L/s or about 37% of observed night flows.

Aside from this positive change and some fluctuations in Martinborough over November/December, Figure 3 shows night flows have been reasonably stable. Should we observe sustained increases we will seek to initiate leak detection surveying.

Figure 3. Night flow 3-month trend. Note the drop in night flow on the Featherston curve (circled in red) resulting from a mains leak repair.

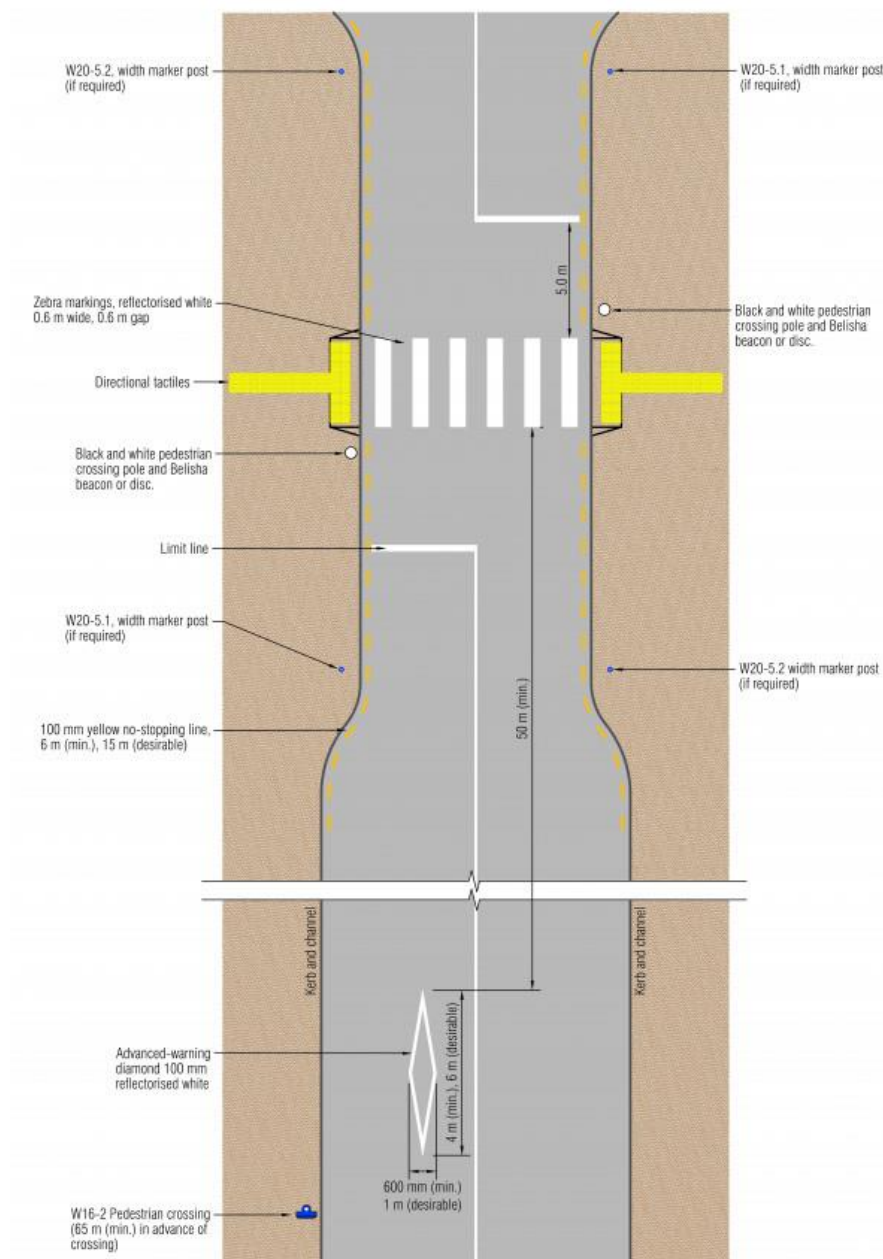
Figure 3.1: Typical layout for pedestrian crossing (zebra) with kerb extensions

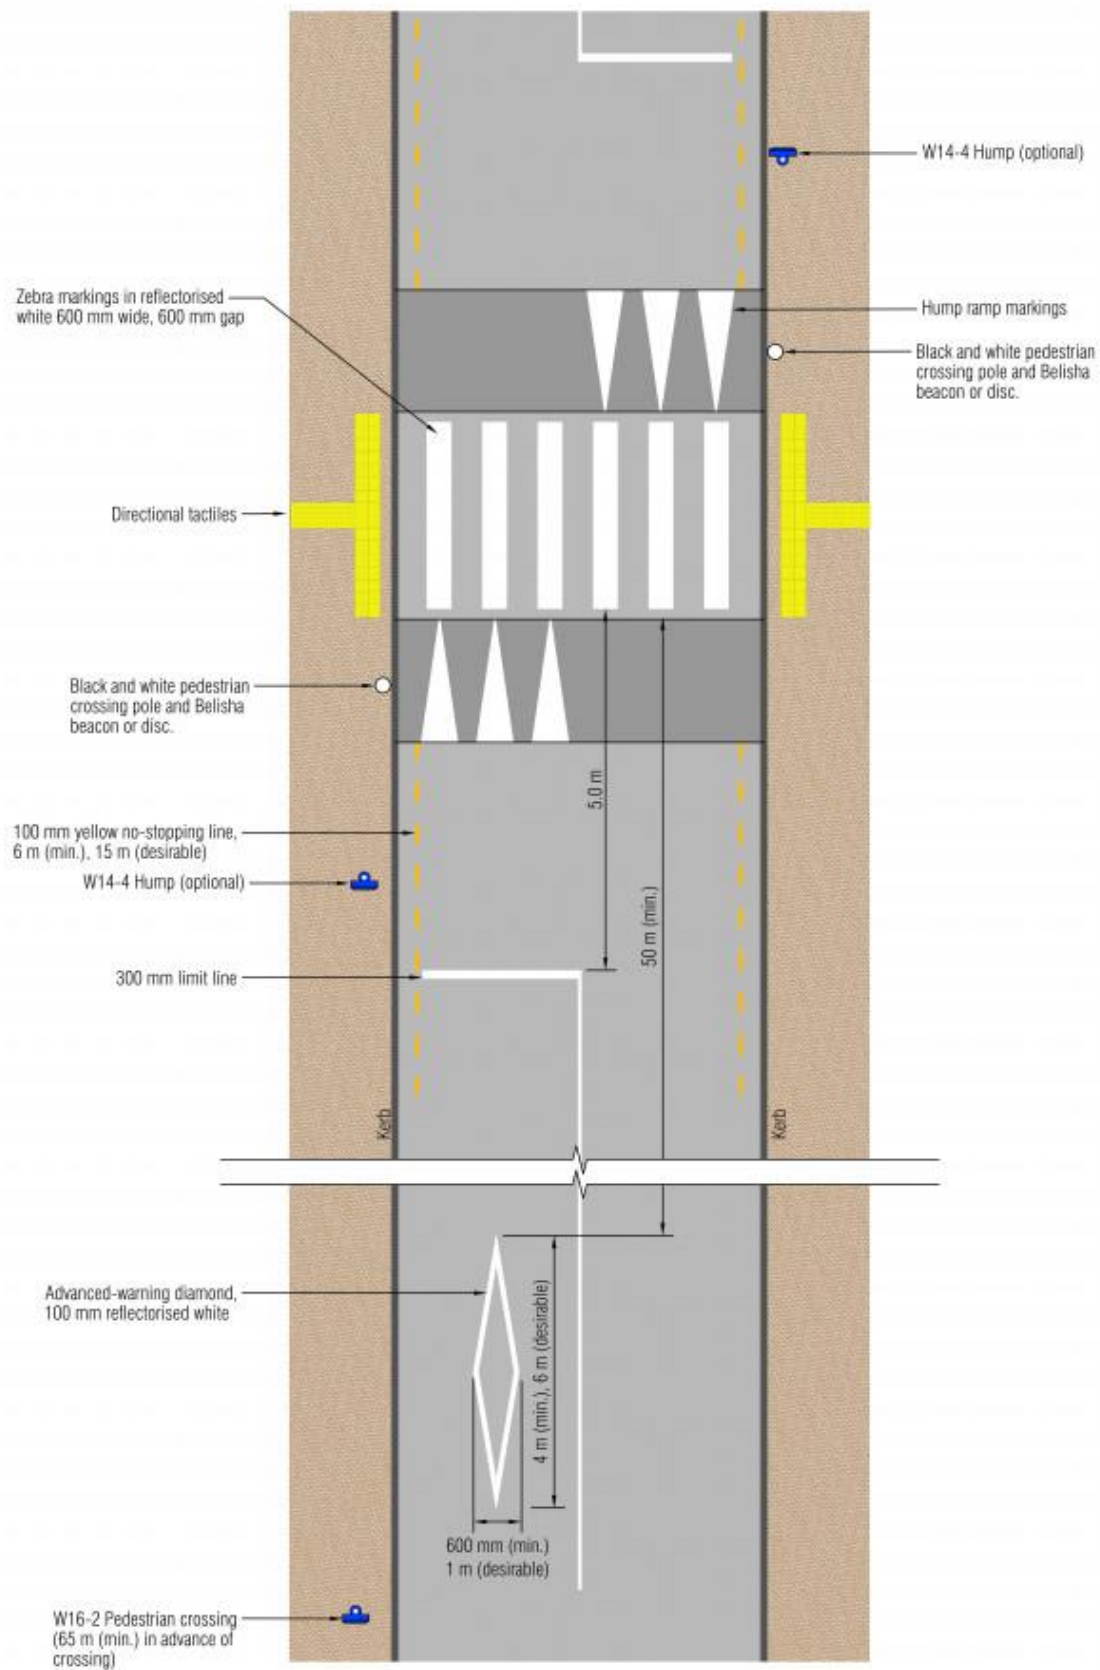
Figure 3.2: Typical layout for pedestrian crossing (zebra) on raised platform

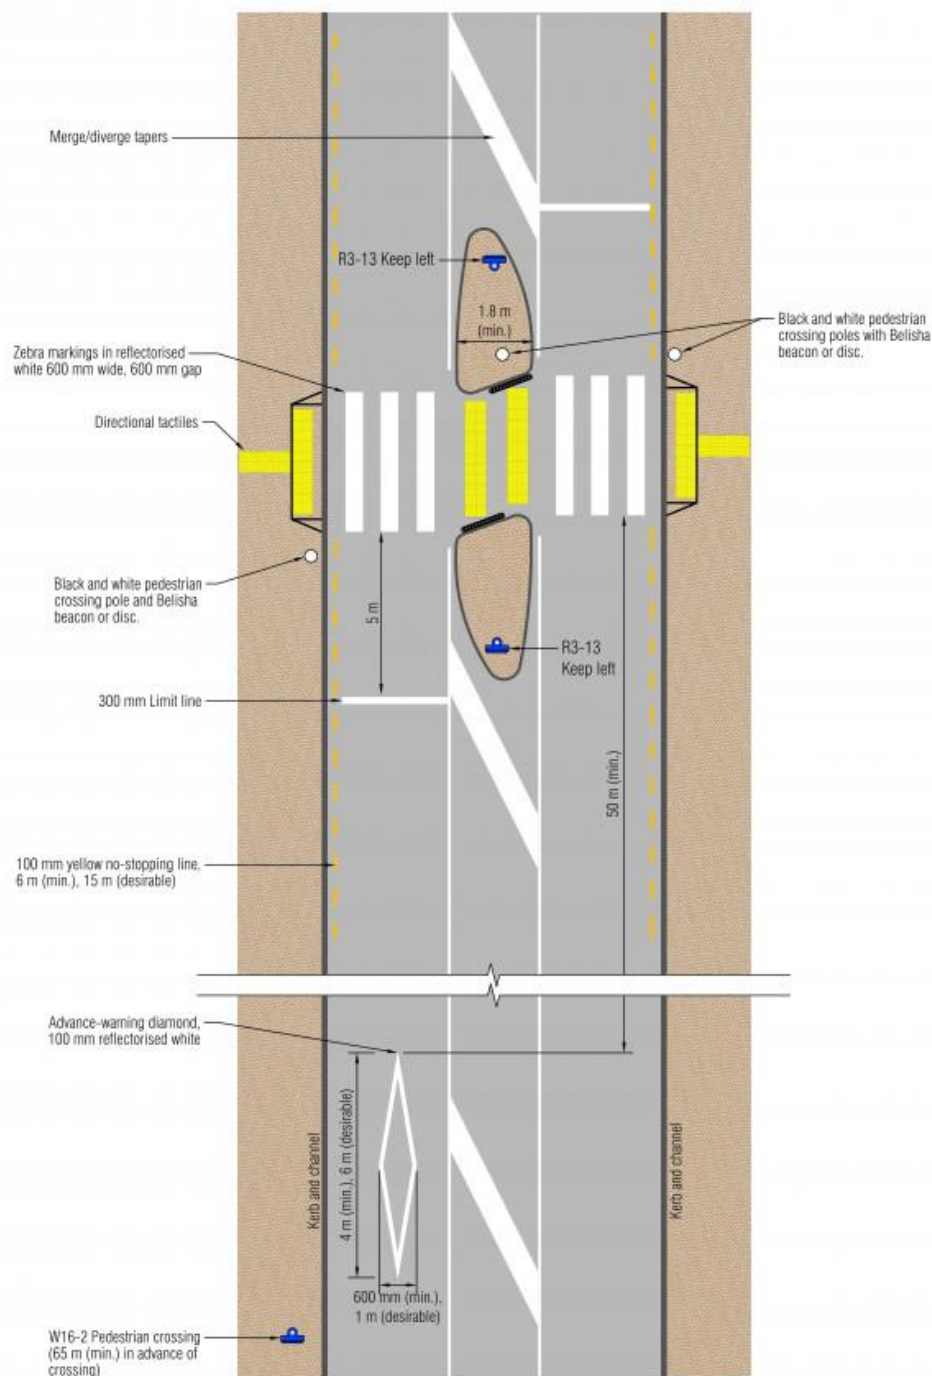
Figure 3.3: Typical layout for pedestrian crossing (zebra) with pedestrian refuge island in a flush median

1. Tactile Ground Surface Indicators (TGSi) shall not be installed within pedestrian refuges less than 1.2m deep.
2. This layout is also appropriate where a pedestrian crossing (zebra) is installed on a road with a solid median. The flush median's hatchings and boundaries may be omitted.

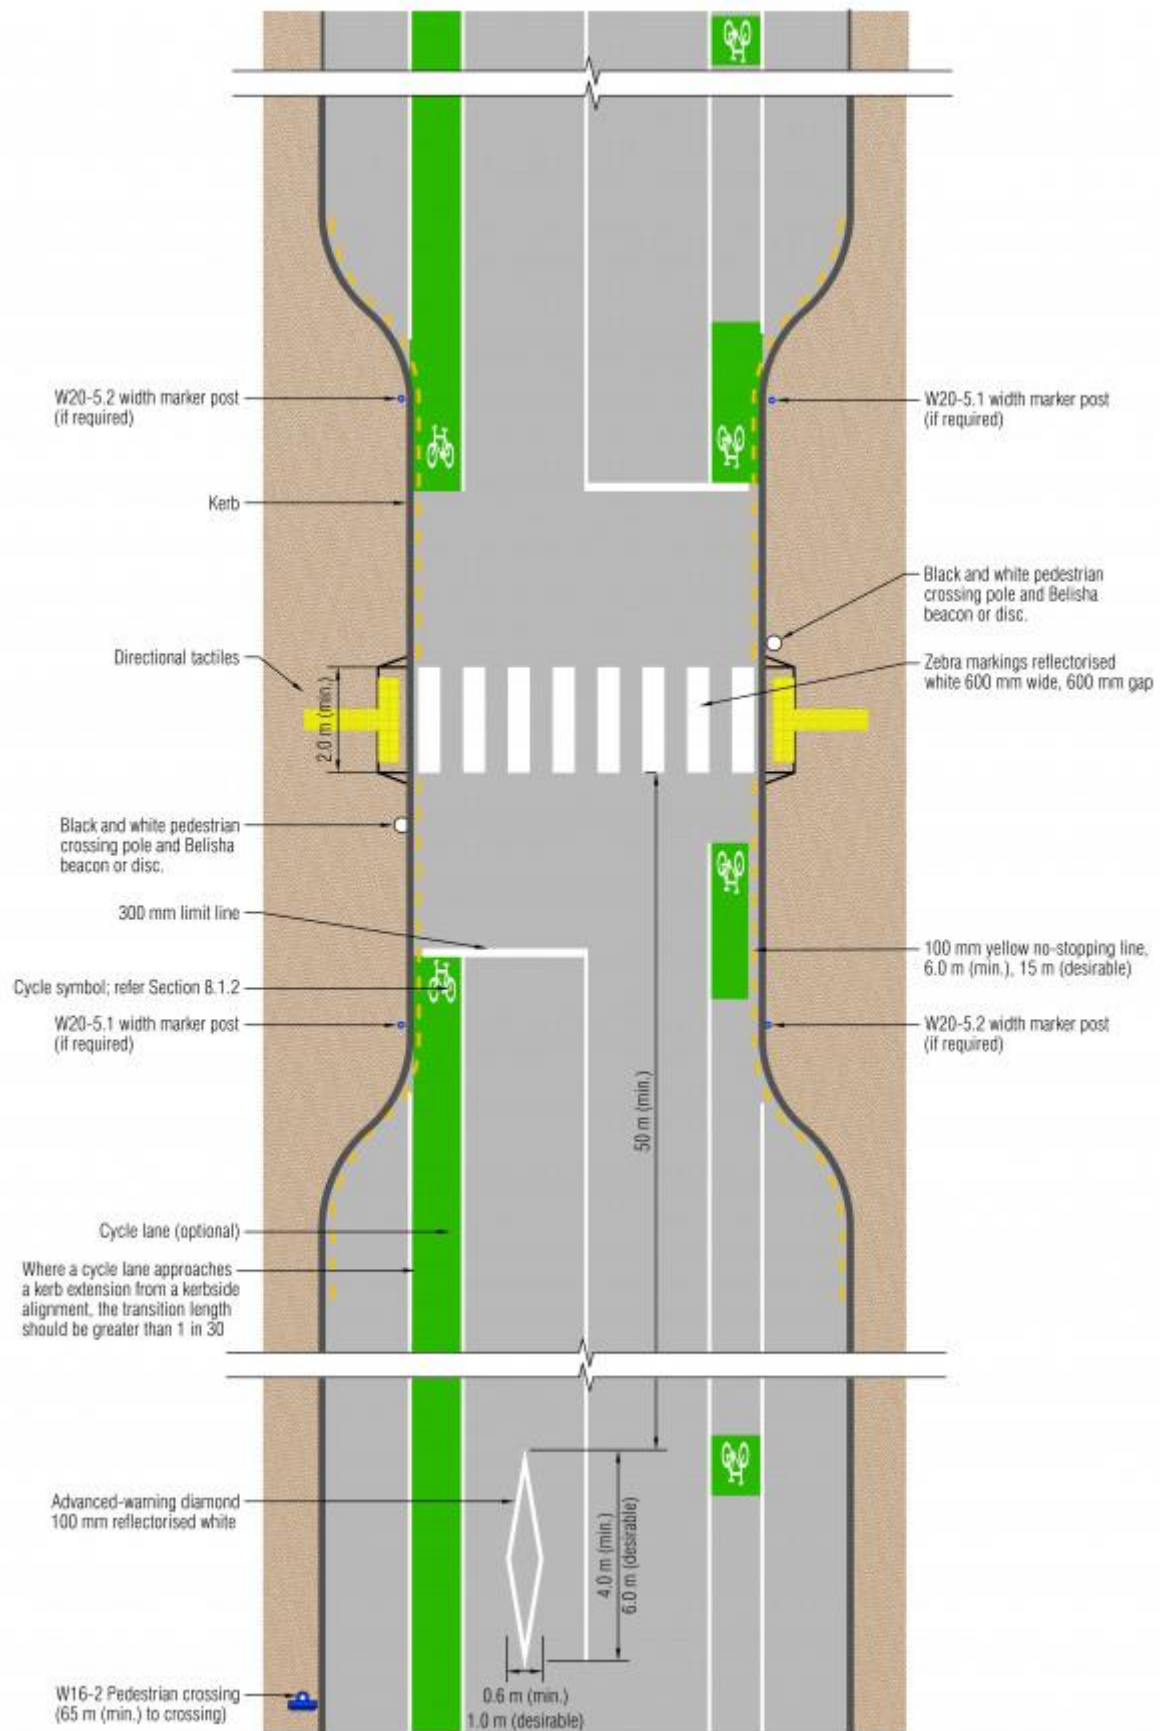
Figure 3-4: Typical layout of a pedestrian crossing (zebra) with on-road cycle lanes

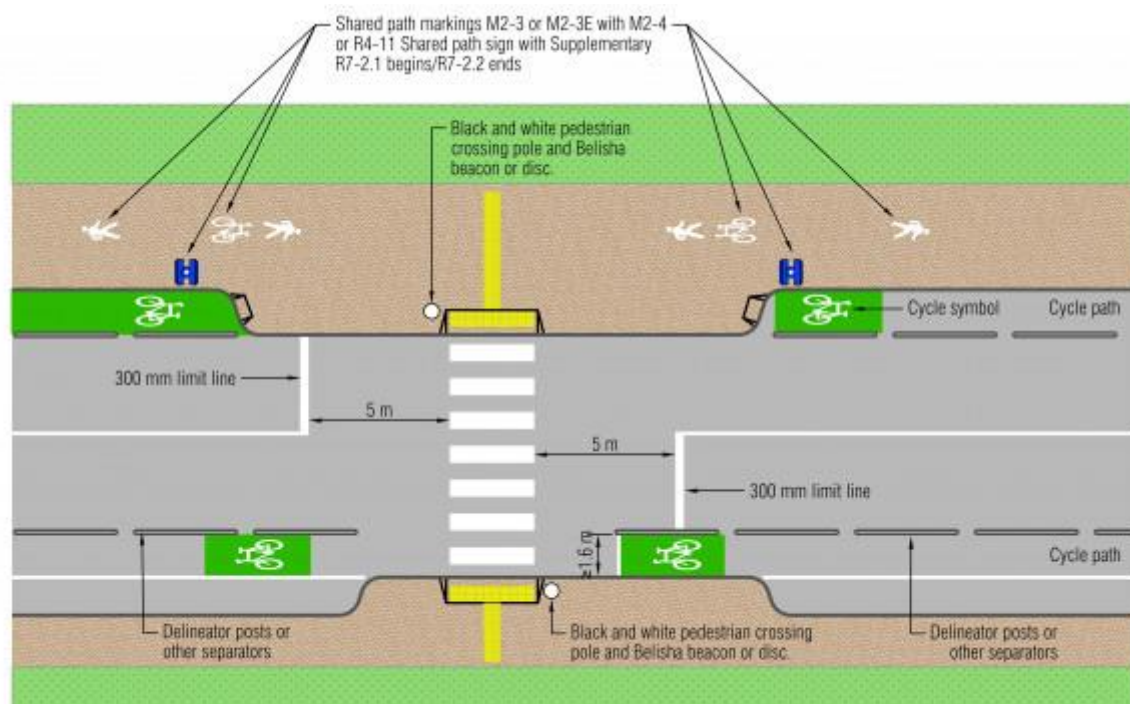
Figure 3-5: Typical layout for a pedestrian crossing (zebra) with a cycle path (cycle path is interrupted)

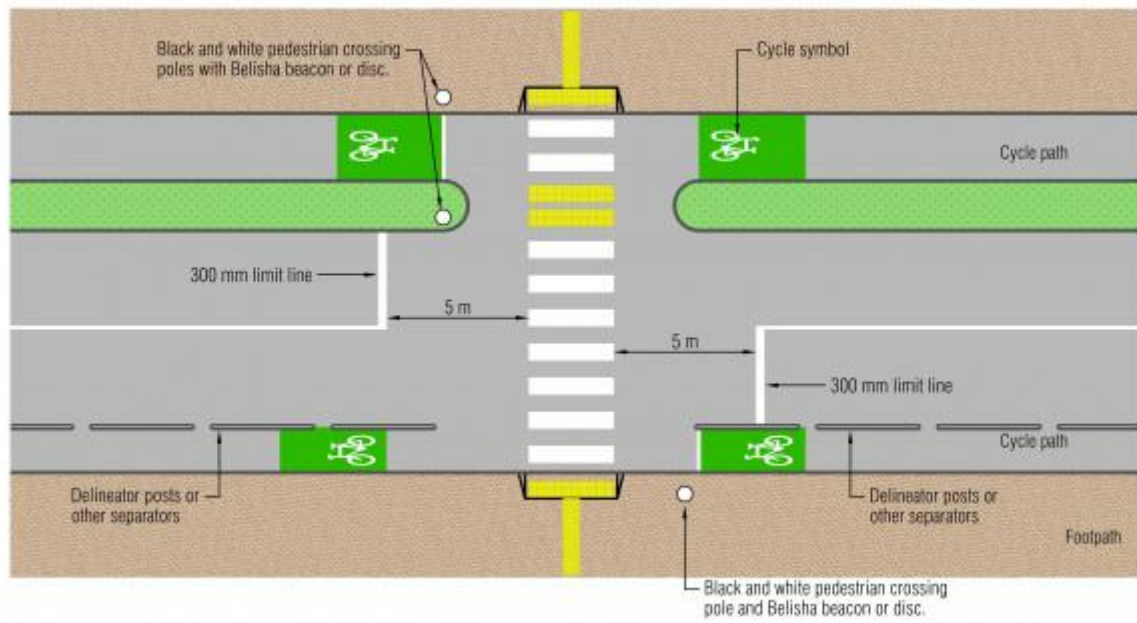
Figure 3-6: Typical layout for a pedestrian crossing (zebra) with a continuous cycle path
