SOUTH WAIRARAPA DISTRICT COUNCIL

SWIMMING POOLS REPORT

Report Featherston Pools

Report Greytown Pool:

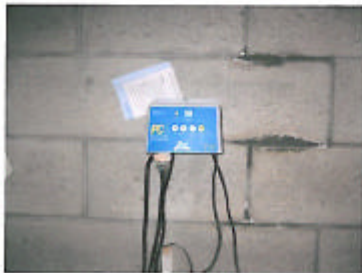
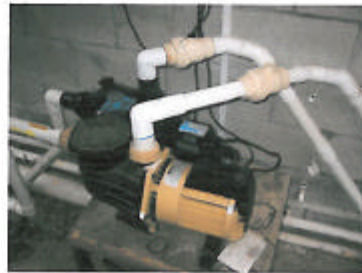
The Solar System is now running fine. The pumps are running ok 1 x H/P Davey pump is old but ok. The Poolrite ¼ H/P pump is only 5 months old.

This Solar controller is new supplied only 5 months ago.

The solar panels on the rugby grounds building are fine, and the system on the pool roof admin area is also fine. (This is part of our yearly service check)

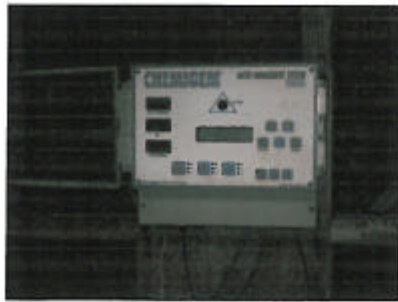
The CM100 Chemigem was service 3 months ago and is working well. The Chemigem at the learner's pool is also working well.

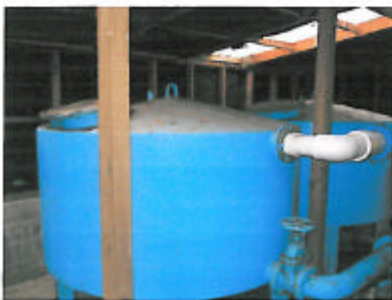
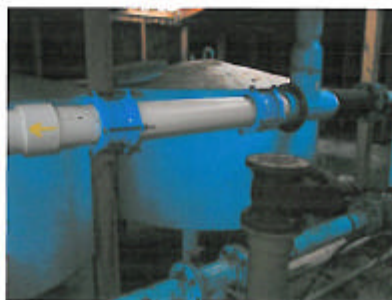
Filters in Featherston are very old and do not meet the current requirements for filtering the pool this size NZS standard 444/2008.

At present the system only has 1x150mm pipe feed the suction line from the balanced tank to the pumps should be 2 x 150mm pipes minimum.

It has currently 1x only pipe, this would need another pipe put in place to feed. More holes are needed in the barge pipe to cope with the extra water flow.

The following is required to meet NZ standards.

6 x 1.6 Fiber pool filters	@ \$ 11,932.40	=	\$ 71,594.40
6 x Value systems manifold	@ \$ 2,818.07	=	\$ 16,908.42
2 x FD 131 pumps	@ \$ 11,208.00	=	\$ 22,416.00
Filter media glass diamond clean			
6 x	@ \$ 5,872.00	=	\$ 35,232.00
A P/C sum for all filter pipe work			\$ 21,000.00

Cost: P/C Sum \$ 15,000.00

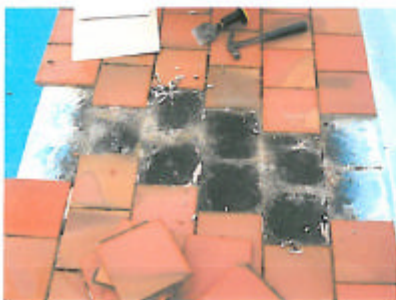
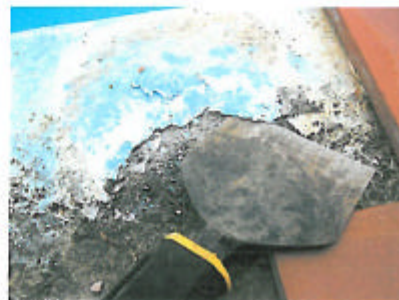
The tiles around the pool are lifting off due to the incorrect way they have been glued down. The fibreglass that goes up the walls and over the edge of the pool is finished only 100mm from the edge. No glass is under the tiles. This leaves just bear concrete, it is then fibreglassed at the edge of the water return valley.

The tiles have been grouted down and the chlorine has eaten out the grout and concrete. The water from the pool is also getting behind and under the fibreglass skin. This will create a structural delamination failure of the fibreglass skin on the pool wall. Once the water gets between the concrete and fibreglass, this cannot be removed.

The area under the tiles needs to be fibreglassed and the tiles re-glued back on with the appropriate adhesive.

Cost of job: P/C Sum \$ 26,000.00

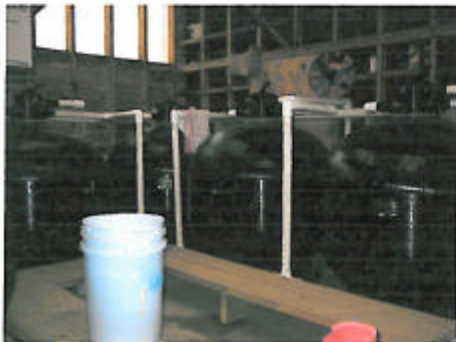
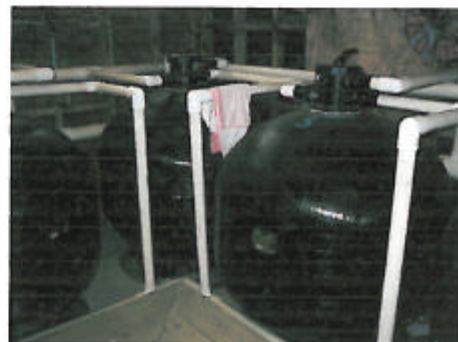
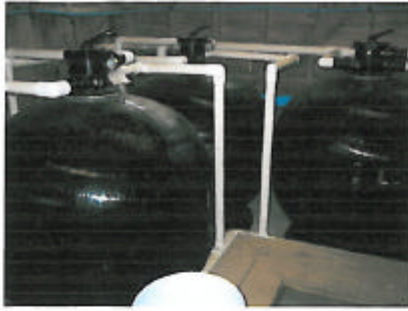
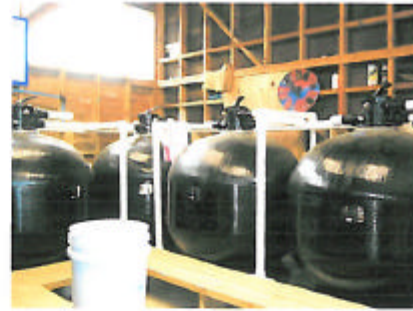
This pool currently has a DE filter and pump which needs to be replaced to 1 x 1200 filter and 1 x SQ700 pump, to bring in line with New Zealand's standard.

Filter Pump Glass Media	\$ 8,420.00
-------------------------	-------------

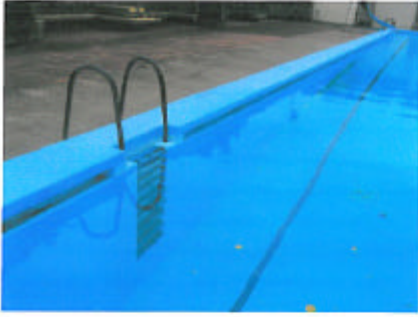
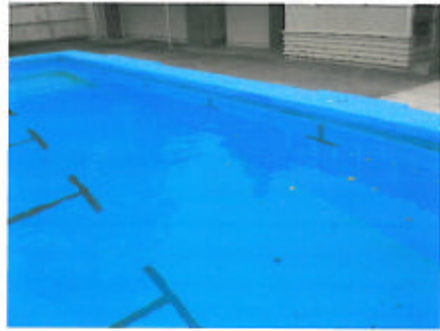
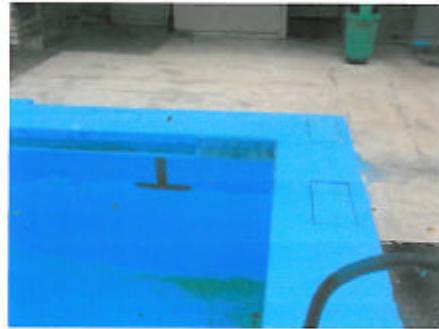
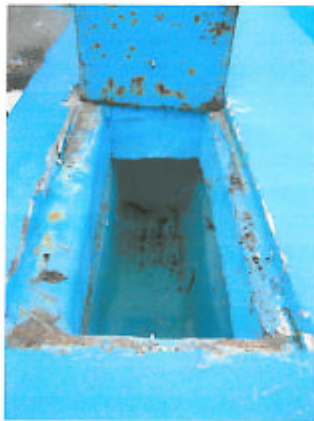
The pool is large at 30.4 x 12.2 there are years of house paint on the pool which is flaking off, house paint is not to be used on swimming pools.

The pool is not able to skim water as it should by law. For a pool this size it must have skimming troughs, the full length of the pool. These troughs have been filled in and blocked off. Due to the consistent leaking, the pool has a skimming system put in one corner close to the overflow tank this was to only be tempary I was told, until a permanent repair was done. This has now become the only means for the pool to skim.

Any pool over 150 sq meters must have skimmer troughs in place the full length of the pool both sides, to remove body fat etc of the surface of the pool. This now needs to be rectified. Nz standard 4441/1:1.1

We can achieve this by the following drawing with what is already there at the pool. The pool would need to be fibreglassed as it is also leaking water, and we would create new skimmer troughs from the old bringing the pool back to 100%

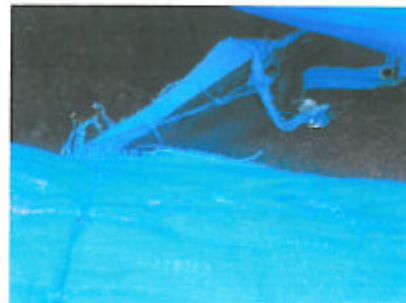
The main pool requires new covers.

The intermediate pool requires one new Cover and roller. 1 x Duokote Thermal Blanket 4.950 x 9.950m

Duokote Thermal Blanket 2 x 5.5 x 25m \$ 10,292.00

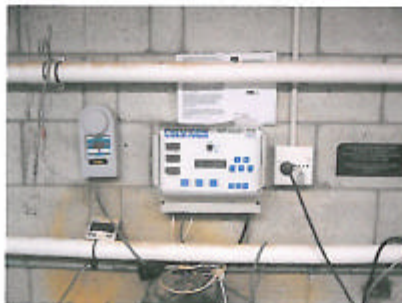
The CM100 is due for service now and we are currently servicing the DM51

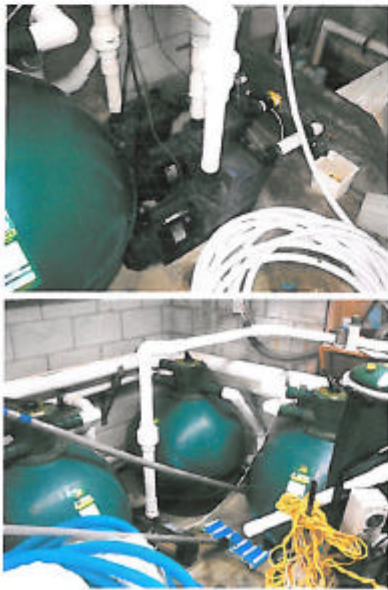
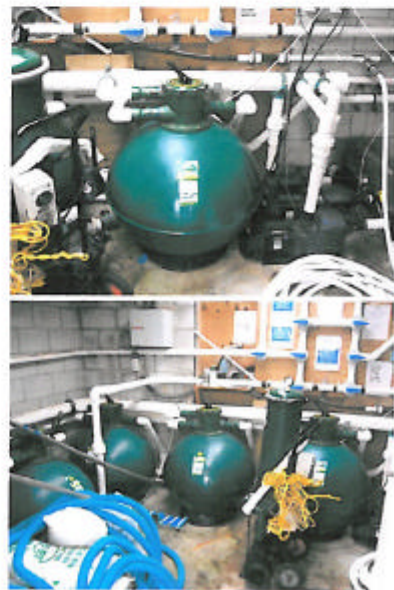
The main pool has four x S9000 Poolrite Filters of which the sand was replaced 3 months ago. The filters are run with 3PM60 pumps. These do not meet the requirement, and do not meet the current standard of filtering required.

The Intermediate is also filtered by 1 x S9000 this also does not meet the standard.

The toddlers pools filter also does not meet the standard.

The following is required to bring up to New Zealand's standard 4441/2008

3 x 1.6 Fibrec Pool Filters @ 11,932.40	\$ 35,797.20
3 x Valve Systems Monifold's @ 2818.07	\$ 8,454.21
1 x FD131 Pump	\$ 11,208.00
Filter Media Diamond Clean Glass	
3 x 5872.00	\$ 17,616.00
Pipe Work Would be a P/C amount of Labour	\$ 10,000.00
	\$ 3,000.00
Total:	\$ 86,075.41
