WELLINGTON WATER RUAMAHUNGA FINDINGS ON MARTINBOROUGH OVERFLOW INCIDENT

**Appendix 1 – Martinborough
Wastewater Treatment Plant Overflow
Incident Investigation and Report**

Martinborough Wastewater Treatment Plant Overflow Incident Investigation and Report: January 2020

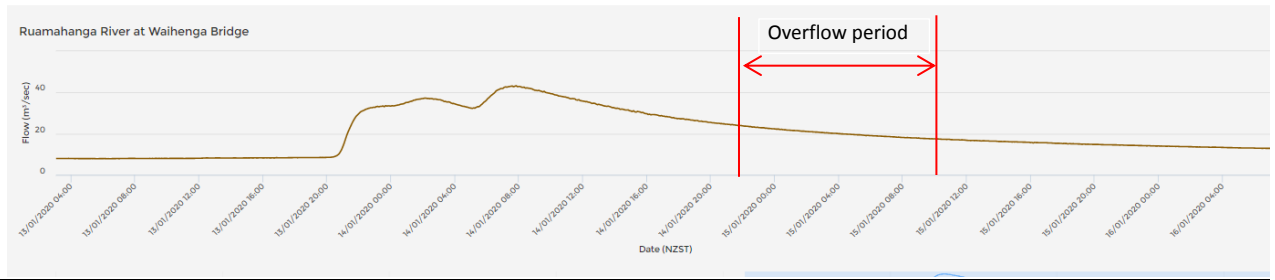
Figure 1- hydrograph for Ruamahanga River at Waihenga

Table 1 – Dilution comparison between consent and overflow incident

Parameter	Consented	Dilution (minimum)	River Flow
Discharge rate	11L/s	2,266:1	At minimum 24,930 L/s
Overflow	2L/s	8,600:1	17,200 L/s at 10:15am

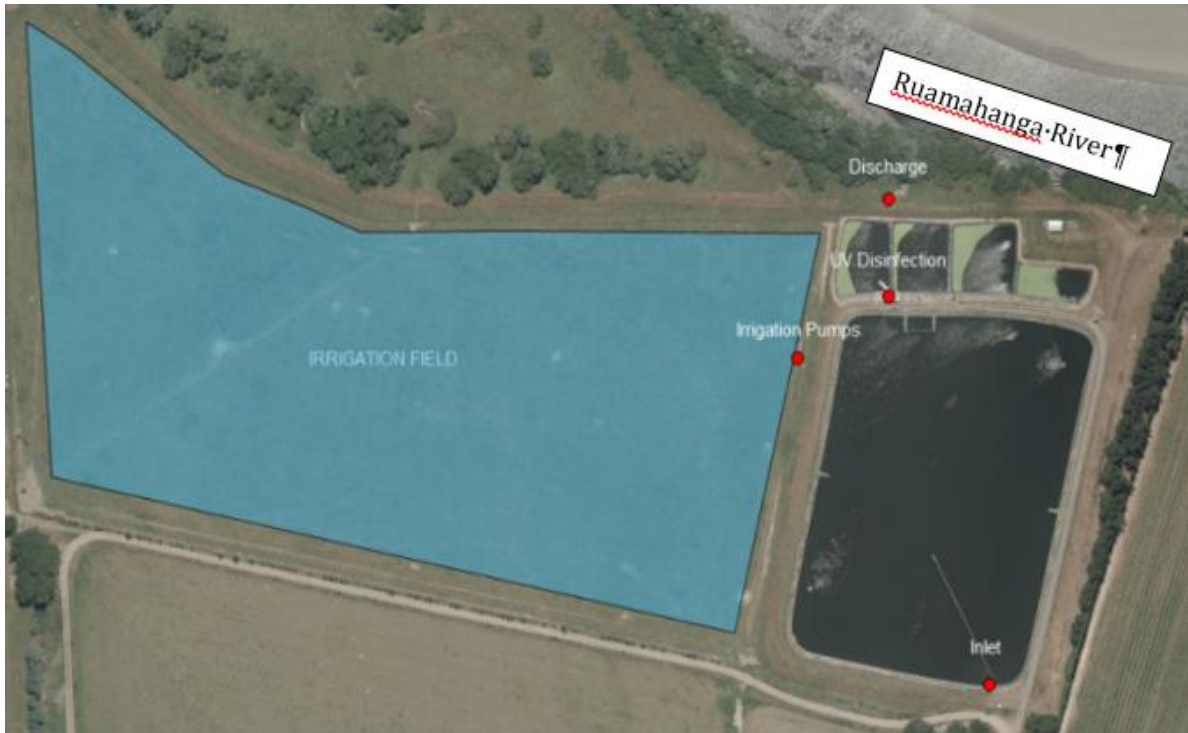
Figure 2: Aerial map of Martinborough WWTP

In summary, the only significant effect is expected to have been from elevated E.coli levels. The discharge is likely to have been about 60 times the consented average concentration, however the relative level of dilution in the river (due to the low rate of discharge) was about 4 times better than the Assessment of Effects on the Environment assumed. The net effect is that the 12.5 hour discharge was at a concentration of E.coli of about 15 times higher than the average consented discharge allows for. The levels of E. coli can vary significantly (refer Appendix 2) with a 90 percentile of 26,500 and a maximum of 190,000. The consented 90th percentile is 1,400cfu/100mL.
