Appendix F

Performance of Existing Coastal Protection Measures

F.1 Section 1 – DOC Station

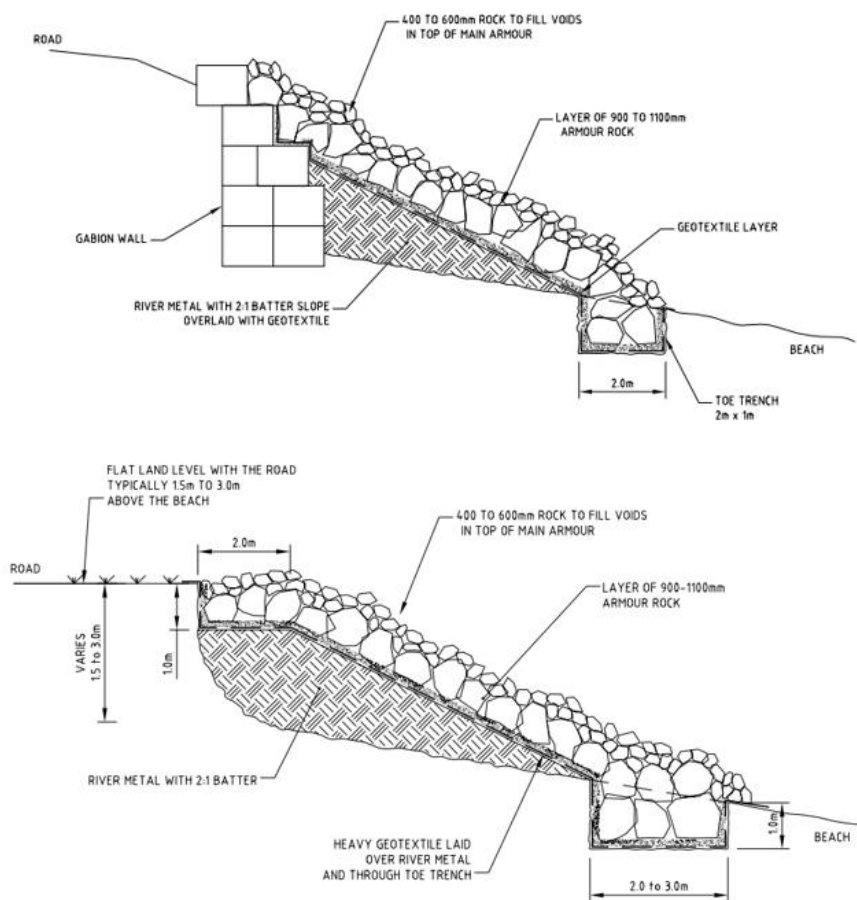
Figure 26: Original revetment design with and without gabion wall (Beca, 2009).

The original revetment design is shown in Figure 26. These original drawings show that the revetment was design with a single layer of armour rock over a geotextile layer. One of the main advantages of rock revetments, is their ability to dissipate wave energy: a combination of rock layers allows the dissipation of some incoming wave energy instead of fully reflect it.

Furthermore, the toe detail indicates a trench of only 1 m below beach level. The toe detail is a key element of a revetment, hence needs to be designed according to expected wave conditions and foreshore variations. Due to the dynamic nature of the beach foreshore at Cape Palliser, i.e. seasonal and episodic fluctuations of the foreshore's vertical level, the toe detail combined with limited capacity of the single rock layer to dissipate wave energy has proven to be insufficient to maintain an adequate level of service for the road.

The latter led to a high maintenance structure with a short serviceability life and currently unreliable.

- **Exposed geotextile and gabion baskets** (Figure 29). The original revetment design (Figure 26) is no longer withstanding. The rocks composing the rock revetment armour layer are now scattered along the beach creating longshore irregularities. Also, both the geotextile placed underneath the armour layer and the gabions baskets used as a wall to sustain the road embankment are now in poor conditions and exposed to sea action. As mentioned before, this coastal structure is no longer fulfilling its erosion protection function.
