Appendix A Historic Cliff Crest Alignment Plans

Appendix B Site History

Appendix C Site Hazards

Appendix D Site Geology

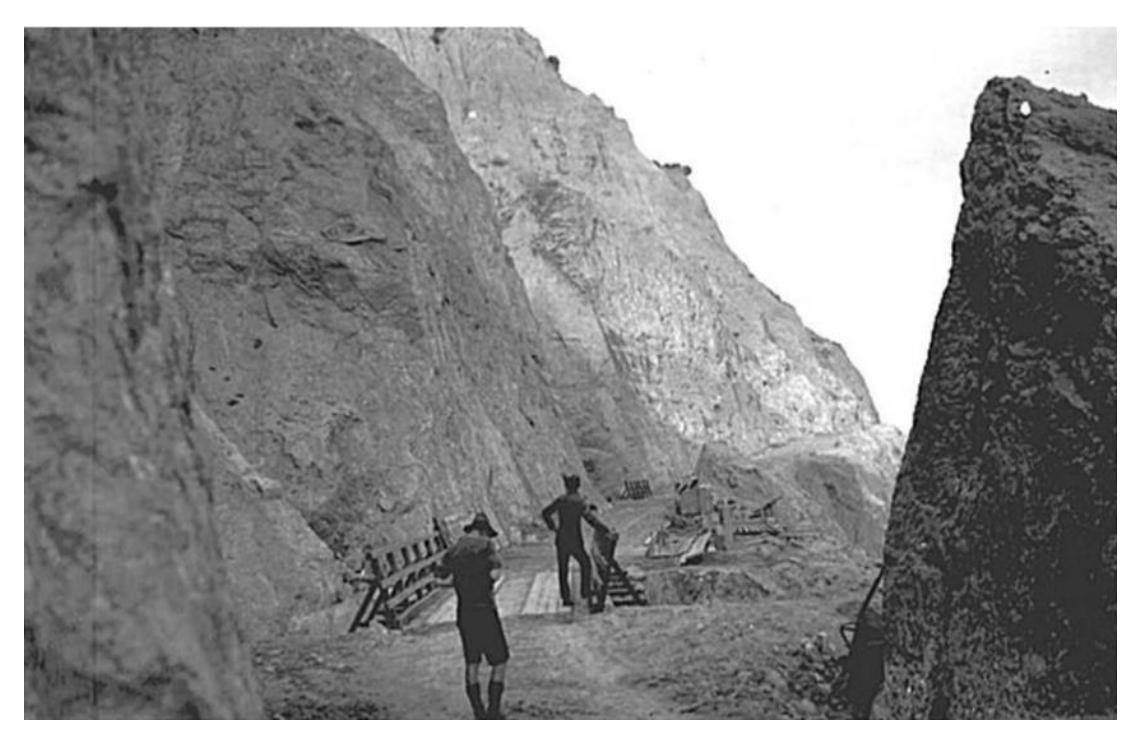
Historic photographs at Whatarangi Bluff, from 1931 and 1947, show an early iteration of Cape Palliser Road cut into coastal cliffs (Figure 9, Figure 10). The steep slopes below the road are still present today, and are vulnerable to wave erosion at the toe which leads to slumping.

Figure 9: Cape Palliser Road at Whatarangi Bluff in April 1931 (Stidolph, 1931).

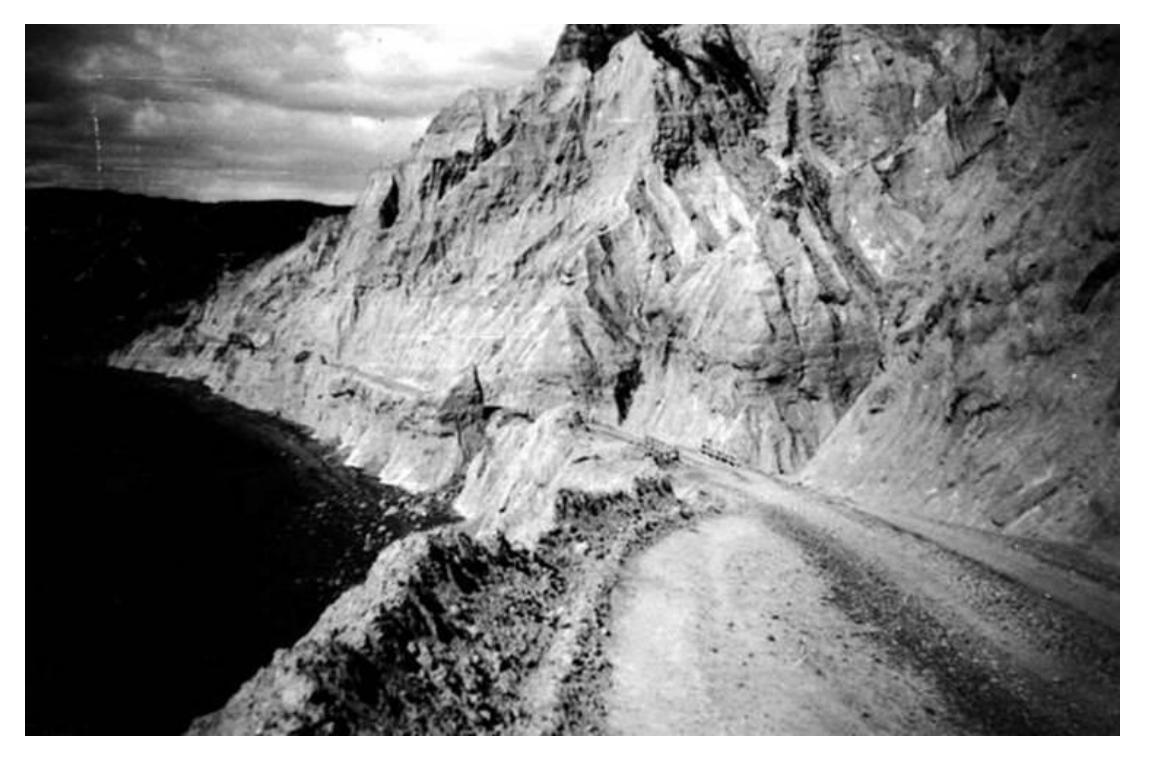
Figure 10: Cape Palliser Road at Whatarangi Bluff in 1947 (O'Brien family, 1947).

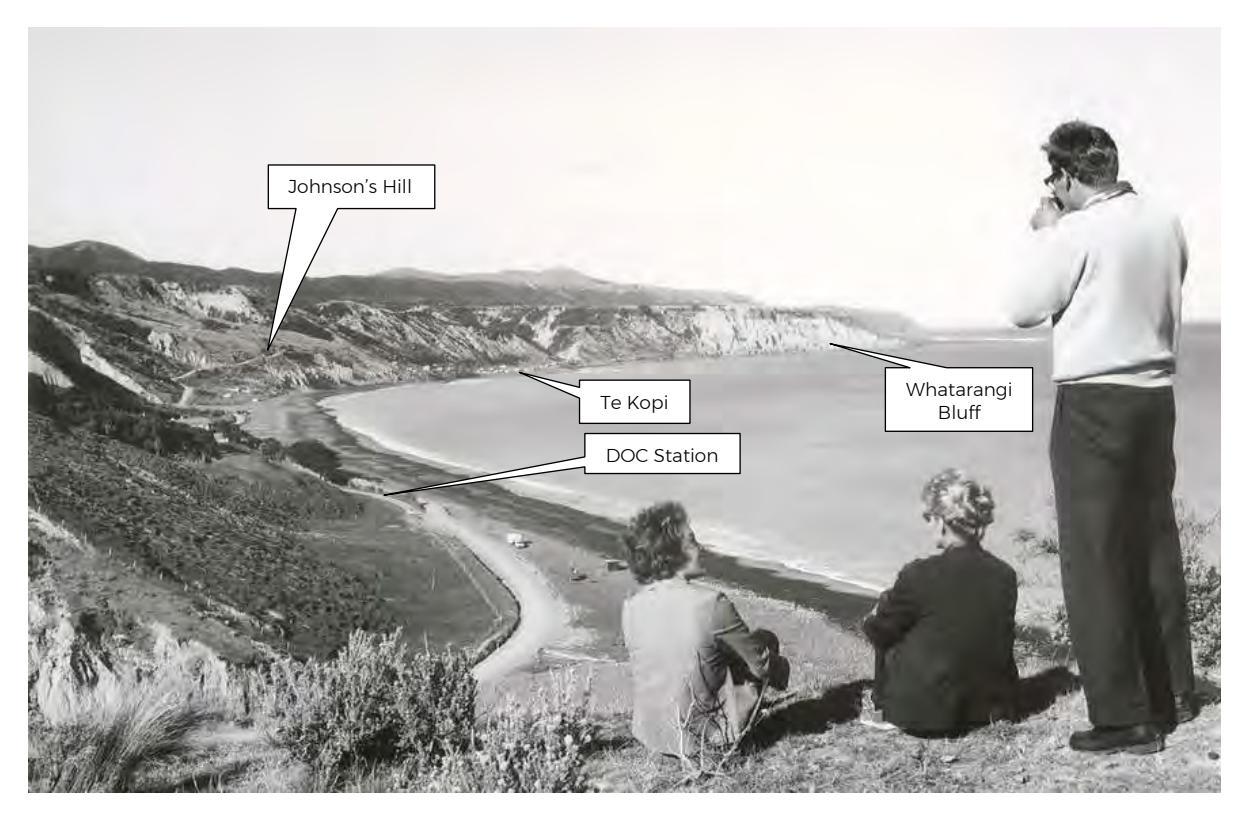
Ongoing coastal erosion also affects the road elsewhere within the study area. By comparing a 1964 photo that overlooks the site (Figure 11) to an image from August 2020 (Figure 12), it can be seen that the width of the beach in Section 1 has been reduced significantly over the past half century. The 3D model produced from WSP's 2020 UAV imagery allows this perspective view of the study area to be seen in more detail (Figure 13).

Figure 11: Cape Palliser Road in 1964, looking across the study area from Hurupi Stream to Whatarangi Bluff (Anderson, 1964).

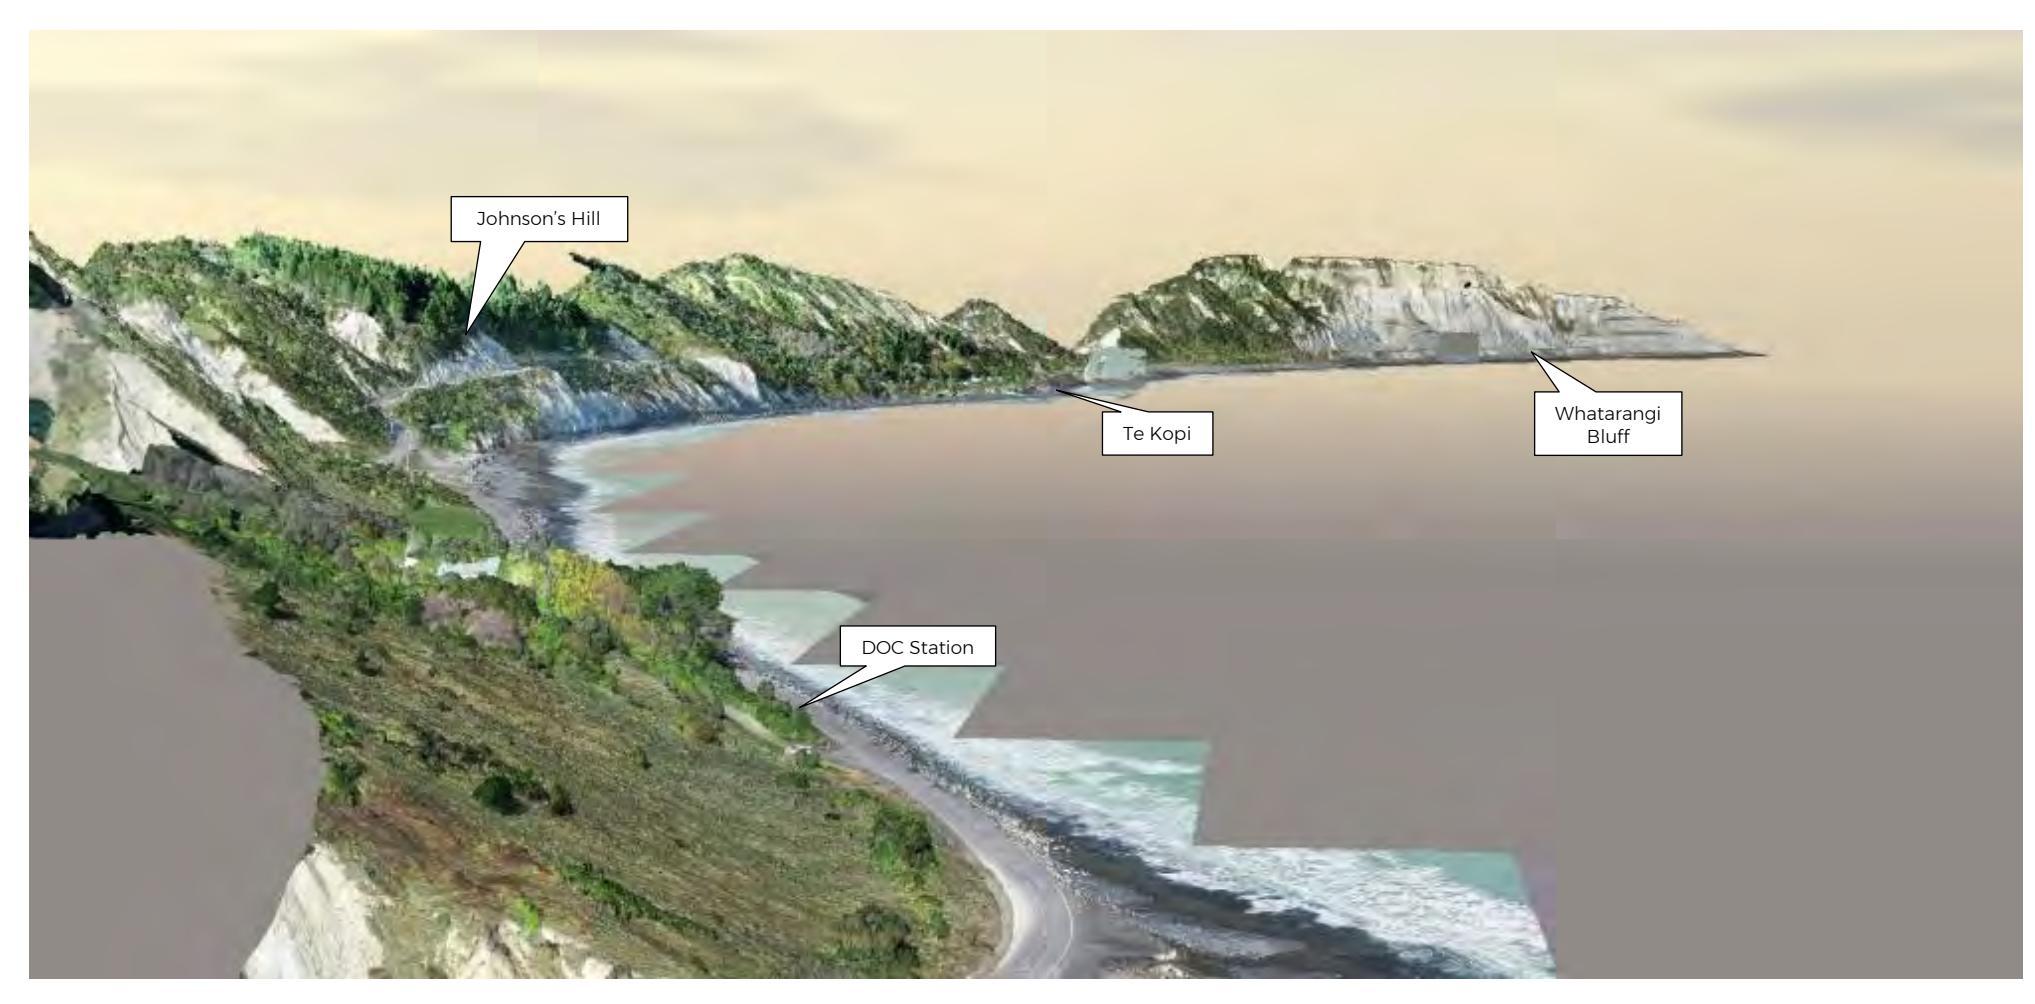
Figure 13: A perspective view across the study area at Cape Palliser Road, as seen in the 3D model produced from WSP's UAV survey imagery, captured in May 2020 for this study.

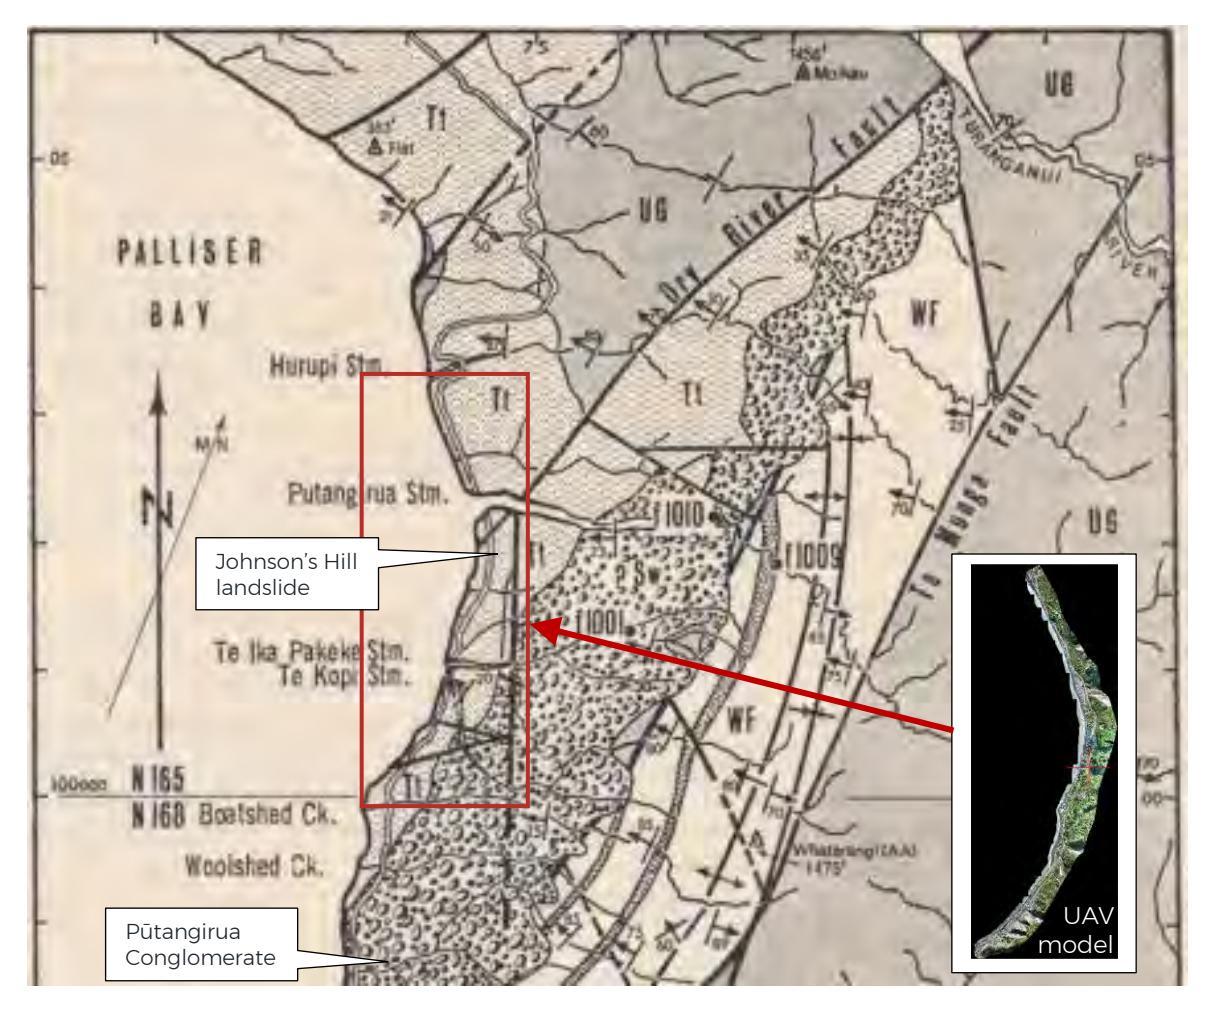
Figure 19: Geological map of eastern Palliser Bay from Bates (1969), showing bedding orientation angles within the Bells Creek Mudstone (Tt) and inferred faults.

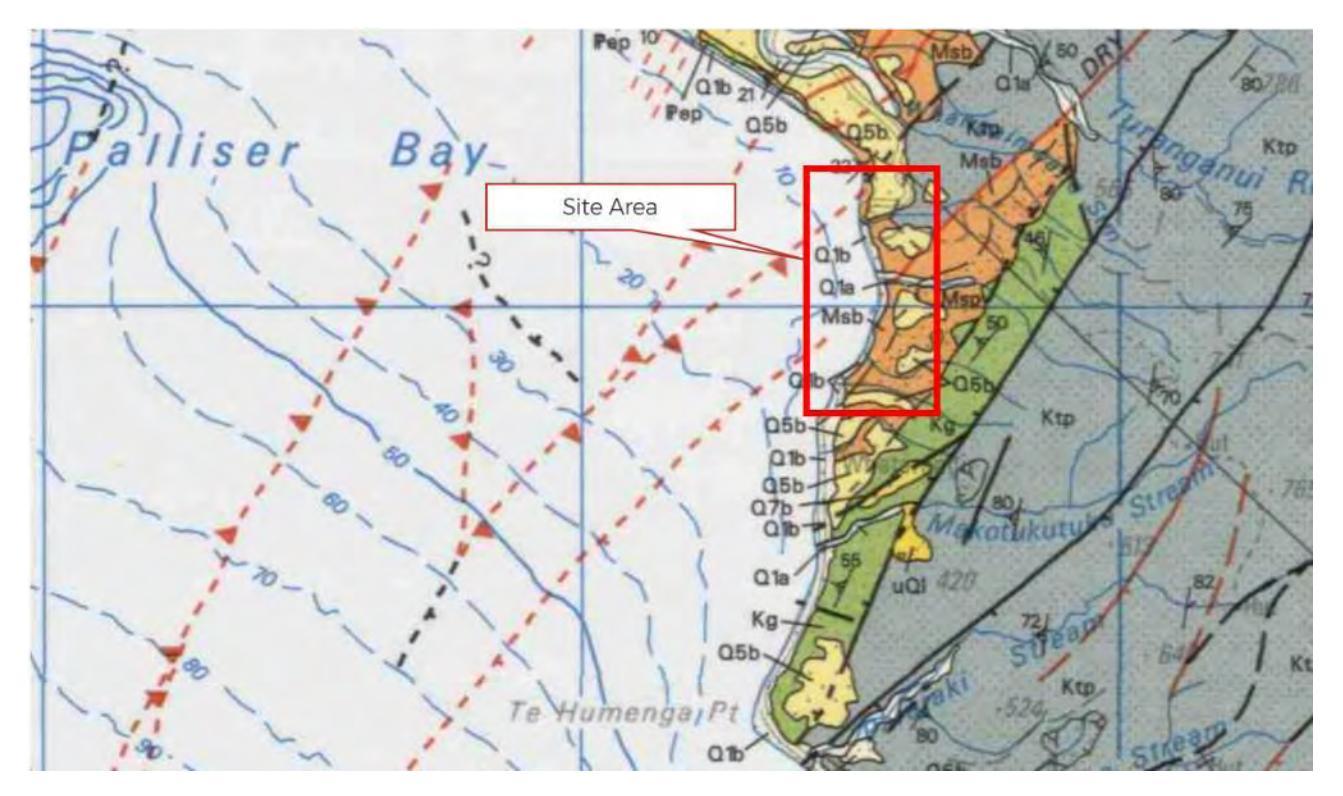
Based on the GNS regional geology maps of Wellington (Begg & Johnston, 2000), the geology of the site is variable. A geology map from Bates (1969) shows bedding orientation angles and fault locations as inferred in 1969 (Figure 19). As indicated in Figure 20, geological units encountered across the study area include:

Figure 20: Geological map of eastern Palliser Bay from GNS (Begg & Johnston, 2000)

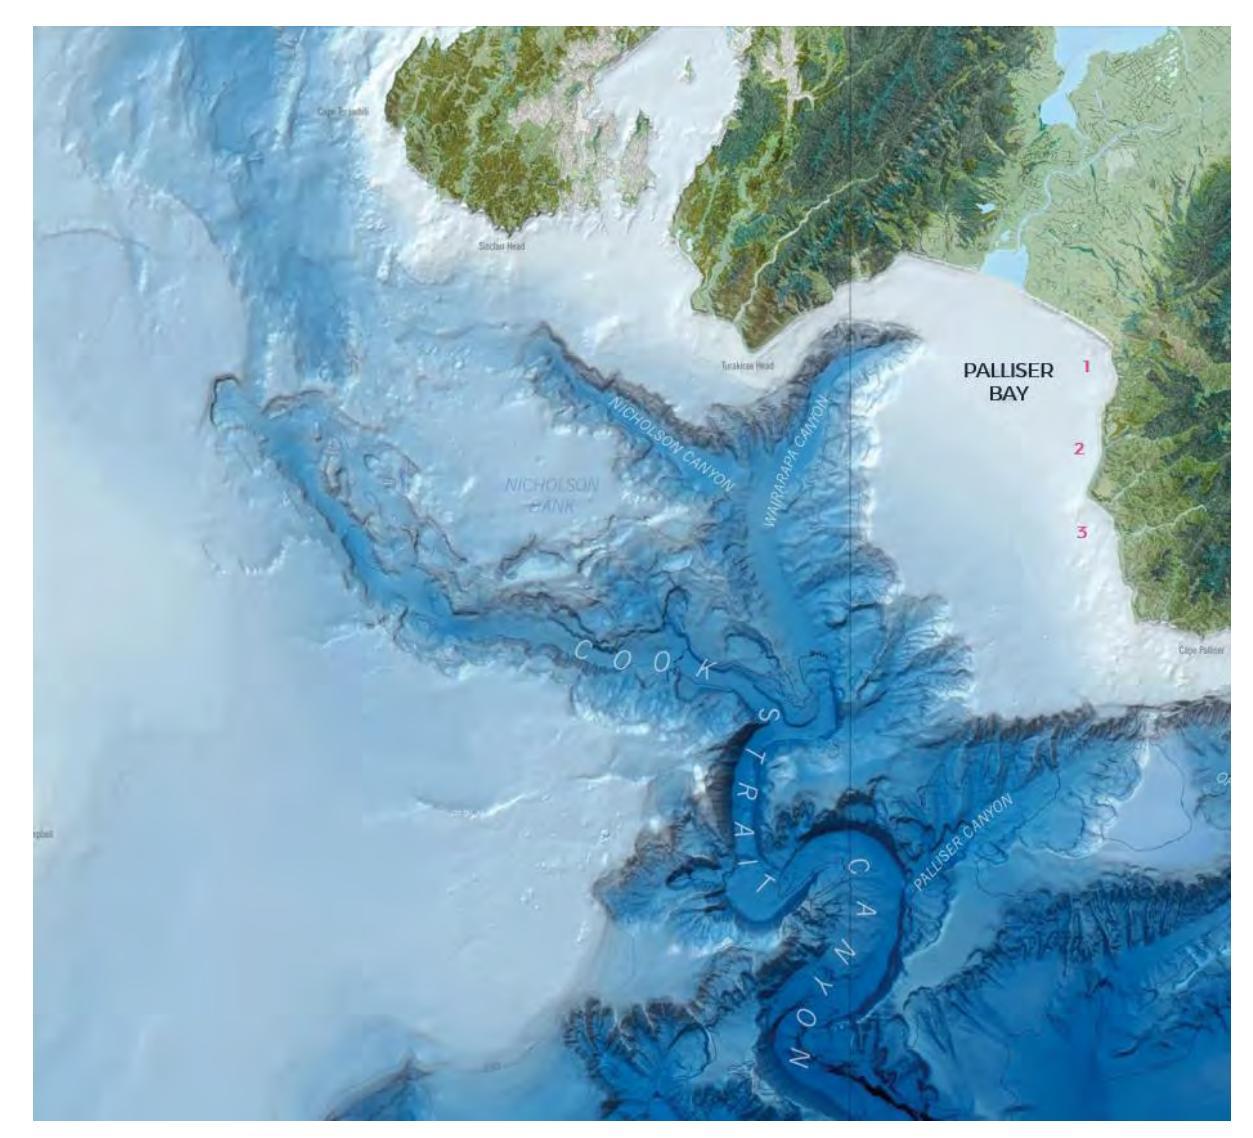
Figure 23 shows the bathymetry of the Cook Strait, offshore Palliser Bay, where the Cook Strait canyon is easily identifiable. Barrow (2002) highlighted that eastern Palliser Bay, where the study site is located, is an area where cliff recession rates are particularly high due to the rapid marine erosion of soft mudstone and sandstone cliffs. He observed "the more resistant rocks retreat more slowly and remain as headlands while weaker formations are cut back to form embayments".

Figure 23. Poster showing the bathymetry of the Cook Strait Canyon, offshore of Palliser Bay (NIWA, 2009). The Palliser Bay label and the magenta numbers have been added later. The magenta numbers refer to an approximate location of data points for wave heights.
