HINEKURA ROAD EROSION AND LANDSLIDE REMEDIATION REPORT

HINAKURA HILL - RECOMMENDED EROSION AND LAND SLIDE REMEDIATION PLAN

To	Ben Turner, Tim Langley (South Wairarapa District Council)
From	Giles Farquhar, David Stewart
Office	Wellington
Date	16 August 2021
File/Ref	5-C4072.01; GER Report 2021/46
Subject	Hinakura Road Landslide July 2021 Assessment

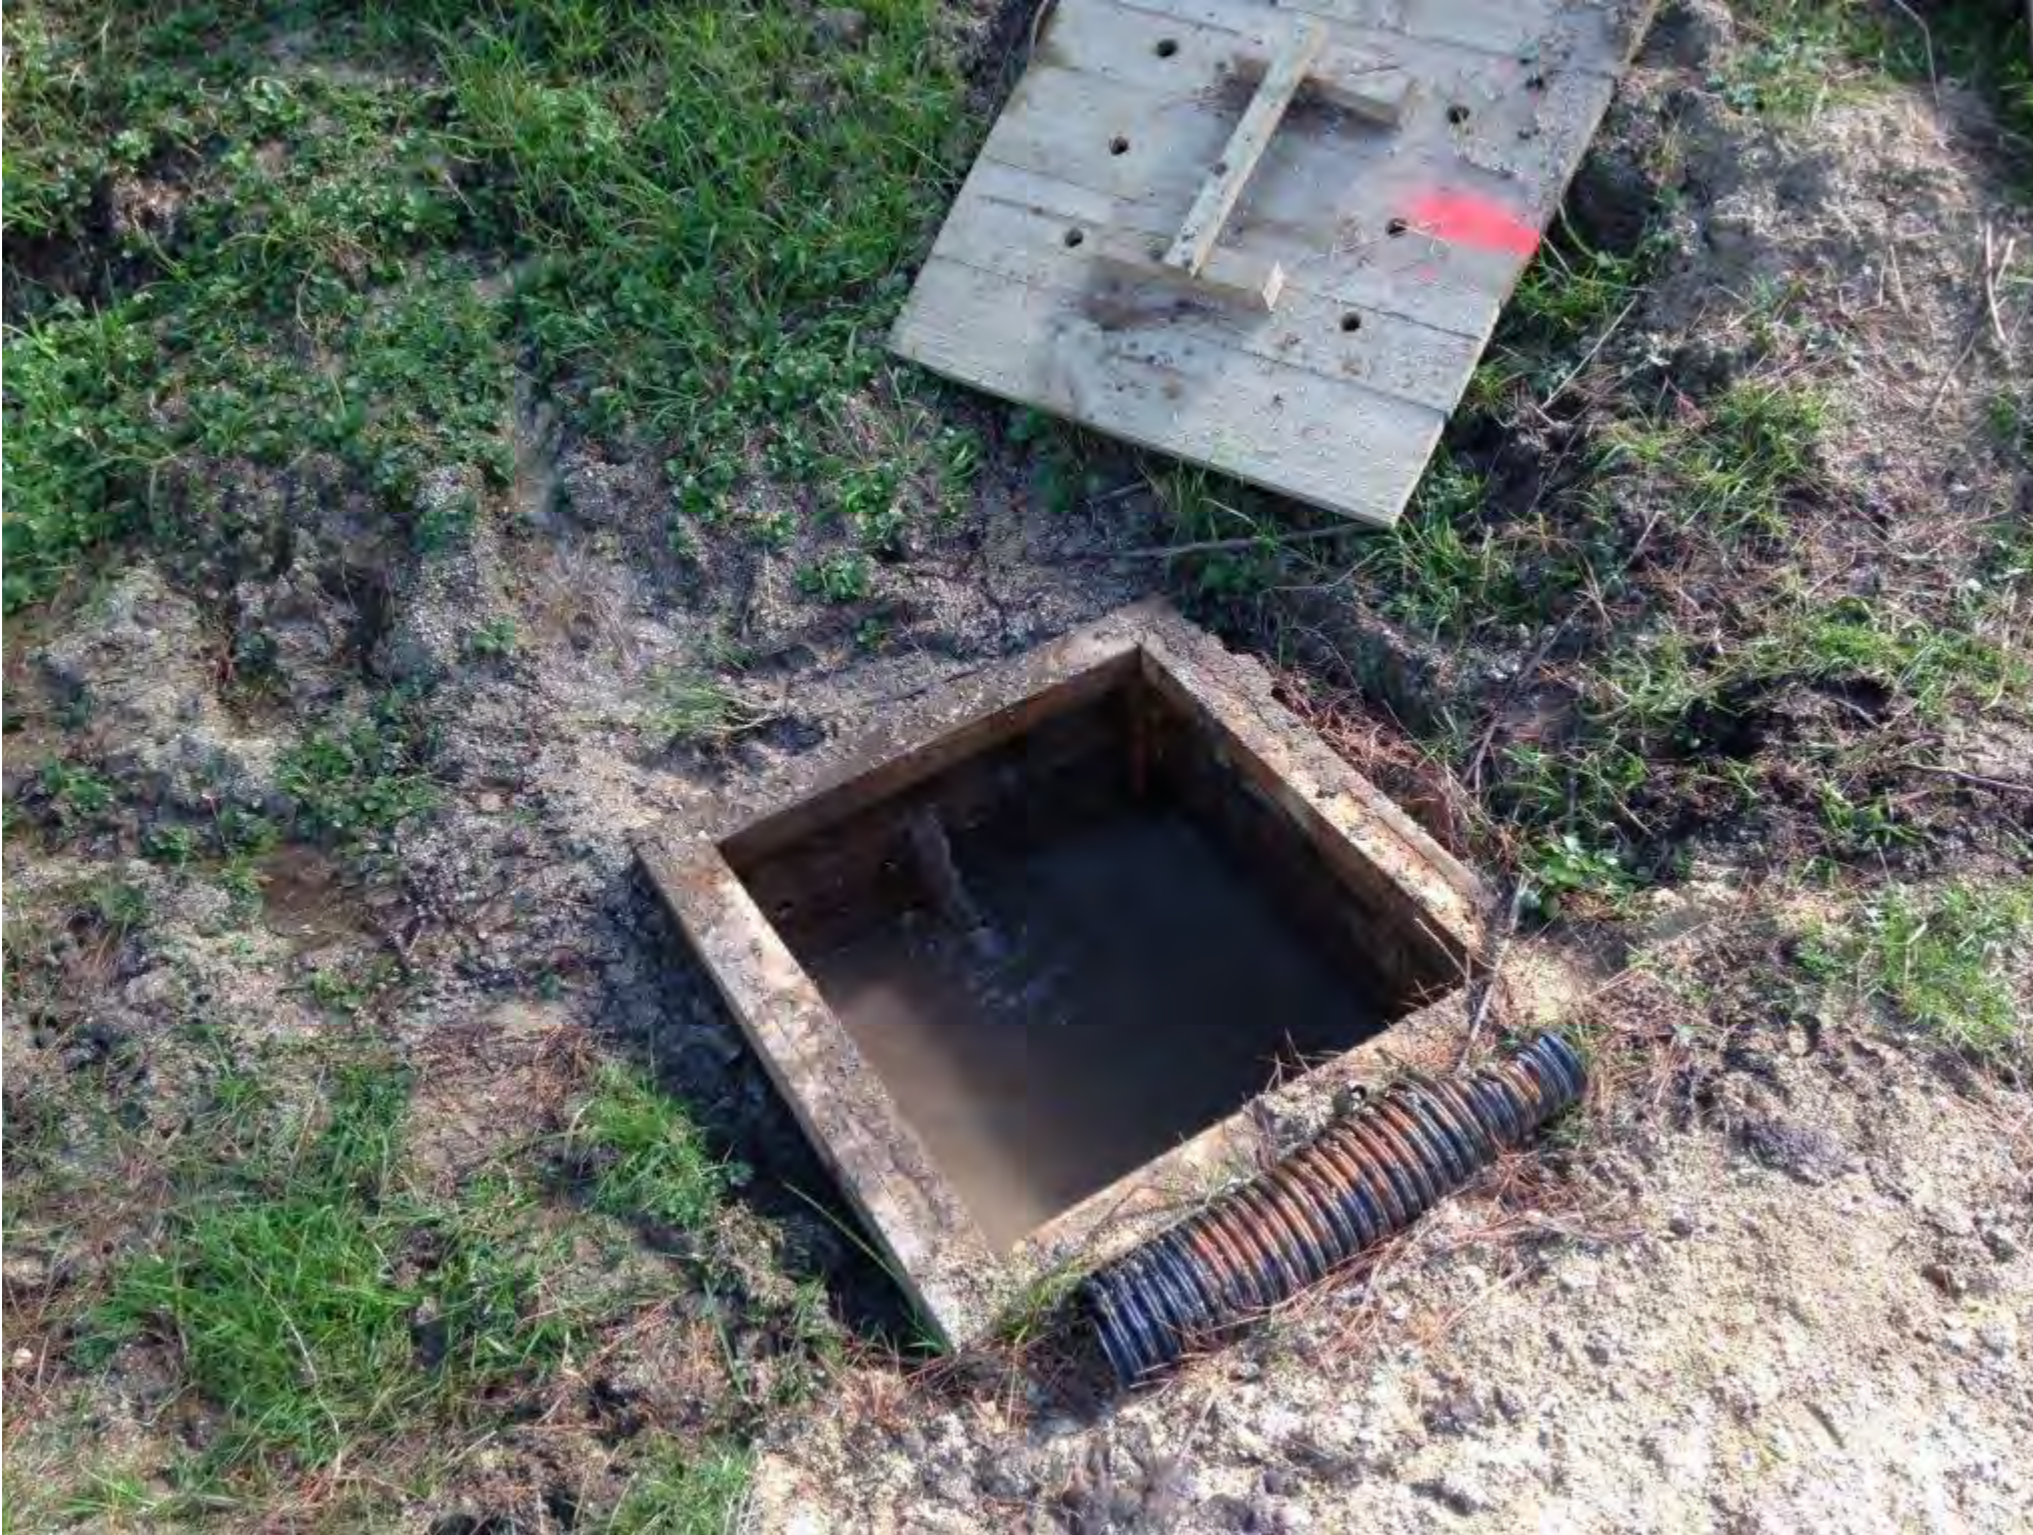
Appendix 3

Picture of a catching box, with inlet visible where water is running. An outlet is on the other side of the box.

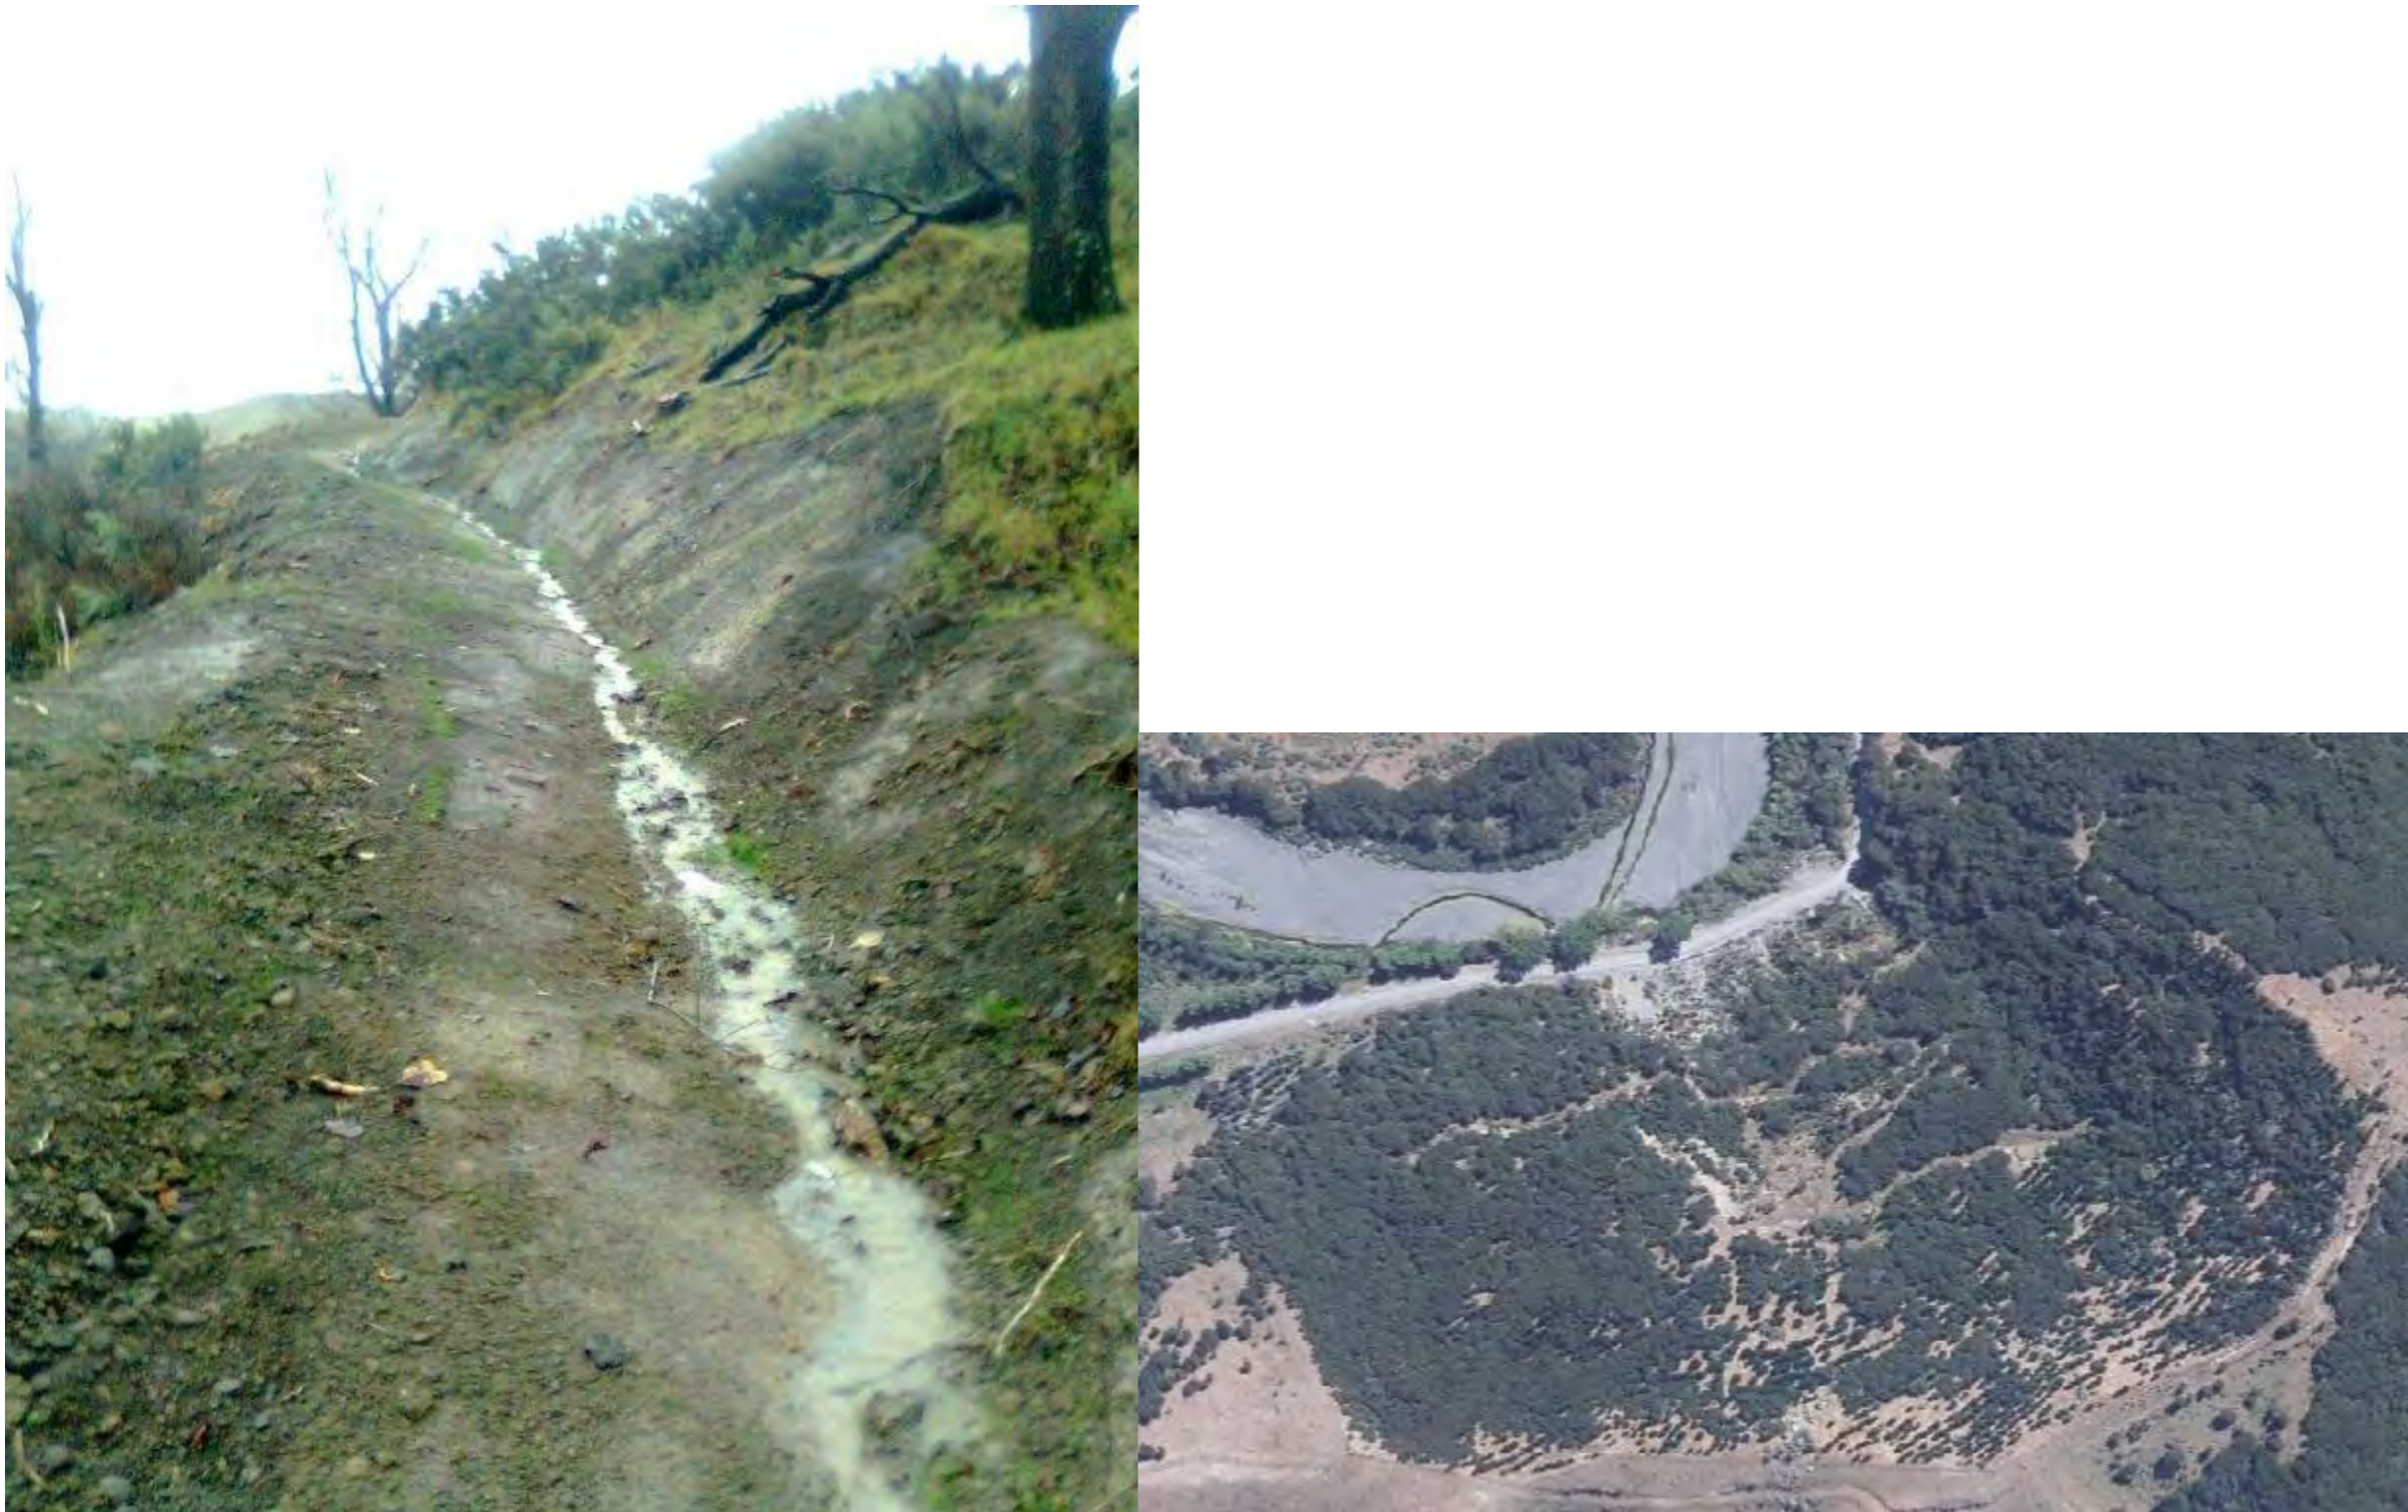
Picture of a v drain, with the aerial view of this v-drain on the right, White Rock Road.

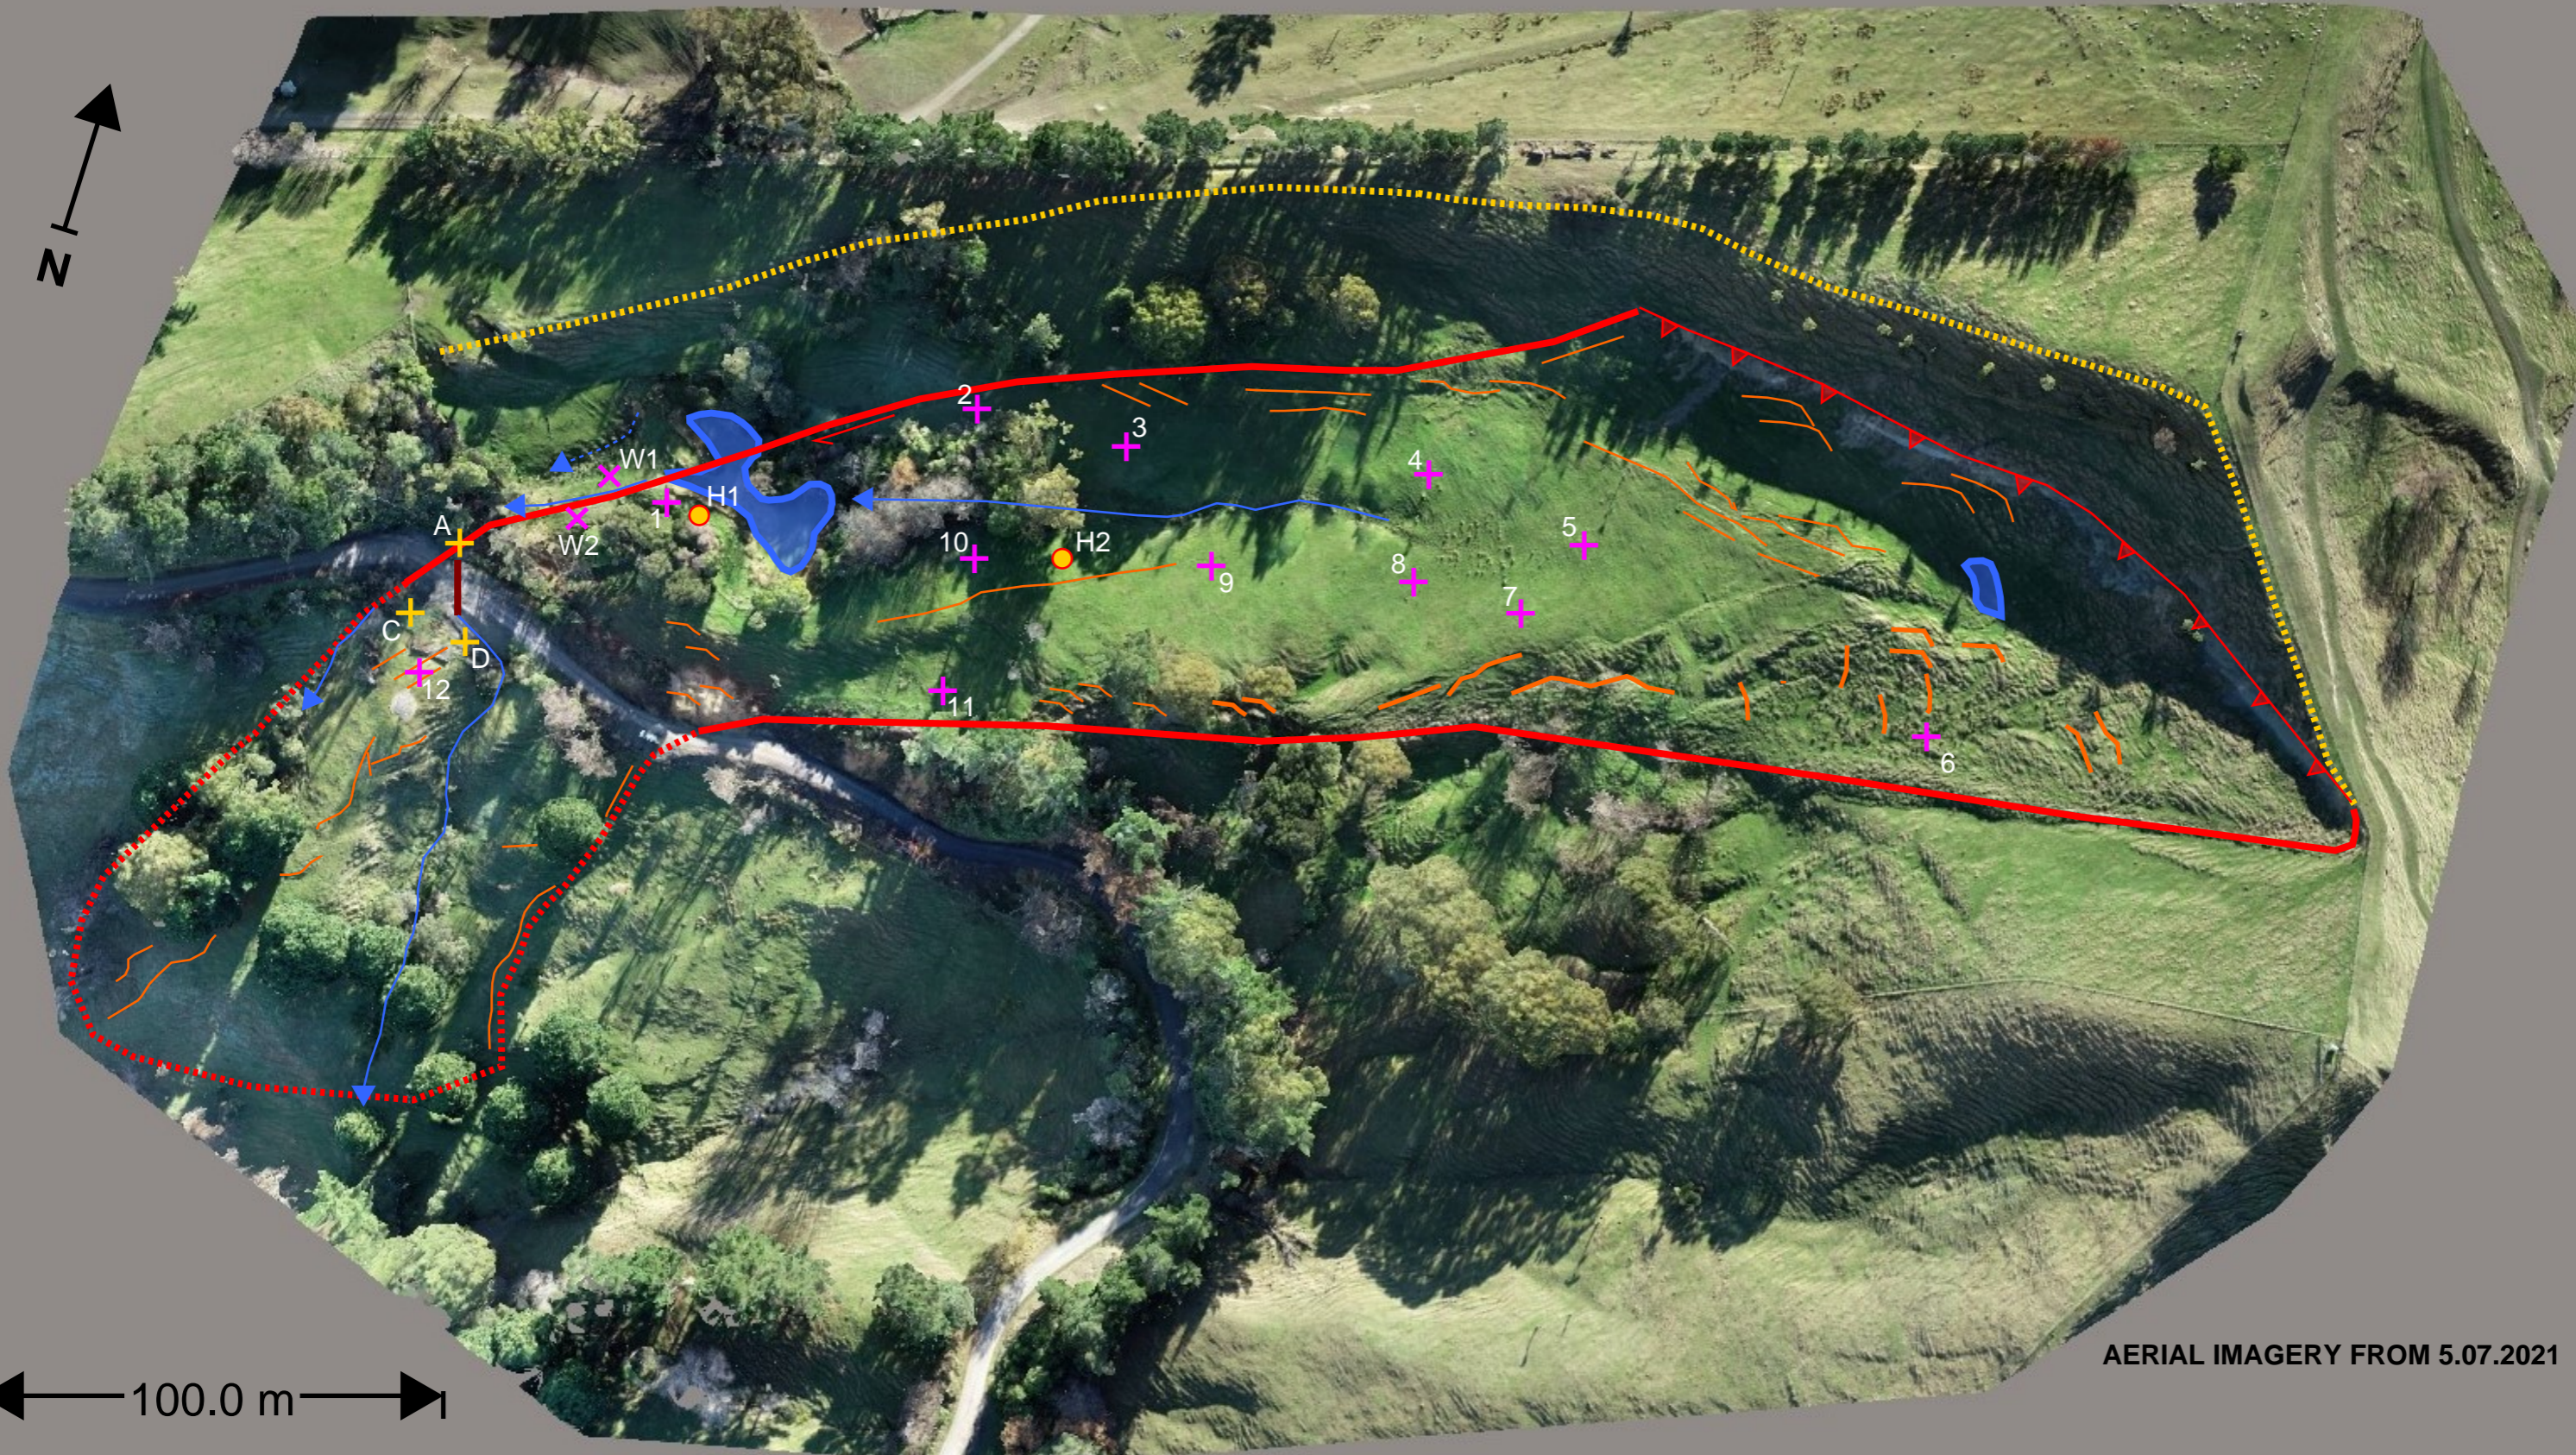
Appendix B – Engineering Geology Map

Two hand auger investigation holes were carried out in an attempt to get information on ground characteristics and identify the failure depth. One hand auger was located on the dam crest and the second to the east of the dam, but reaching only 1.5m and 1.0m depth respectively. Both hand augers were terminated due to the stiff squeezing nature of the soils and the failure plane was not identified. Hand auger locations are displayed on the Appended Engineering Geology map (Appendix B).

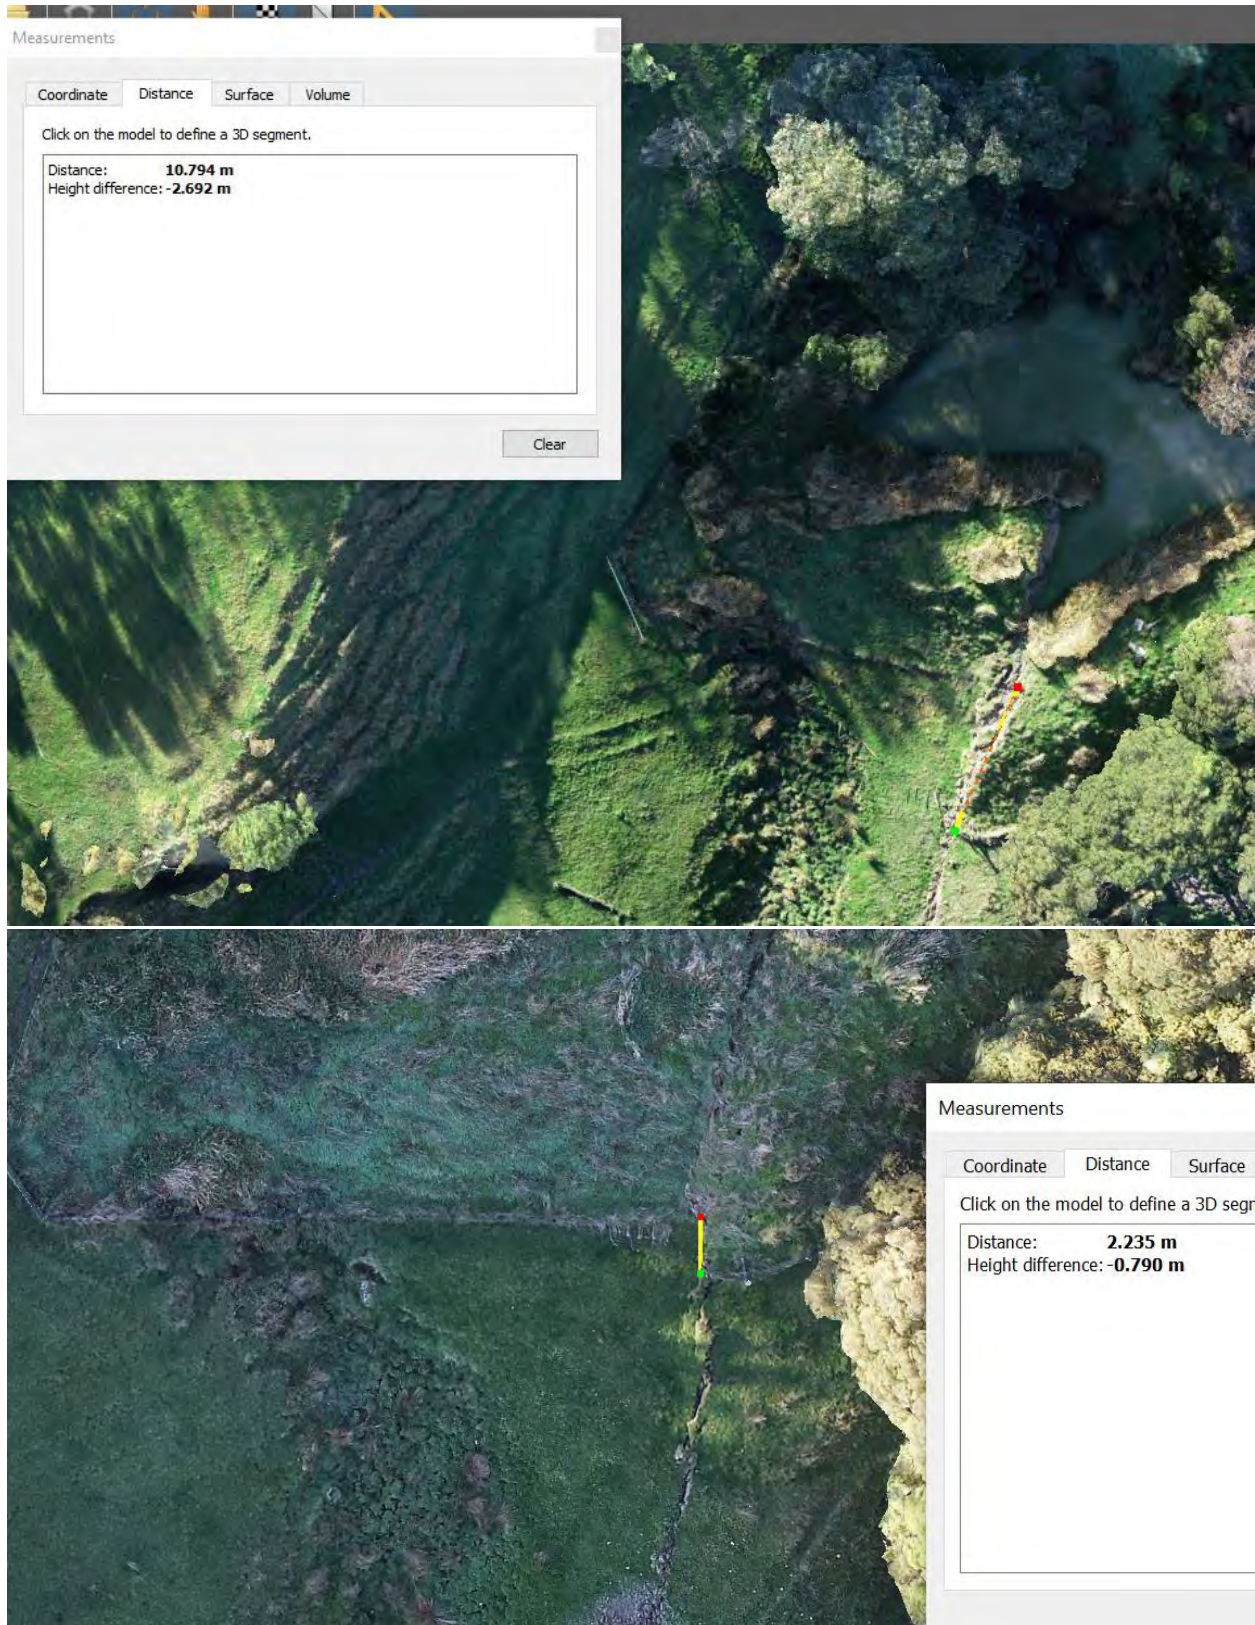
Appendix D: Measurements of Fence Offset below Dam off 3D models July 2021 and June 2020

Total horizontal offset of ~ 10m is indicated at the dam crest as the fissure marking the western extent of the landslide intersects the dam (Figure 1a). Horizontal movement of the fence below the dam crest between June 2020 and July 2021 is ~8.5 m (compare Figures 1a and 1b and Figures 2), with about 1.6m of vertical displacement over this 12 month period (refer Appendix D). Comparison with the 2013 LiDAR (Figure 2) shows that much more movement happened in the last 12 months than the period between 2013 and 2020.
