CONSERVATION AND MAINTENANCE PLAN

'The Old Library Building' and Kouka (Cabbage Tree) Cottage

> at Stella Bull Park Greytown GJ/RW/1515 November 2009

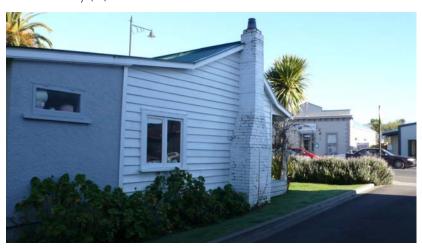
Brick chimney (hf)

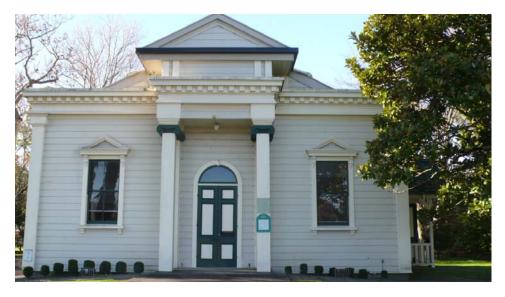
"Old Library Building" Stella Bull Park, Greytown – Street (West) Elevation (former Masonic Lodge, relocated)

Painted timber columns (hf)
