MARTINBOROUGH TOWN HALL

CONSERVATION PLAN

August 2011

The Conservation Plan has been prepared by David Kernohan BArch, MSc, FNZIA, Architecture Diagnostics, c/o Gladstone Vineyard, Gladstone Road, RD2, Carterton.

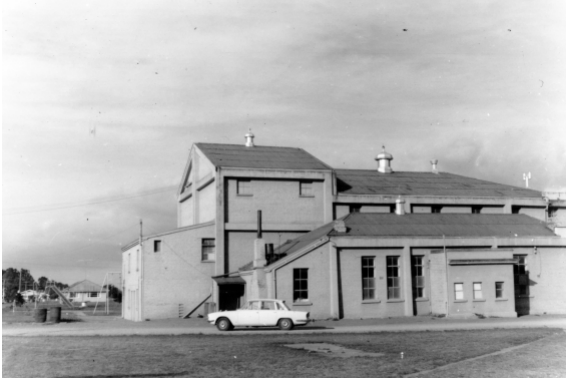
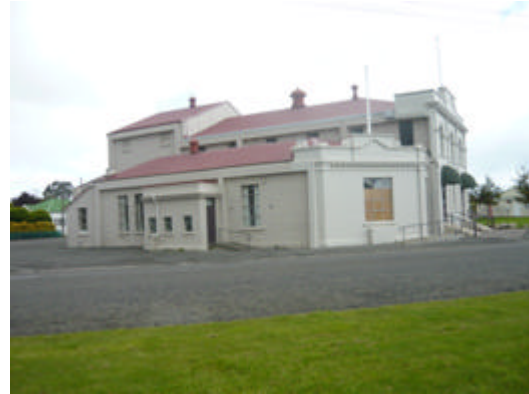
In general terms, the east facades of both the main auditorium and of the annex are essentially original and in good condition though it is unclear just how much of the remedial work recommended by Spencer Holmes (2007) has in fact been carried out.

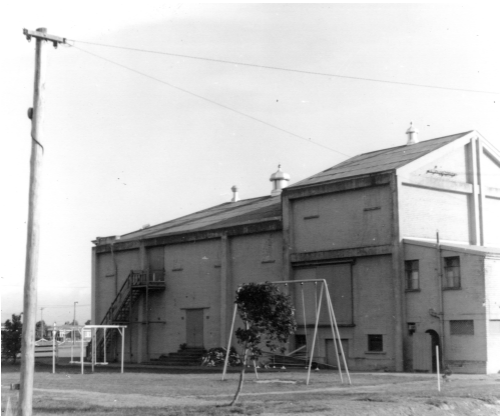
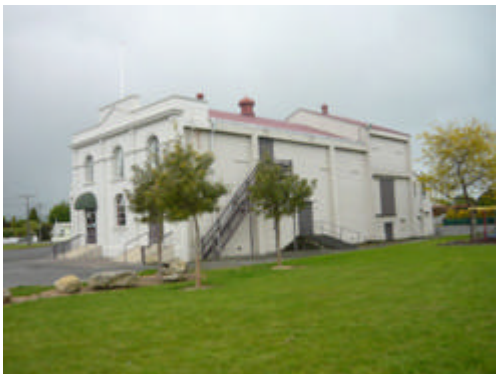
Also constructed in painted un-reinforced brick masonry, this façade is largely utilitarian in aspect but authentic save for the addition of the structural bands applied in 1944. The three principal bulks are the hall itself, the stage and the back of stage facilities.

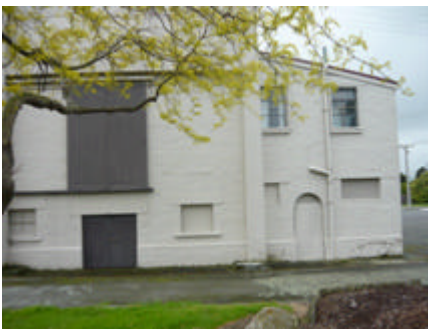
Stage service access and toilet at lean-to storage area

There is clear slumping of the lean-to storage building. This is due most probably to a soak pit or similar having been located too close to the south-east corner of the lean-to, undermining the foundations.

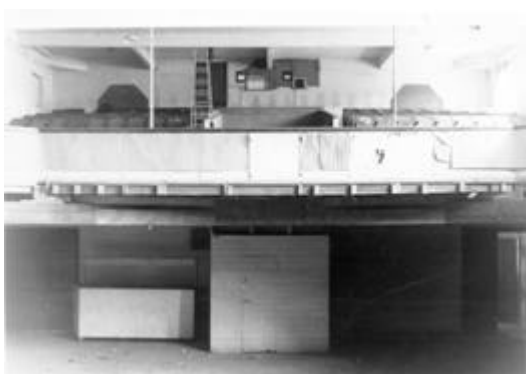
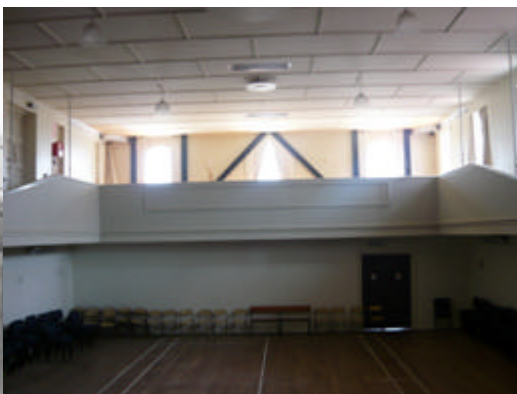
The gallery has been severely foreshortened, apparently to provide floor space for badminton. The side wings remain essentially intact but the principal area has been reduced from about 12 rows of seats to effectively two. The rear wall of the auditorium is dominated by the steel cross braces inserted in 1997 to improve the building's performance and safety during an earthquake. Formerly, there were two entry doors to the auditorium aligned with the external doors. A stair placed centrally and accessed from the foyer led to the gallery. Now, there is no effective access to the gallery (see below).

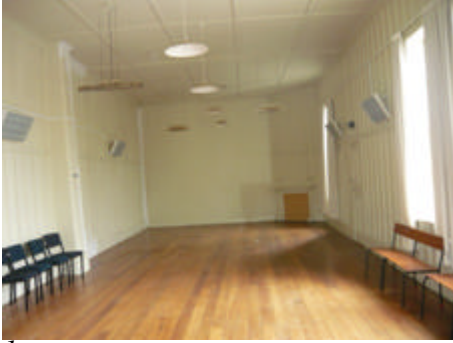
1

1. Beyond, but not accessible from this end of the room is the ladies' toilet. The door on the right leads to what was formerly the Town Clerk's toilet. The lost fireplace could be re-instated.
2. View towards kitchen with serving hatch and door. To the right is a short stair and door leading to the auditorium. Floors, walls, and ceiling are original though the latter two have contemporary paint regimes..

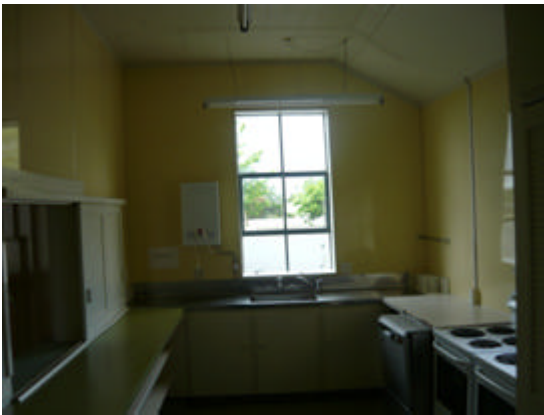
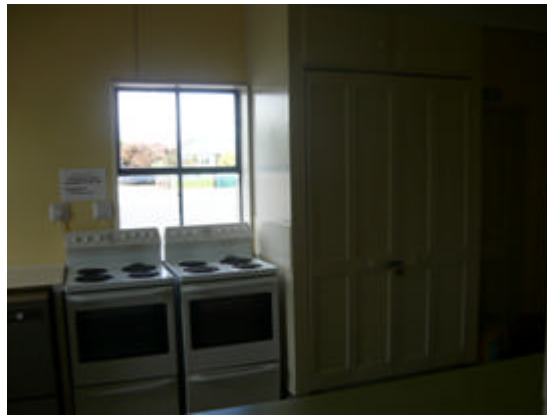
Kitchen

The kitchen space is essentially original as are the windows and possibly the doors. Equipment, fixtures and fittings have been changed over time. The fireplace has been removed and the chimney no longer serves any functional purpose.

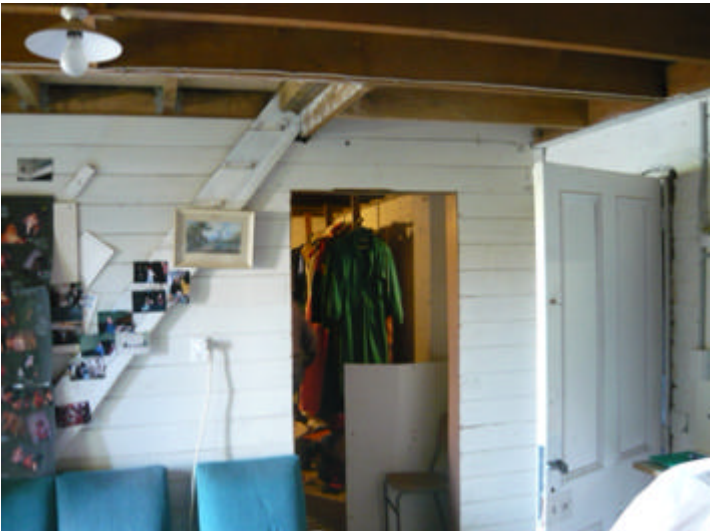
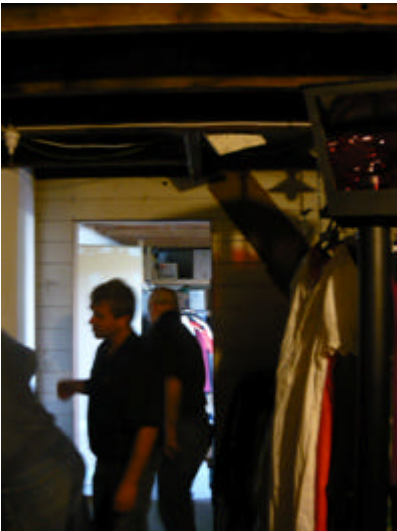
This area has experienced much change over the years. Nevertheless its original ‘shell’ is intact.

Stairs and walls have been removed, re-configured, adapted in various *ad hoc* ways. Formerly, public toilet facilities were provided at ground floor level but these are no longer open. Without a serious “clear out” it is difficult to ascertain authenticity and condition. This part of the building has been used in robust and pragmatic ways – possibly its intended function.

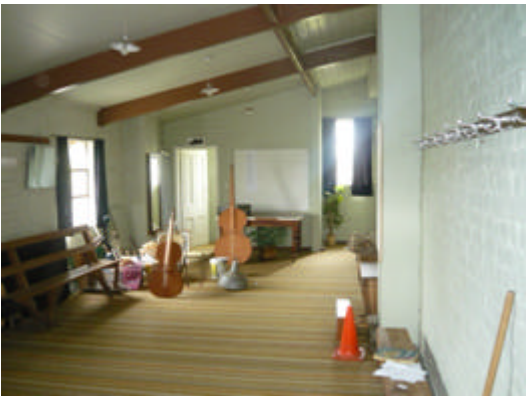
View to west

This area provides Green room and changing facilities. Toilet facilities are provided and these may have original fixtures and fittings. The whole is ‘tired’ in terms of its finishes (lime coating on brickwork) and furnishings and is inadequate spatially for current uses. Access between the ground and upper floor is external and uncovered. There is one access door to backstage.
