TREE INSPECTION

PREPARED BY
PAPER STREET TREE COMPANY

• 54A WOOD STREET GREYTOWN •

REPORT DATED: 9/12/22

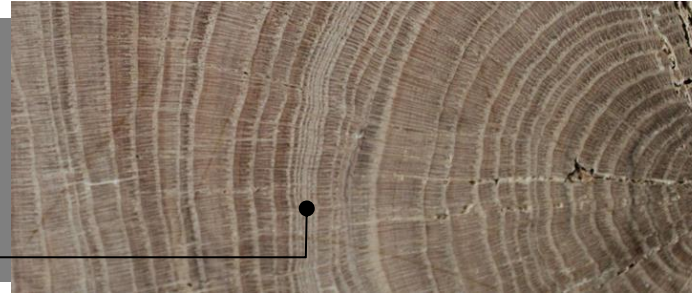
Fig.3

The tree exhibits around 25% dieback within its southern lower canopy. The decline is also present at the tree's apical reaches, along with density reduction and minimal shoot extension. Incremental growth is assessed as reduced over 2017 measurements, which is not surprising given the tree's condition.

A tree lays incremental growth each year. During times of stress incremental growth can reduce. The image on the right shows a cross section of a red oak (*Quercus rubra*) narrow growth rings correspond to periods of drought (stress).

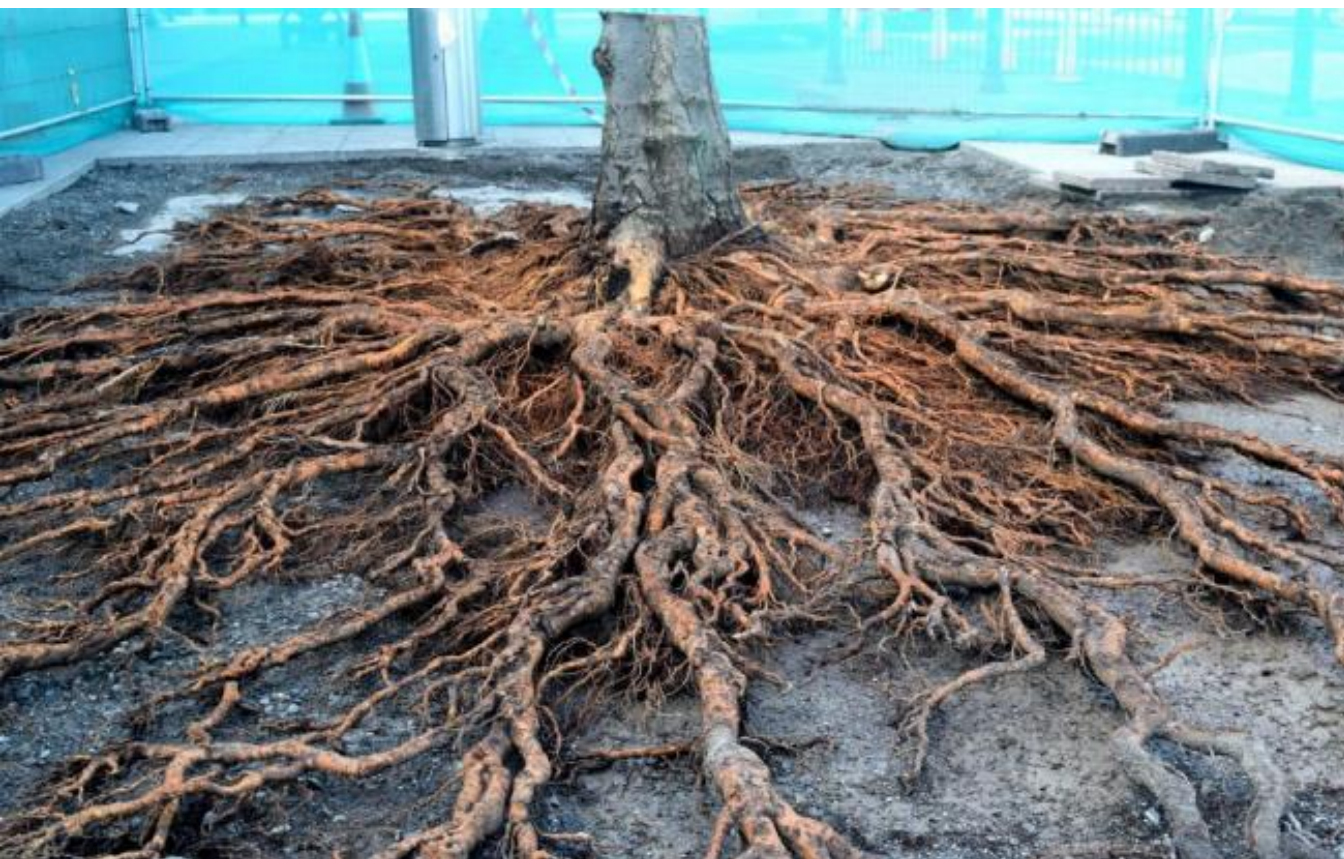
Fig.11

3.1.4 Fig. 11 is an example of a tree's root spread. However, in this instance, the tree is located on an old riverbed, where the distribution of roots on the vertical plane is likely to be broader due to the rocky nature of the soil medium.

3.1.5 However, as the above image shows, roots are generally within the upper levels of the soil, and therefore, a level drop of up to 40cm would almost certainly effected/damage the tree's southwestern root system.

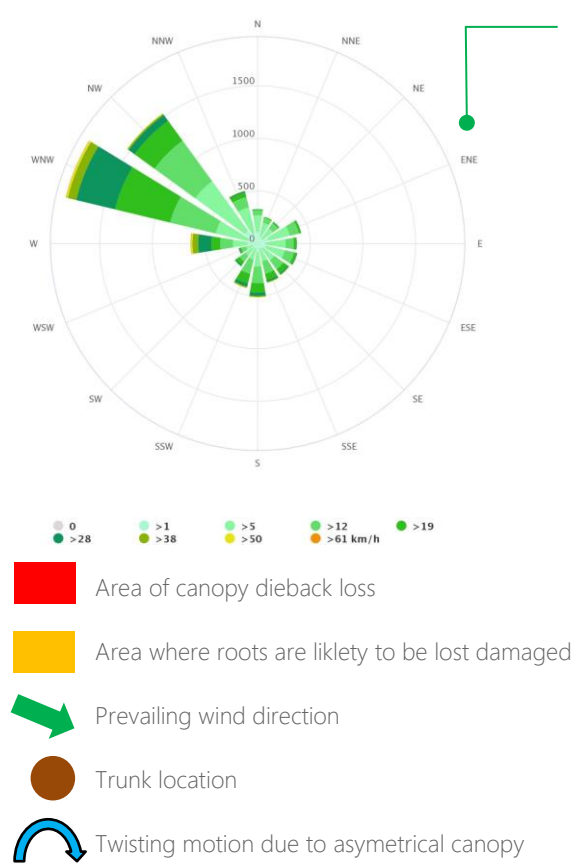
Wind rose for Greytown Meteoblue (Meteoblue.com)

3.2.4 If failure were to occur, it is considered to occur during a high-wind event. The prevailing winds would cause a torsional load at the tree's base. Due to dieback and past historical loss, the tree has developed a highly asymmetrical canopy. Considering the tree's structure, the predominant wind direction, the damage to rooting area, and the slight lean east, the tree is highly likely to fall in an easterly direction.

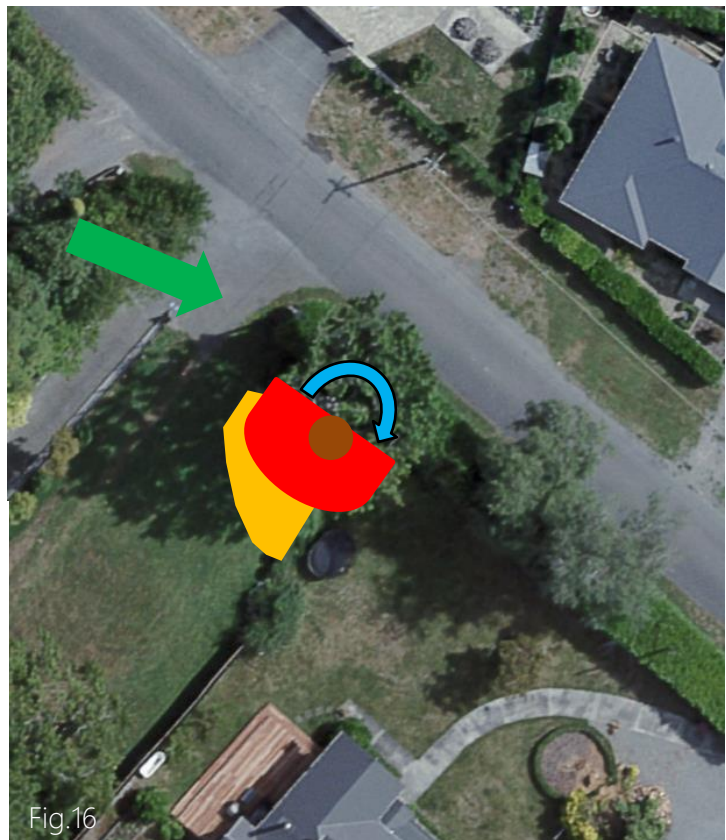
Fig.16

3.2.1 Overall, the tree's structure is assessed as poor.

3.2.2 The tree has a mechanical weakness due to decay and possible weakness caused by root loss/damage. As the previous images shows, the decay area is at the base of the stem which will spread within its roots. It is assessed that failure of the weak point would result in whole tree failure.

3.2.3 The tree has been reduced by 26%, which can lead to around 50% reduction in load at a tree's base (Rinn, 2014). Due to the reduced loading at the tree's base, the likelihood of failure is seen as emerging (i.e., low current chance of failure, but the wood-holding properties are diminishing in strength).

- 4.7 Therefore, I recommend removing the tree and planting a replacement tree.
- 4.8 Please do not hesitate to get in touch should there be any further questions or queries
