# SWDC - Whakatomotomo Road Slip – Remedial Options Memorandum

Prepared for:  
SWDC

Prepared by:  
Stantec New Zealand

Project/File:  
310206618

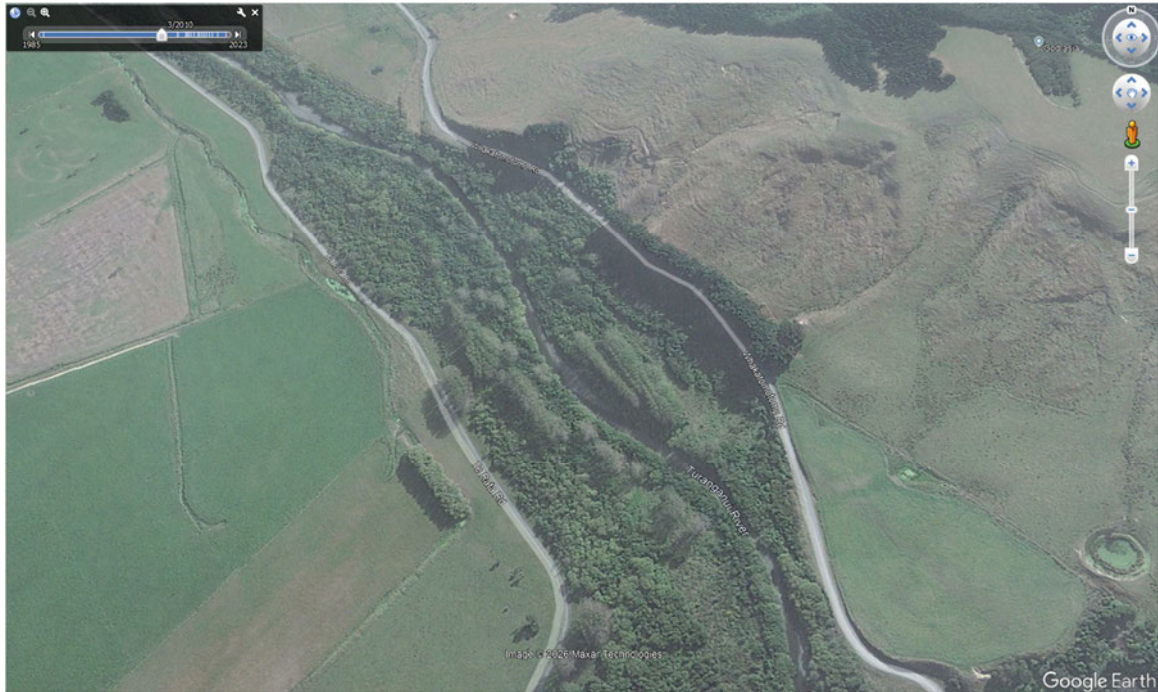
Figure 14: Aerial image of the site (Google Earth, March 2010).

Available Google Earth imagery is presented in Figure 14 to Figure 18. The imagery indicates that, up to 2021, the road was protected by a natural river berm. However, since 2023, the river channel appears to have progressively migrated towards the road, reaching the location of the observed failure.

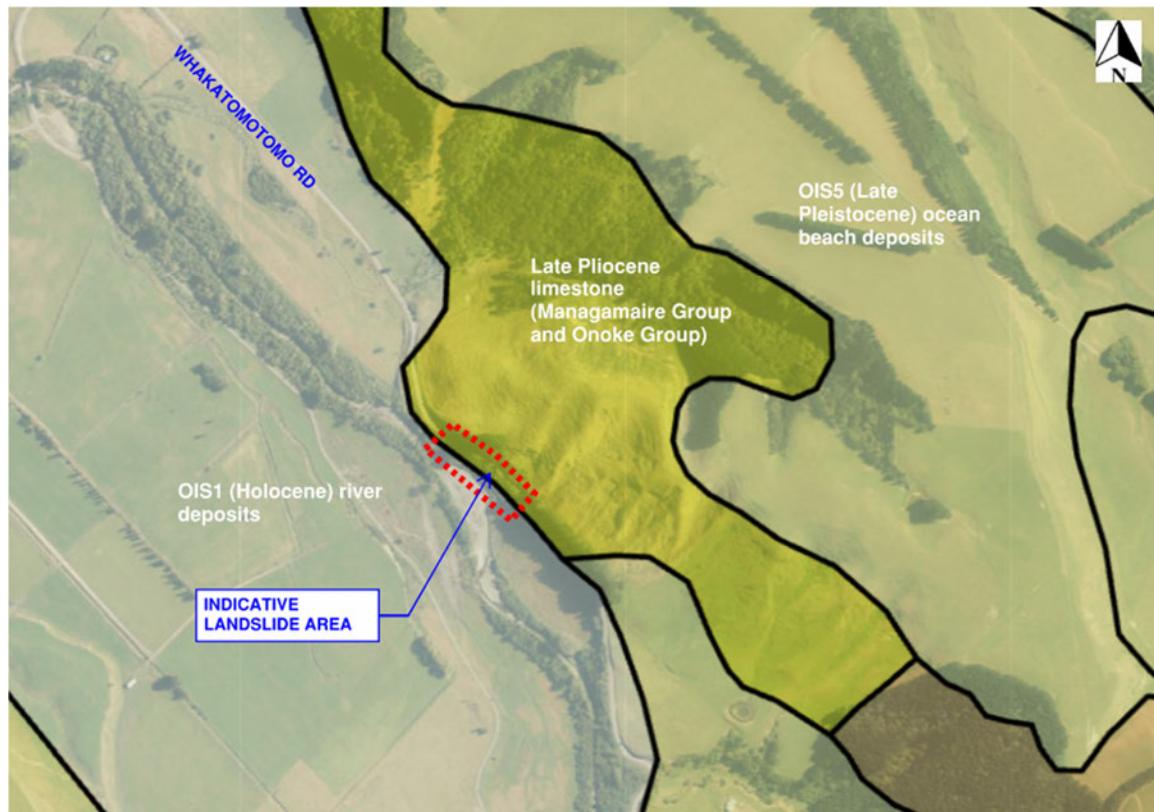
Figure 19: GNS Science 1:250,000 geological map at the landslide location

According to the GNS Science 1:250,000 geological map shown in Figure 19, the site is underlain by Late Pliocene limestone of the Managamaire Group and Onoke Group, comprising poorly to well-cemented shelly limestone, coquina, calcareous sandstone, and siltstone and sandy mudstone with minor grit.
