SOUTH WAIRARAPA DISTRICT COUNCIL

**ORDER PAPER FOR AN EMERGENCY MEETING
TO BE HELD IN
The Supper Room, Waihinga Centre, Texas Street,
MARTINBOROUGH
ON
24 April 2019**

Document Details	
Client	South Wairarapa District Council
Project	Martinborough Incident Review
Project Number	SWDC001
Report Title	Martinborough Water Treatment Plant – Incident Review
Report Number	SWDC-R01-11
Report Status	Final
Issue Date	04/04/19

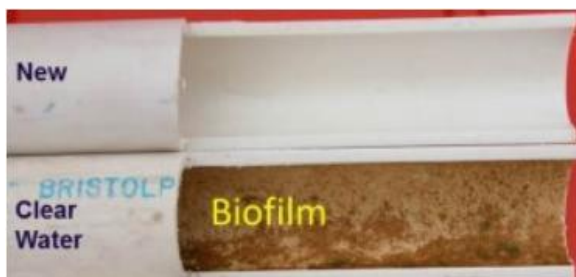
1. Inside the pipes is a biofilm (Image 3) that naturally accumulates on the pipe walls (like cholesterol in arteries).
2. The groundwater from the bores contains manganese, this when mixed with chlorine will discolour the water and while completely safe to drink, being blackish in colour is not palatable.
3. As the water is pumped through town to the tanks, the manganese settles on the bottom of the pipes, in the biofilm, and is suspended in the water.

Image 3 – Biofilm inside a pipe

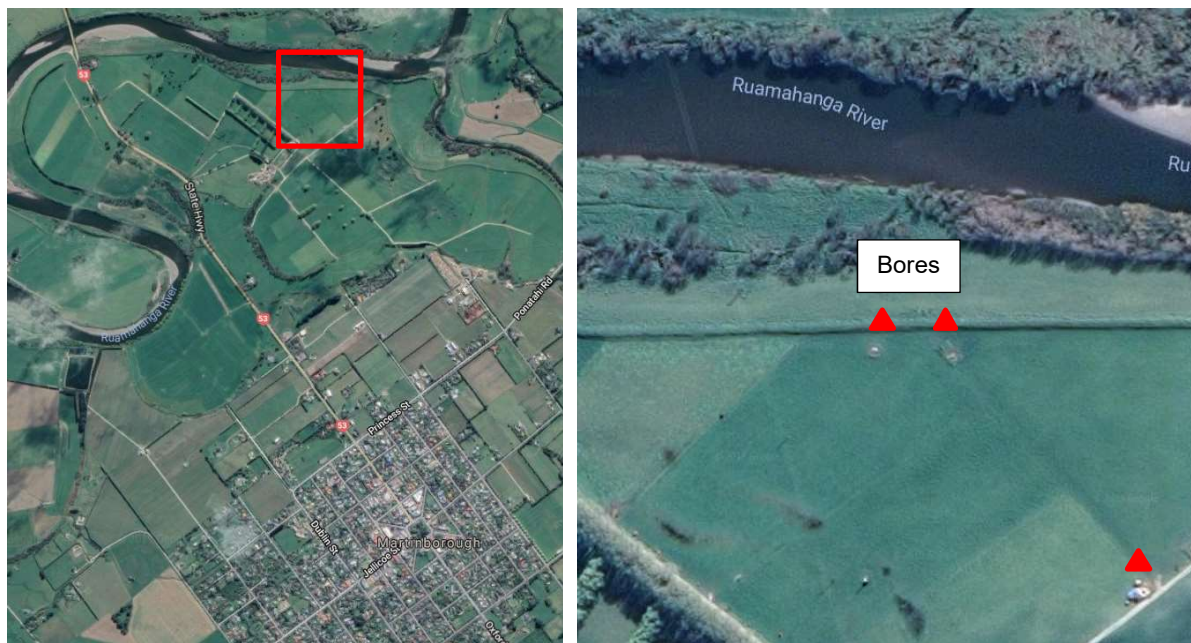
Water for the Martinborough supply is sourced from two bores – Herricks Bores 3 and 4 – located adjacent to the Ruamahanga River on a private dairy farm (Figure 1). The bores are classified as not secure (Morris and Mzila, 2019) and according to the Water Safety Plan (Graham, 2015) require 4 Log protozoa treatment. It is noted that *Cryptosporidium* testing undertaken between June 2016 and July 2017 (SWDC, 2019) showed no *Cryptosporidium* oocysts detected, indicating that the source is likely to require a maximum of 3 Log protozoal treatment. However, this sample data has not yet been assessed by the Drinking Water Assessor (DWA).

Figure 1 – Location of water source and water treatment plant.

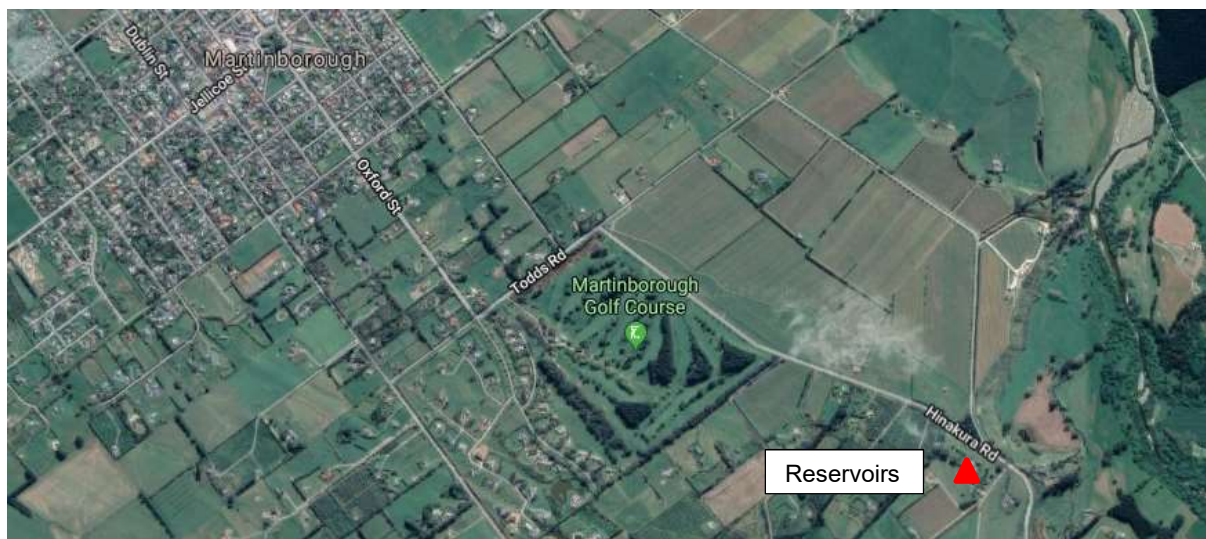
Water is pumped directly from the bores, through the water treatment plant to the reticulation system. There are four reservoirs located at the far end of the system providing a total storage volume of approximately 4000 m³ (Figure 2).

Figure 2 – Location of treated water storage reservoirs.

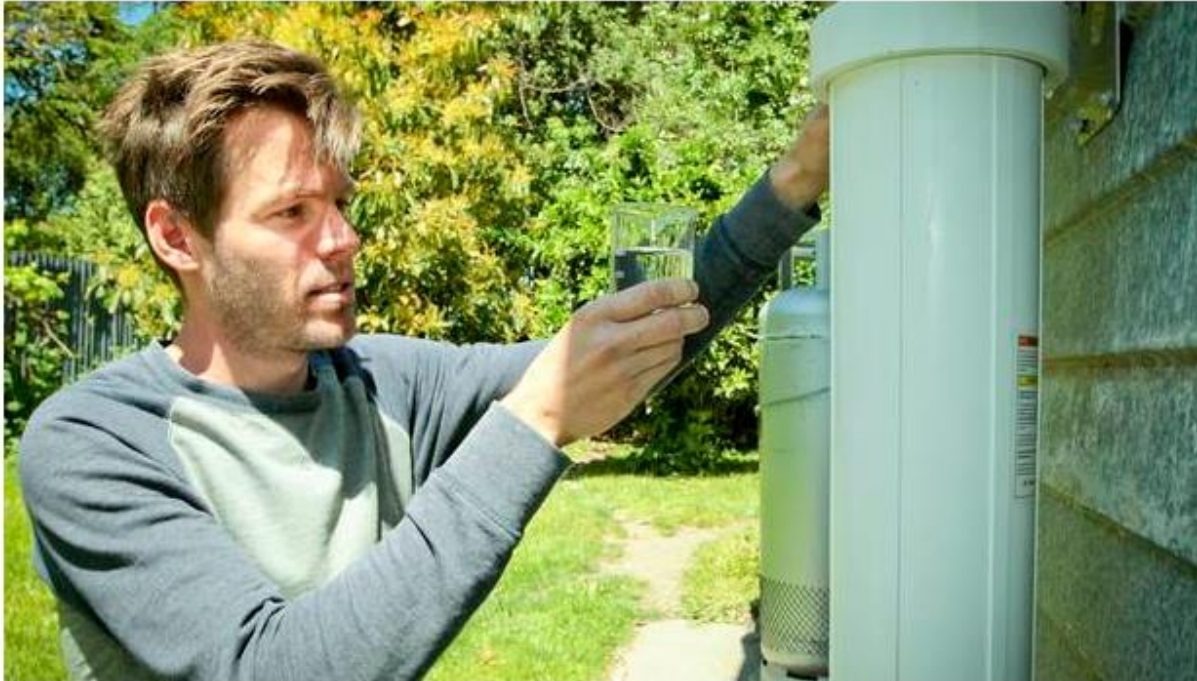
Hastings brewer Matt Smith, owner of Brave Brewing Co, with the carbon filter he has installed to extract the chlorine during beer production. PHOTO/WARREN BUCKLAND
