Cover note from SWDC on the ‘Technical Report: Martinborough Water Treatment Plant – Incident Review’

Document Details	
Client	South Wairarapa District Council
Project	Martinborough Incident Review
Project Number	SWDC001
Report Title	Martinborough Water Treatment Plant – Incident Review
Report Number	SWDC-R01-11
Report Status	Final
Issue Date	04/04/19

- To describe the incident.
- To identify potential intervention points that could have helped prevent this incident happening.
- To recommend corrective actions that will prevent a repeat of the incident.

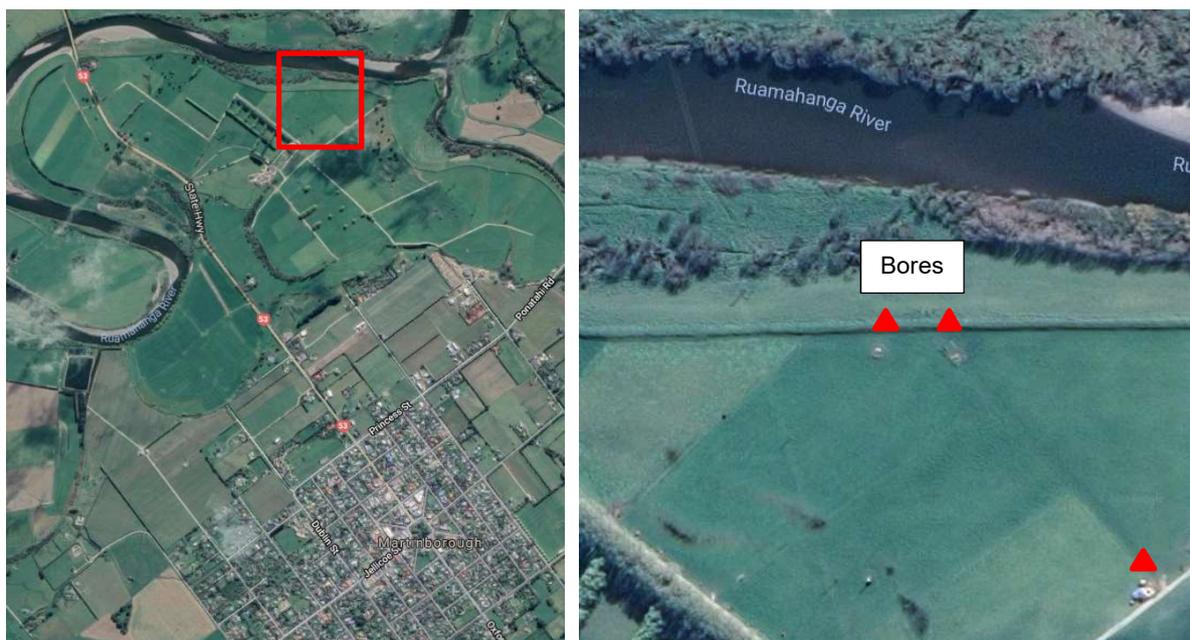
Water for the Martinborough supply is sourced from two bores – Herricks Bores 3 and 4 – located adjacent to the Ruamahanga River on a private dairy farm (Figure 1). The bores are classified as not secure (Morris and Mzila, 2019) and according to the Water Safety Plan (Graham, 2015) require 4 Log protozoa treatment. It is noted that *Cryptosporidium* testing undertaken between June 2016 and July 2017 (SWDC, 2019) showed no *Cryptosporidium* oocysts detected, indicating that the source is likely to require a maximum of 3 Log protozoal treatment. However, this sample data has not yet been assessed by the Drinking Water Assessor (DWA).

Figure 1 – Location of water source and water treatment plant.

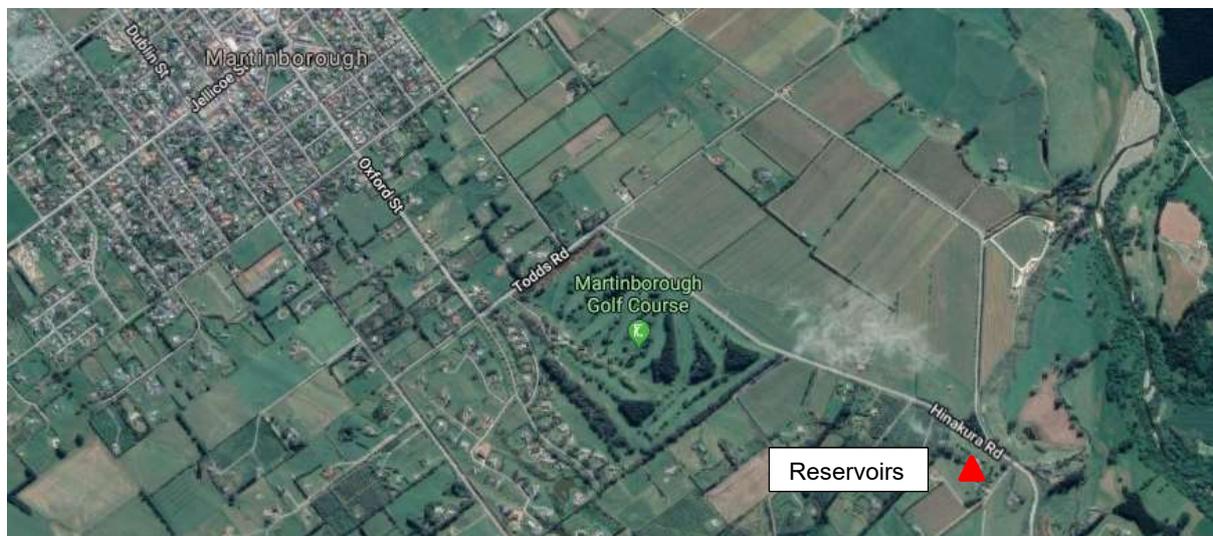
Water is pumped directly from the bores, through the water treatment plant to the reticulation system. There are four reservoirs located at the far end of the system providing a total storage volume of approximately 4000 m³ (Figure 2).

Figure 2 – Location of treated water storage reservoirs.
